## **Geological Solutions for Providing a Scientific Basis for Differing Site Condition Claims**

### **Abstract**

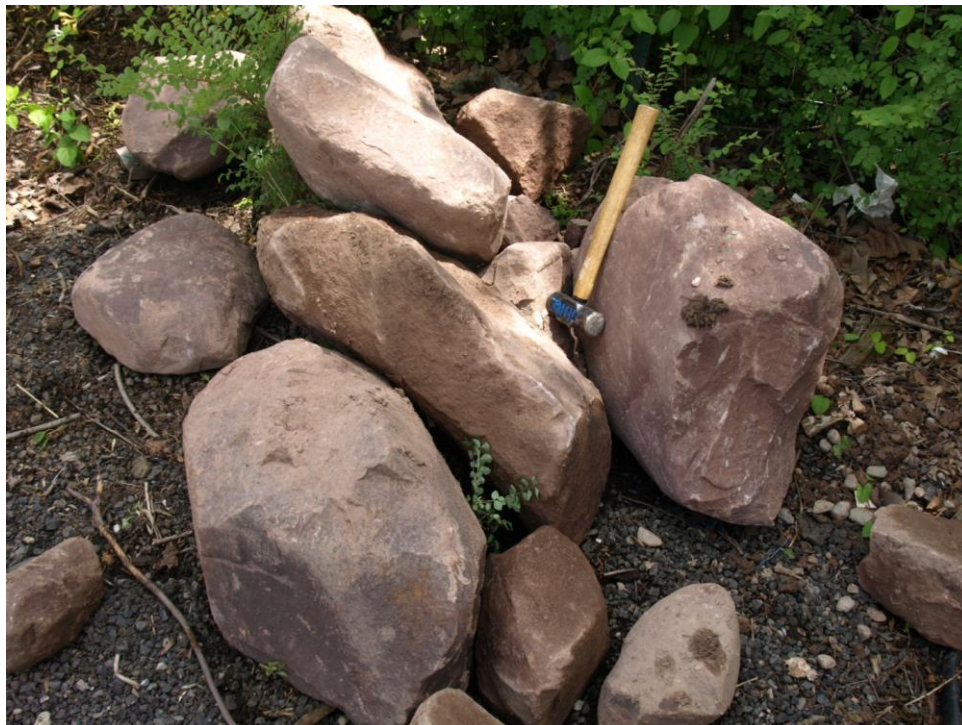
The boulders mucked from within Shaft #23 examined on-site were sub-angular in shape and somewhat tabular, partially smoothed and consisted of Mesozoic Passaic Formation sandstone and siltstone (Figure 3). Notably, although somewhat similar in appearance to glacial boulders, they exhibited curved scratches indicating circular transport and grooving not the straight parallel striae associated with glacial activity. In addition, the boulders did not show the characteristic sub-rounded to rounded shape nor polish glacial boulders and were not exotic but consisted of rock types that are indigenous to the Passaic Formation which underlies the site. One boulder showed parallel joint surfaces outlined with greenish-white mineralization (chlorite+quartz infilling) suggesting the presence of subsurface fractures (joints and/or faults).

Based on the presence of mineralized joints, sub-angular/tabular shape aspect, and curved scratches, our conclusion was that the boulders were locally harvested (not of glacial origin), introduced from the shaft walls during drilling of fractured ground and dragged about during the drilling or mucking process before they were removed from the base of the shaft. Boulder composition was an identical match with the local Passaic bedrock. They were not Paleozoic quartzite or limestone which had been reported as indigenous boulders from within the Passaic

Formation by other field workers. Indeed, these observations forced the conclusion that the boulders were introduced from the shaft walls during construction drilling.

**Figure 3** – View of subangular boulders and cobbles of Passaic Formation siltstone and sandstone mucked from base of Shaft #23. Note the tabular aspect of the boulders, a relic of original bedding, and the incipient polishing by mechanical means. Hammer is 38 cm (15”) in length. (Dukelabs digital image taken 14 June 2013.)

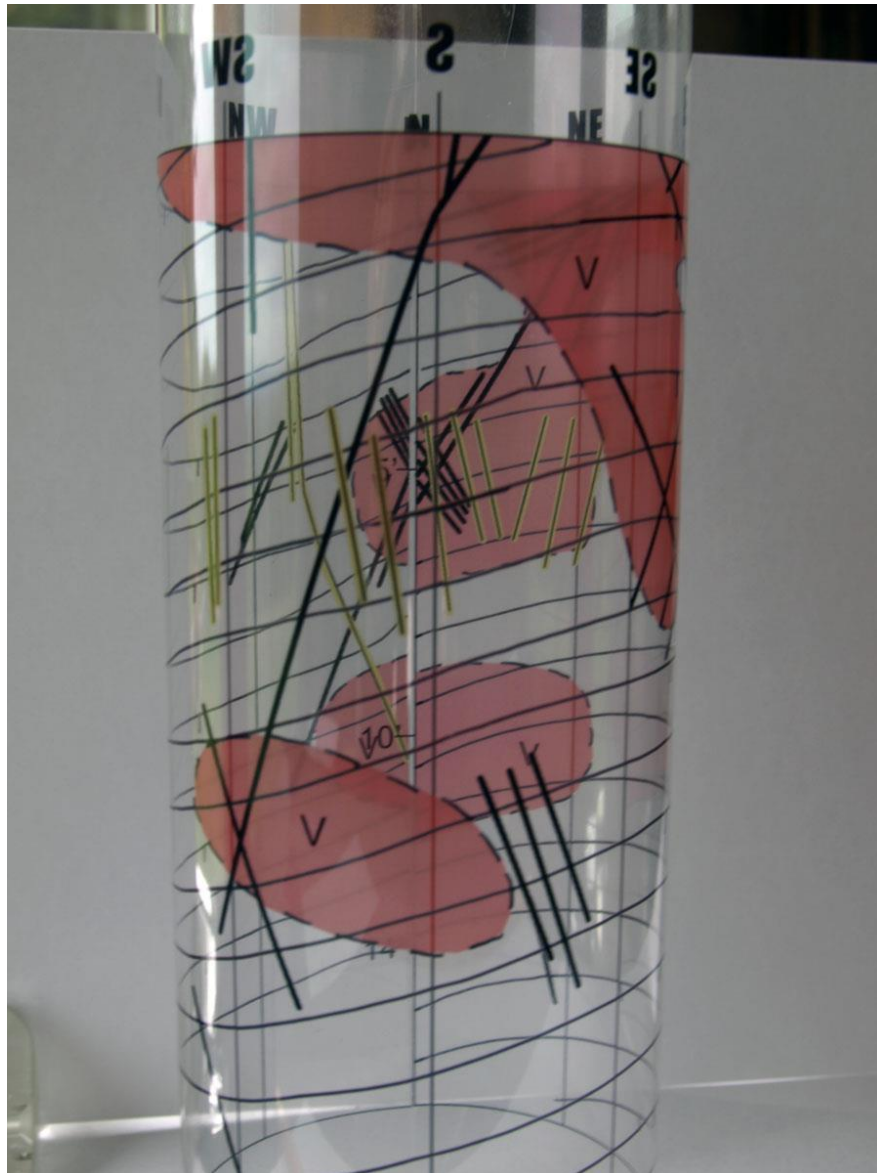
**Figure 7** – Northward view of Shaft #23 rock socket acetate map of Figure 6 curled into a cylinder showing the relationship of bedding planes ( $\sim 14^\circ$  NW dip [thin closely spaced lines]), NNE-, NE- and NW-trending fractures (steep, black lines), and voids (pinkish areas - v). Note that some of the steeper, NNE-trending fractures (outlined in yellow) are mineralized by calcite or whitish zeolite, common minerals found within faults and joints in the Newarkian strata and also observed in the boulders shown in Figure 3, above. Not obvious are gently inclined ( $\sim 14^\circ$ ) fractures that parallel bedding near the top of the map at the base of casing.

The steeper conjugate fractures sometimes show mineralization with calcite or a whitish zeolite mineral as indicated by yellow and black markings in Figures 6 and 7. A third prominent set of steep fractures strike N40°W and dip 70° toward the NE. A fourth set of dislocations occur near the top of rock. These are closely spaced, shallow in dip and cut bedding at a very low angle. These are simple bedding plane joints that trend NE and dip very gently (~14°) NW.

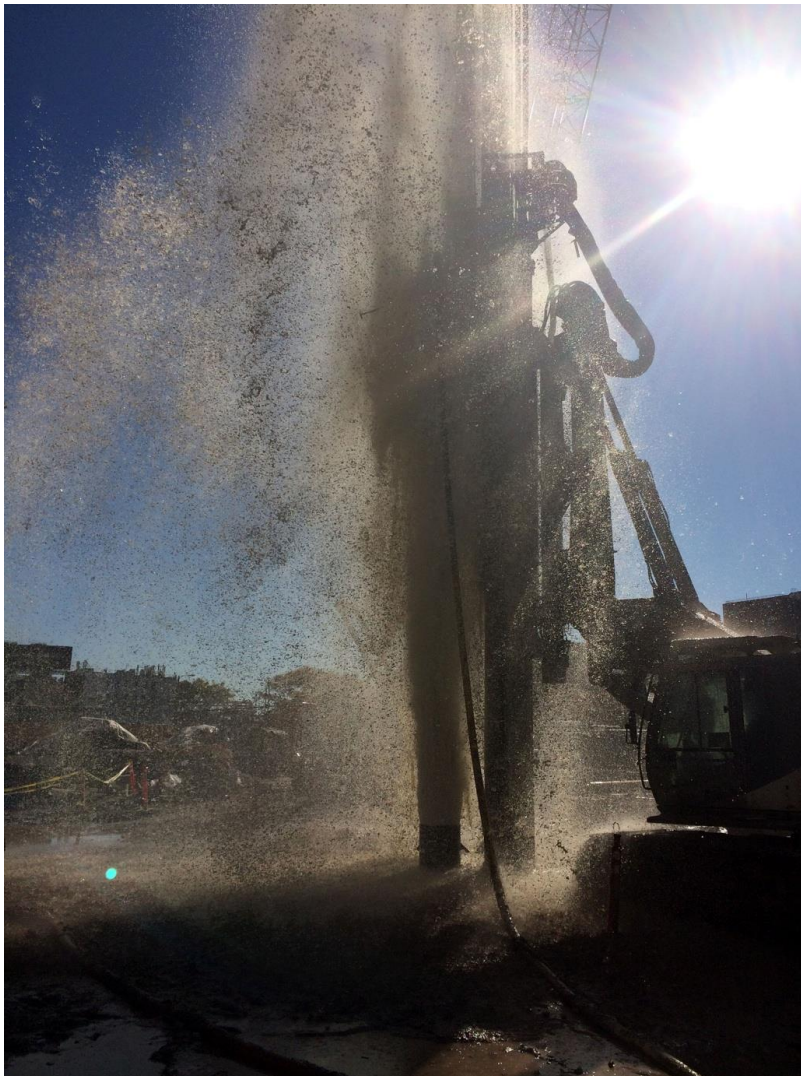
**Figure 9** – View of as-built anomalous water + material flow and geysering associated with caisson drilling in November 2015 at a terrestrial caisson/pile drilling job site. (Contractor image.)

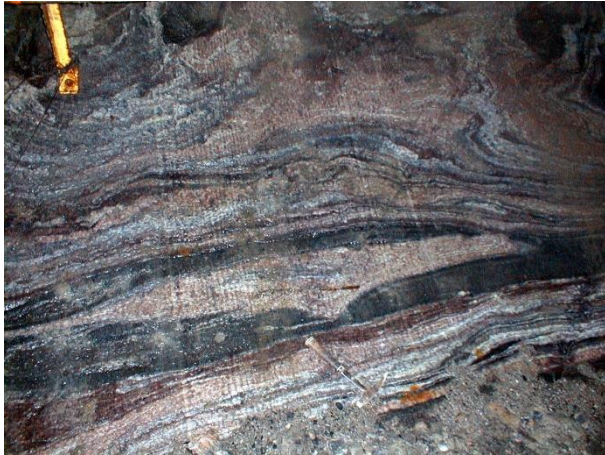
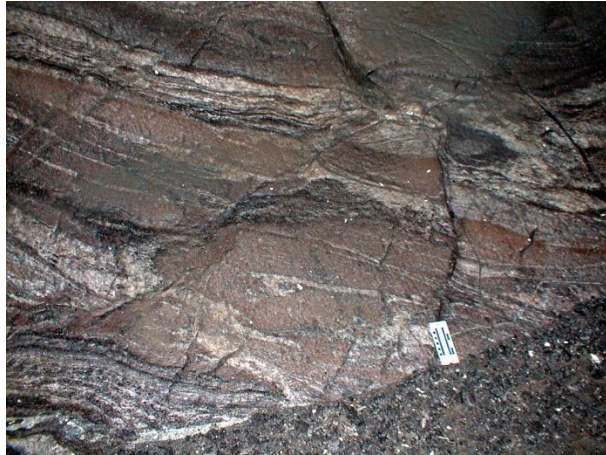
Lacking a penetrative foliation, the coarse-textured granoblastic rock texture and extraordinary garnet content of up to 50% in some zones that underlie ~11% of the entire tunnel (Figures 27A, B; Table 1) together proved an impediment to efficient TBM chip production and resulted in bimodal production of rock powder (excessive fines) and large blocks that choked TBM grizzlies and damaged outgoing conveyor belt systems (Merguerian and Ozdemir 2003).

**Figures 27A, B** – Views of two of the 32 garnet zones mapped in Tunnel #1 showing the anomalously high concentration (up to 50%) of dense garnet that defines such zones. Highlighted in yellow on Table 1 (below) the garnet zones 9 (A.) and 21 (B.) were produced during phases of granulite- followed by upper-amphibolite facies metamorphism as detected in the petrographic analysis of mineralogy and rock mass textures.
