Geological Solutions: Pre-Bid Risk Assessment and As-Built Claims in the NY Metropolitan Region

Charles Merguerian¹, Ph.D., P.G. and J. Mickey Merguerian², M. Sci.

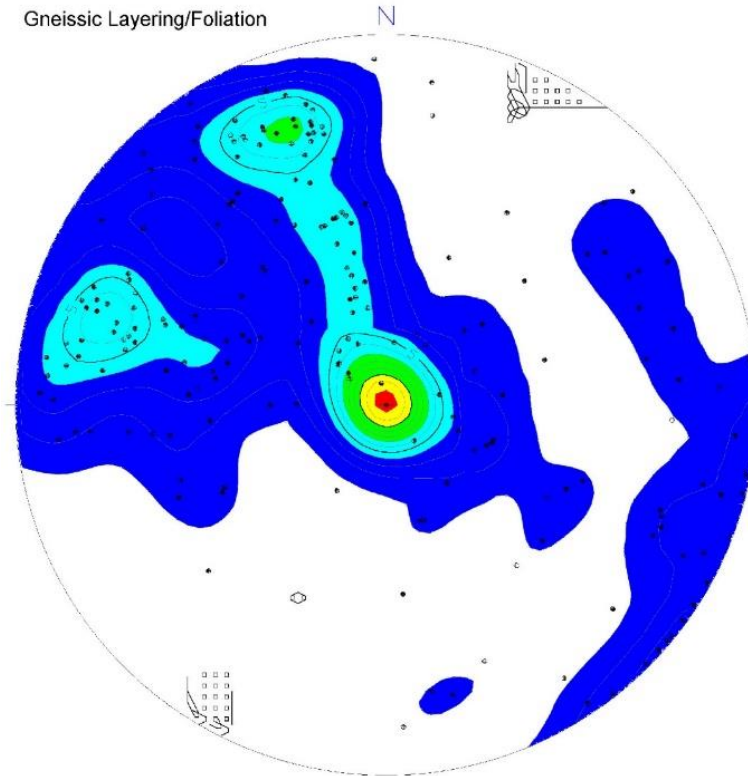
that the gneissic fabric exposed in Tunnel #1 was not in a favorable orientation for efficient TBM mining. Although the pre-bid data indicated a NE-trending moderate to steep SE-dipping rock fabric, stereonet analysis (Figure 4) of the gneissic layering between Stations 4+00 and 254+00 demonstrated that 26 of 235 poles (11%) indicated subhorizontal layering and that 64 poles (27%) show gentle dips (less than 30°). Thus, subhorizontal to gently dipping rock fabrics underlie broad tracts (~38%) of Tunnel #1. This low-angle structural grain of Tunnel #1 presented an unfavorable rock fabric orientation for efficient TBM chip production and contributed to the problem of rock powdering (excessive fines) and low advance rates.

Figure 4 – Gently inclined clustering of stereonet poles (~38%) together with anticipated NNE- and ENE-strike and moderate to steep scattered SE dips of gneissic layering/foliation (n = 254).

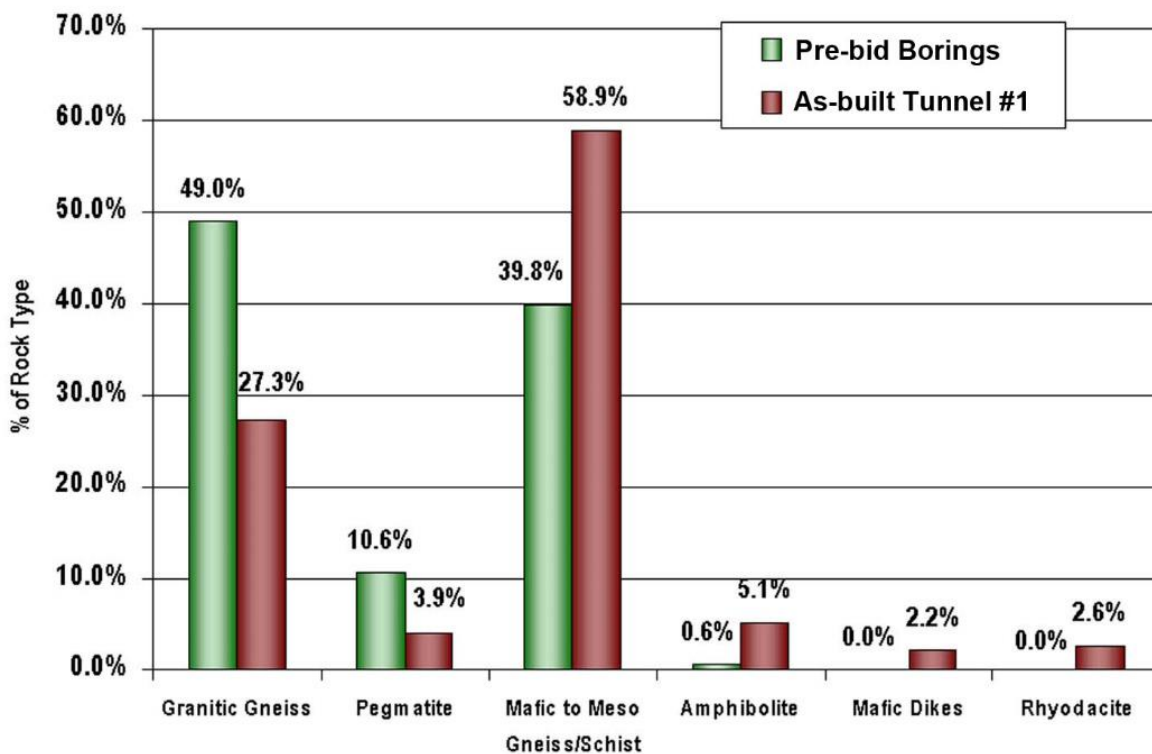
A comparison between mapped Tunnel #1 lithotypes vs. those depicted in the borings logs at the tunnel horizon showed that the logs did not identify the proportion of various rock types (Figure 6). This resulted in an improper choice of TBM cutterhead tooling (cutter metallurgy, number and diameter) for the planned tunnel drive.

Figure 6 - Bar graph showing disparity between anticipated lithotypes identified by examining pre-bid borings (green) vs. those found to occur in the tunnel drive based on as-built mapping (red). Note the difference in the relative proportion of granitic and pegmatitic (felsic) rocks vs. the mafic, amphibolitic, and mesocratic (mafic and intermediate) rocks and the presence of unanticipated rocks of rhyodacite affinity. This lithologic variation from pre-bid anticipation proved an impediment to efficient mining. (Adapted from Merguerian and Ozdemir, 2003.)

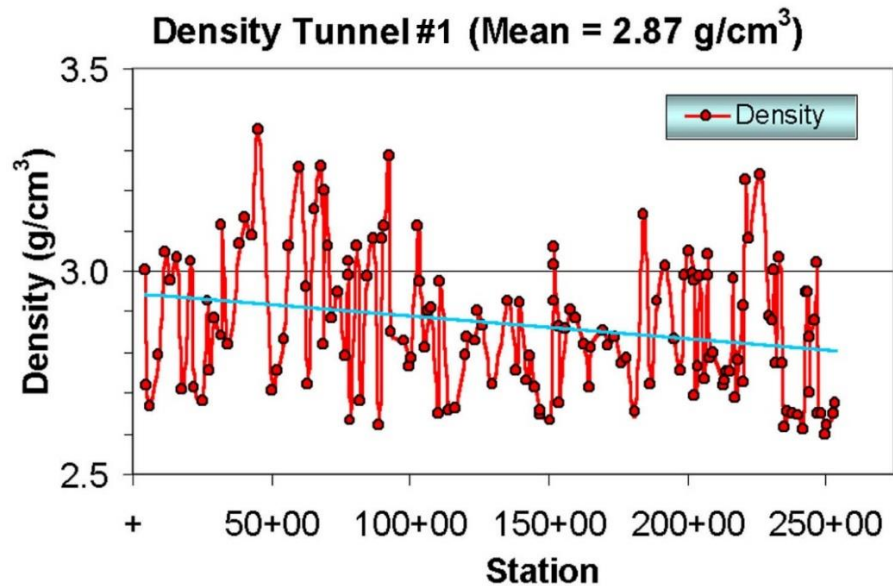
Figure 7 – Rock mass density variation as compiled from sawn slabs from 161 samples collected during as-built mapping of Tunnel #1, NYC. The graph indicates that the bulk density of the tunnel varied from 2.62 to 3.35 gm/cm³ and that density decreased slightly toward the higher stations (sloping blue line) as shown by the mapping. The mean density (2.87 g/cm³) was in keeping with the lithotype analysis that indicated that more intermediate- to mafic lithologies by comparison to what the pre-bid borings indicated. (See Figure 6.) Typical schistose and interlayered granofels such as anticipated in the Hartland Formation should have averaged about 2.55 g/cm³. (Adapted from Merguerian and Ozdemir 2003.)

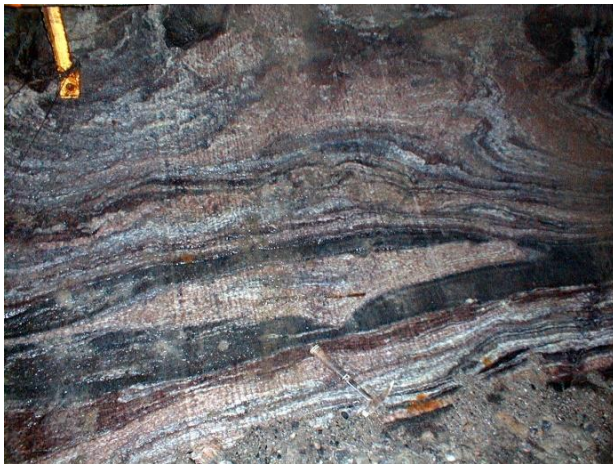
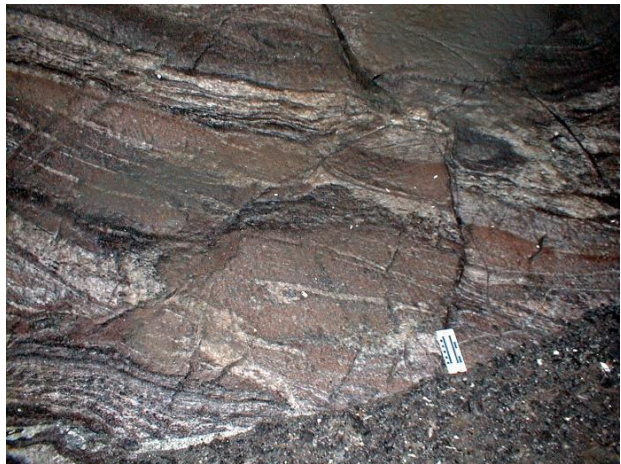
Penetration Rates. Average TBM penetration rates of <2 m/hour were encountered in Tunnel #1 during excavation rather than the 3m/hour anticipated. Despite the fact that pre-bid documents provided by the owner indicated that the Hartland Formation was anticipated along the tunnel alignment, as-built structural, lithologic, and petrographic studies showed that the rocks of Tunnel #1 consisted of tough orthogneiss of mesocratic, mafic and leucocratic composition. These metaigneous rocks developed coarse-textured fabrics during Grenvillian high-pressure granulite facies metamorphism, and retained their nearly anhydrous, poorly foliated character during subsequent high-grade Ordovician and younger deformation and upper amphibolite facies metamorphism (Figure 8). Lacking a penetrative foliation, the coarse-textured granoblastic rock texture and extraordinary garnet content of up to 50% in some zones and mapped to underlie ~11% of the entire tunnel (Figures 9A, B; Table 1) together proved an

impediment to efficient chip production and resulted in bimodal production of excessive fines and large blocks that choked TBM grizzlies and damaged conveyor belt systems.

Table 1 – Compilation of anomalous garnetiferous zones of Tunnel #1 showing that excessive garnet concentrations underlie almost 11% of the tunnel which resulted in untimely TBM cutter wear and the production of excessive fines. Petrographic analysis indicated that garnet production was the result of both primary and secondary metamorphism of the granulite facies metamorphism that effected the terrain. Yellow highlighted zones (Nos. 9, 21) are shown above in Figures 9A and 9B.

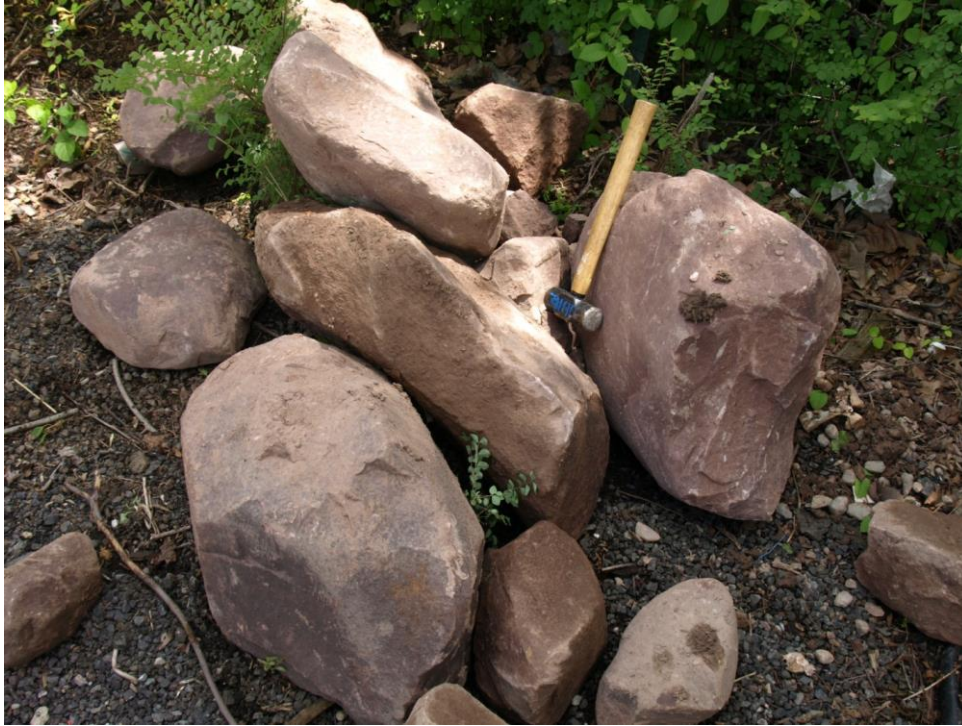
Based on the presence of mineralized joints, sub-angular/tabular shape aspect, and curved scratches, our conclusion was that the boulders were locally harvested (not glacial), introduced from the shaft walls during drilling of fractured ground and dragged about during the drilling or mucking process before they were removed from the base of the shaft. Boulder composition was an identical match with the local Passaic bedrock. They were not Paleozoic quartzite or

limestone which had been reported as boulders from within the Passaic Formation by other field workers. These observations forced the conclusion that the boulders were introduced from the shaft walls during construction drilling.

Figure 12 – View of subangular boulders and cobbles of Passaic Formation siltstone and sandstone muck collected from base of Shaft #23. Note the tabular aspect of the boulders, a relic of original bedding, and the incipient polishing by mechanical means. Hammer is 38 cm (15”) in length. (Dukelabs digital image taken 14 June 2013.)

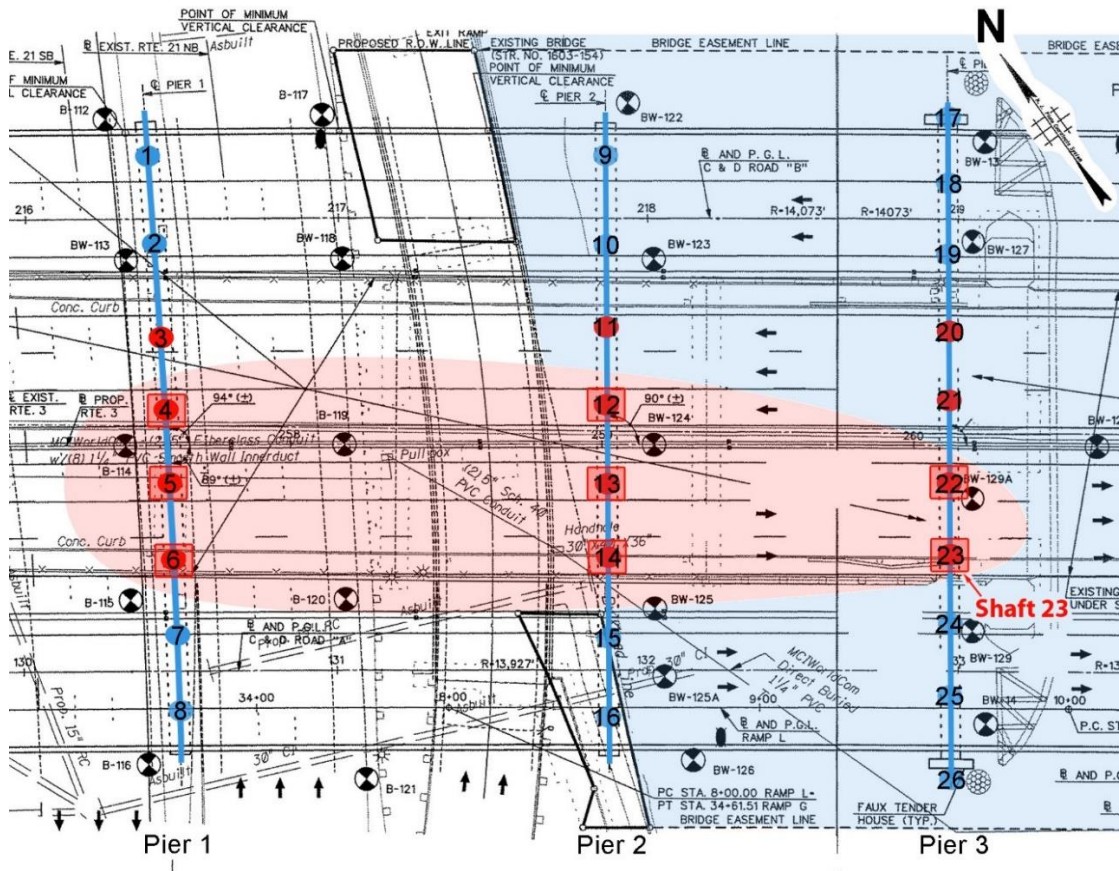
Figure 13 – Site map showing the eight problem shafts (4, 5, 6, 12, 13, 14, 22 and 23 – boxed and numbered red circles) drilled in Piers 1, 2 and 3 and how they define a NW- to SE-trending zone of similar ground effects (pink ellipse) both on land (uncolored) and within the river (blue).

Note that on Figures 13 and 17 that the eight DSC caissons (Shafts #4, 5, 6, 12, 13, 14, 22 and 23) are not evenly distributed throughout the jobsite but are spatially oriented with a NW to SE alignment parallel to the NW-SE faults. This is additional evidence for a DSC with 17.8% of the 45 shafts affected as the extension of mapped faults conforms to the pink ellipse of affected shafts shown in Figure 17. Thus, there appears to be geological explanation of cause and effect.

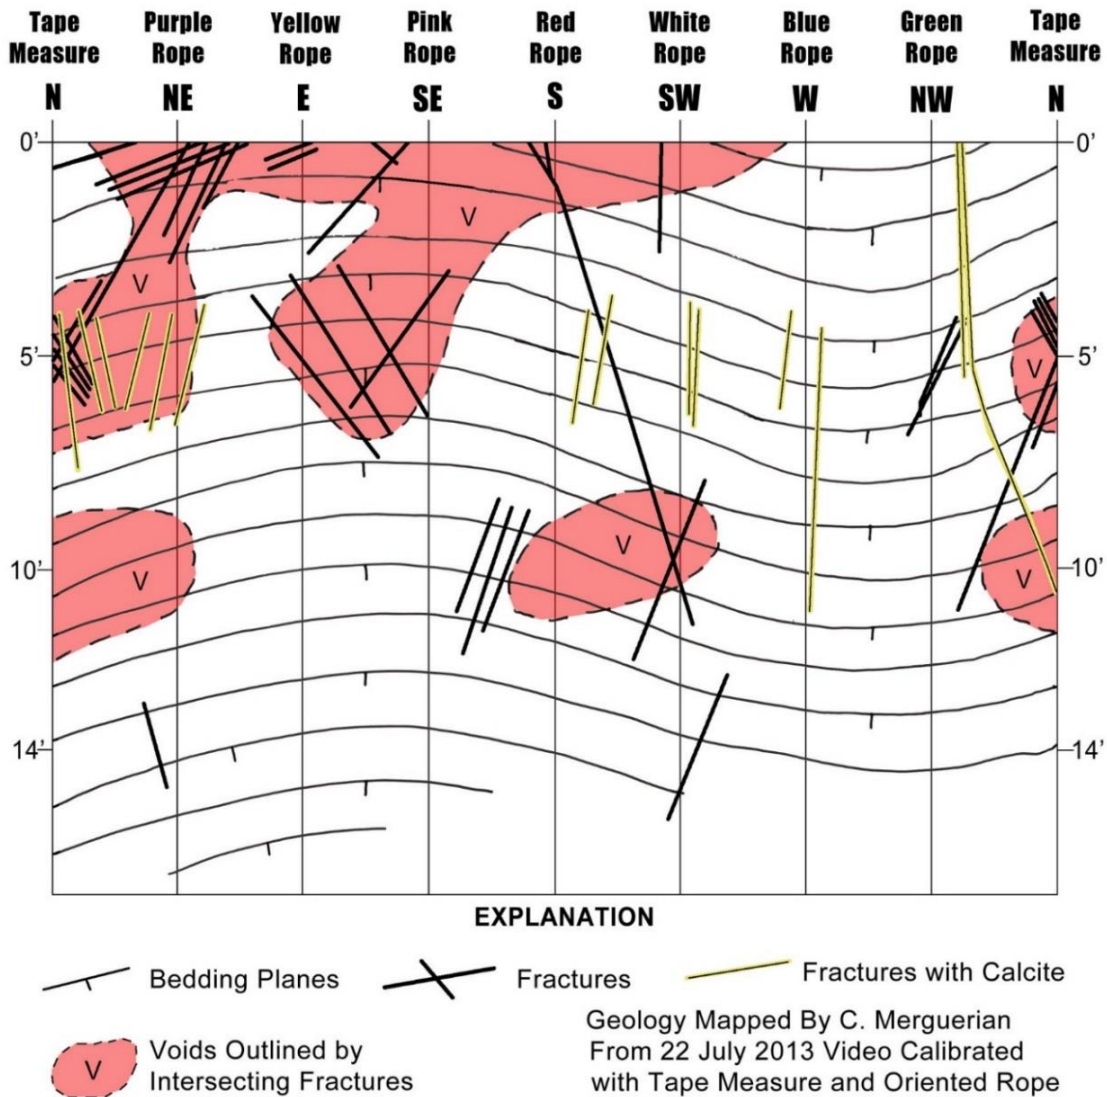
CIRCUMFERENTIAL MAP - SHAFT 23 ROCK SOCKET PASSAIC RIVER BRIDGE

Figure 15 – Circumferential 2-D geological map of bridge Shaft #23 rock socket of 90” (7.5’) diameter showing orientation of inclined bedding planes (thin black lines with tick marks), intersecting steep to gentle fractures (thick black lines) and open voids where blocks fell out of socket sidewall (v - pink areas). Also shown are mineralized fractures in yellow and black. Drawn with no vertical exaggeration. Compass directions are magnetic.

Figures 15 and 16 show gentle NW-dipping bedding ($\sim 14^\circ$ - thin, closely spaced black lines) and bedding-plane joints near the top of rock cut by high-angle (60° - 90°), oft-times mineralized fractures (steep thicker black lines). The steep fractures fall into three major geometric classes. The most prominent and through-going feature is a fissure that extends through the rock socket center and downward over 10' in extent with a $N35^\circ E$ strike and $75^\circ NW$ dip (center of image in Figure 16). Also mapped were at least five (5) less extensive fractures that parallel this main fissure as is common in fault zones. A second prominent set of fractures strike $N40^\circ W$ and dip 70° toward the NE. There is also a younger, third set of shorter, closely spaced mineralized conjugate fractures with a $N25^\circ E$ strike and $80^\circ SE$ dip fanning through vertical to dips of $80^\circ NW$. These discontinuities overlap and seem to crosscut the older NE-and

Figure 15 shows that four major open voids exist in the drilled rock socket of Shaft #23 from the base of the casing to about 8' depth, then again at about 10' depth. The voids are 3' to 8' in extent, extend a few feet deep into the sidewall and are concentrated up-dip in the eastern half-perimeter of the rock socket as would be expected if the blocks initially slid along bedding-parallel fracture planes into the rock socket. Many of the open voids were found to terminate against steep planar fractures surfaces suggesting emphatic fault control. Figures 15 and 16 clearly document the relationship between areas of multiply fractured bedrock and associated voids.

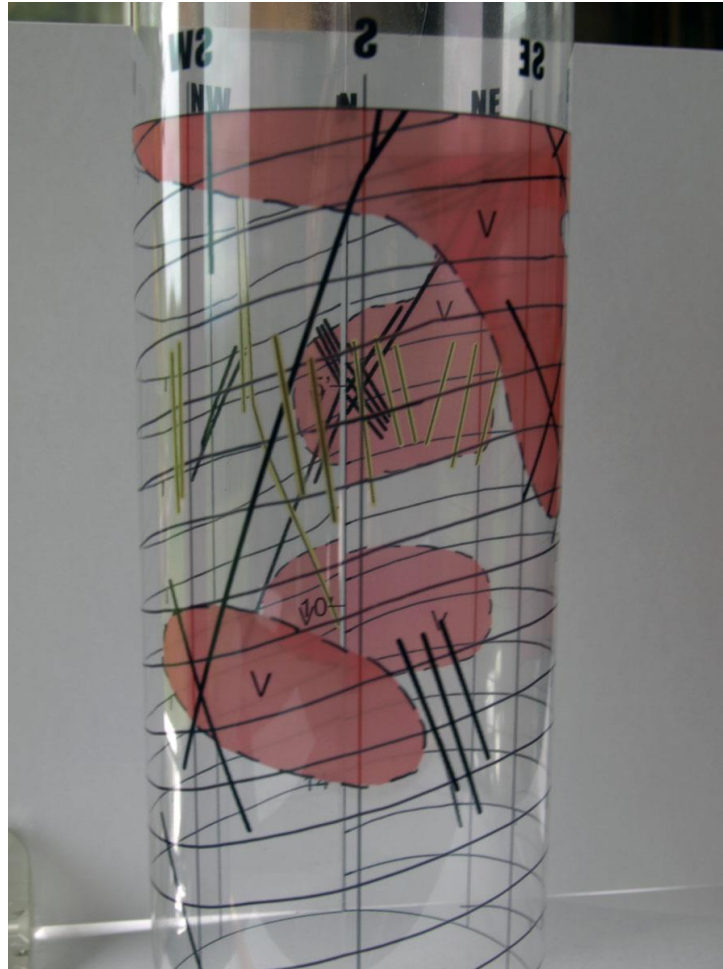
Figure 16 – Northward view of Shaft #23 rock socket acetate map of Figure 15 curled into a cylinder showing the relationship of bedding planes ($\sim 14^\circ$ NW dip [thin closely spaced lines]), NNE-, NE- and NW-trending fractures (steep, black lines), and voids (pinkish areas - v). Note that some of the steeper, NNE-trending fractures (outlined in yellow) are mineralized by calcite or whitish zeolite, common minerals found within faults and joints in the Newarkian strata and also observed in the boulders shown in Figure 12, above. Not obvious are gently inclined ($\sim 14^\circ$) fractures that parallel bedding near the top of the map at the base of casing.

NW-trending fracture sets. The steeper conjugate fractures sometimes show mineralization with calcite or a whitish zeolite mineral as indicated by yellow and black markings in Figures 15 and 16. A fourth set of fractures occur near the top of rock. These are closely spaced, shallow in dip and parallel bedding. These are simple bedding plane joints that trend NE and dip very gently (~14°) NW.

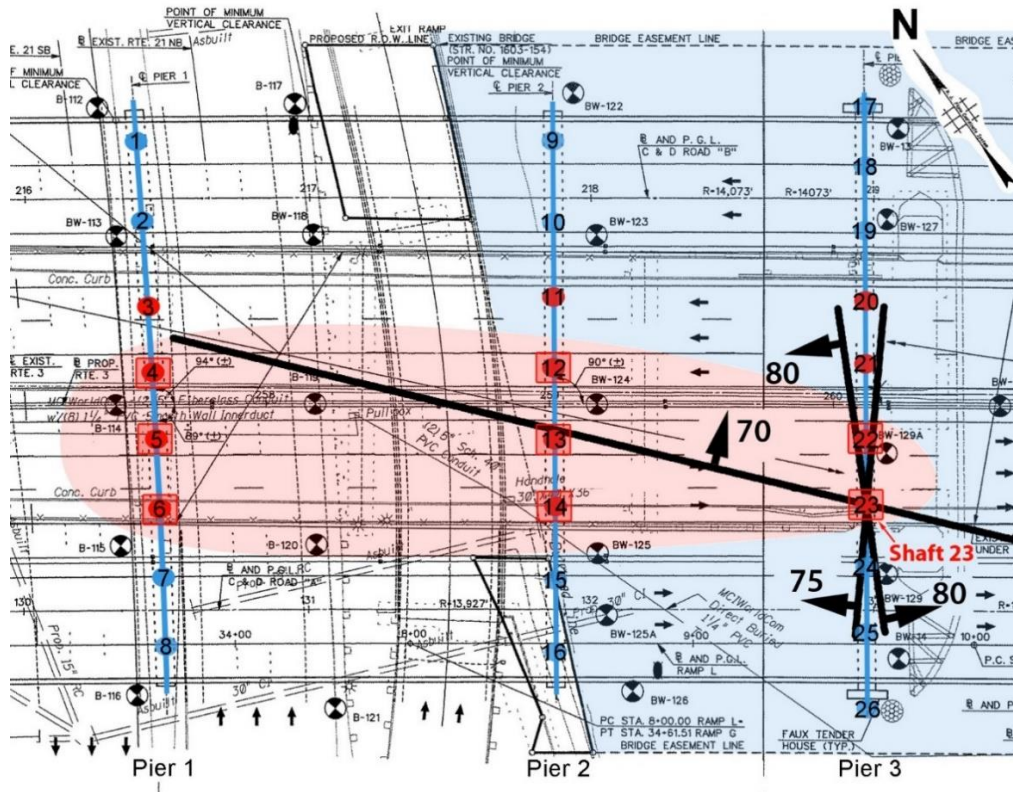
Multiple fault and fracture convergence as found at the Shaft #23 site are unusual geometric subsurface conditions. Convergent high-angle fractures superimposed on gently inclined bedding plane joints created blocky ground and the excavation led to voids because of fallout from the sidewalls. The Shaft #23 site showed changed site conditions but the projection of fracture trends to other shaft sites explained the formidable extent of bad ground conditions extending out from the Shaft #23 zone of fracture convergence and intersection.

analysis and map-based geological analysis. This investigation documented open voids and unstable sidewall conditions at Shaft #23 and provided a natural geological cause for the DSC. Anomalies at Shaft #23 extended northwestward to include other shaft sites where similar voids and blocky, unstable ground with exceedingly short stand-up times resulted in excessive water- and material-inflows and shaft sidewall blocky fallout suggesting far-ranging fault effects of the N40°W-trending fault set that dips ~70°NE. (Compare Figures 15 through 17.)

Figure 17 – Plan view of DSC claim area (pink ellipse) that includes the eight problem shafts encountered during Piers 1, 2 and 3 drilling of the bridge. The faults and related joints mapped and shown in Figures 15 and 16 from Shaft #23 are plotted to show their crosscutting relationships and structural control on the associated problem shafts of the DSC claim. Note the three steep fracture systems (N40°W strike, 70°NE dip; N35°E strike, 75°NW dip and N25°E strike with conjugate dips fanning from 80°NW through vertical to 80°SW). These intersecting fractures extend outward from that zone of convergent intersection and cut gently inclined in-situ bedding planes and sub-parallel shallow joints at Shaft #23. Note that all faults were plotted with respect to True North as the magnetic declination at the site in 2013 was -12° 50' (12° 50' W of True North).

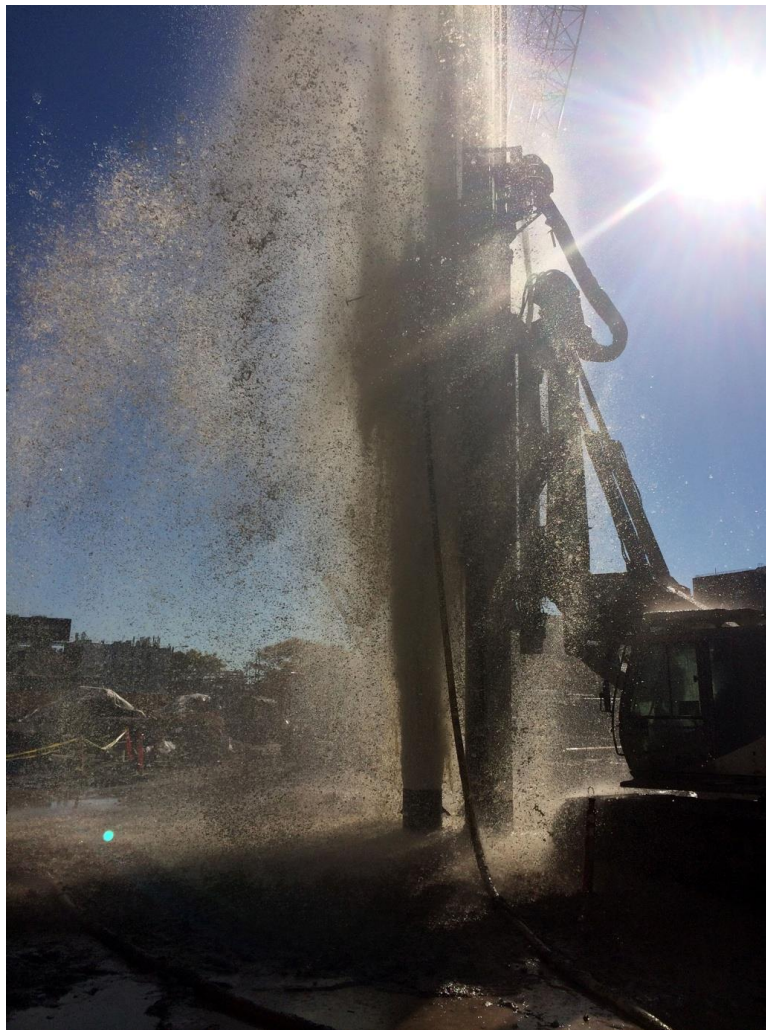
Figure 18 – View of as-built anomalous water + material flow and geysering associated with ~100' deep caisson drilling in November 2015 at the job site. (Contractor image.)

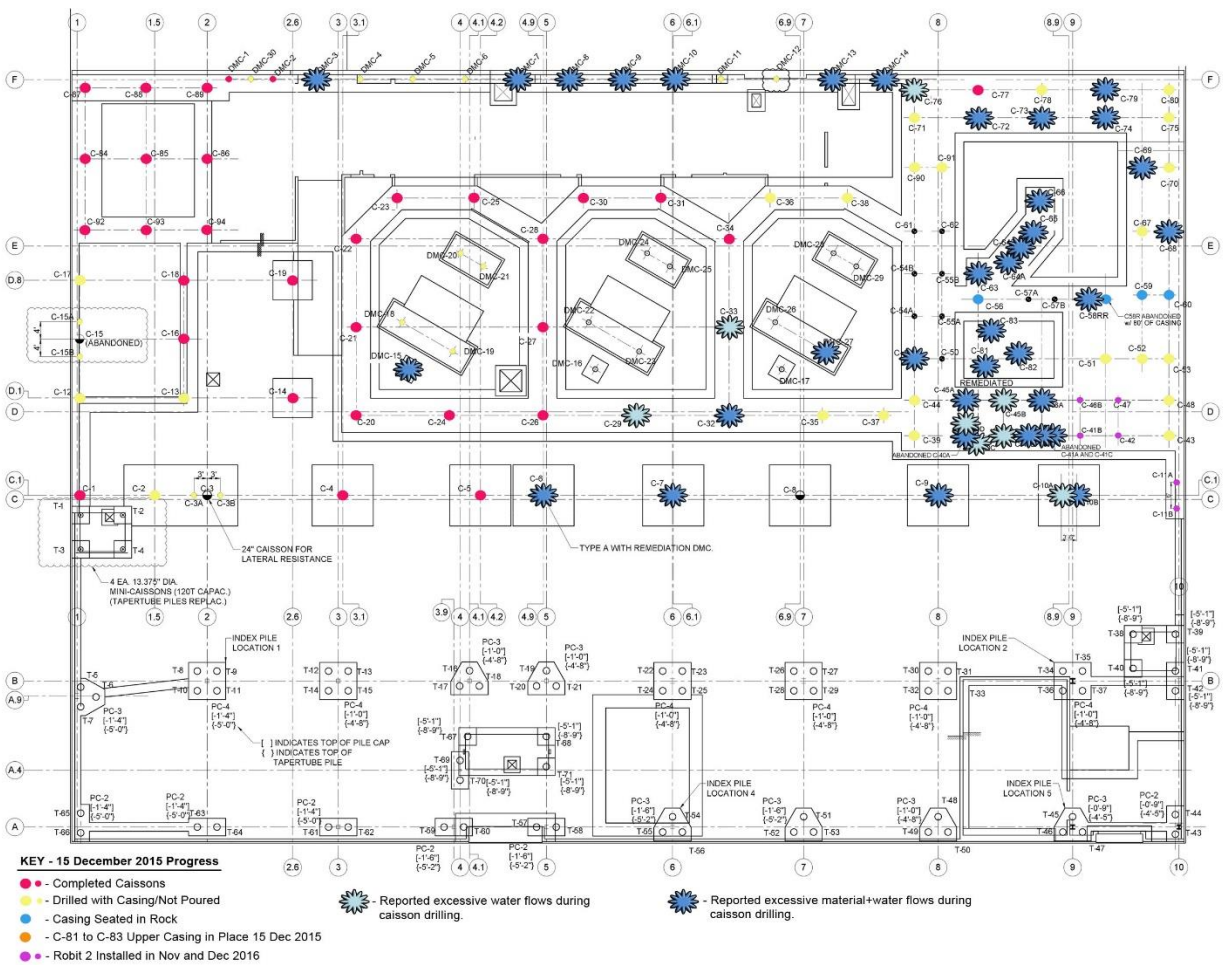
The problem caisson sites were not scattered throughout the site footprint which argued against any notion of improper means and methods (down-the-hole hammer systems) which were approved by the owners. Rather, the problem caissons were clustered in the northeastern corner of the site (Figure 20) near an adjacent, unsupported old-construction brick and mortar building which settled, tilted, cracked and became severely damaged. What is more, water and material communication occurred between widely separated drilled caisson/pile sites indicating significant subsurface connectivity of transmissive features. Site reports by the contractors and the owner's resident engineers reported "heavy water, sand, and rock; excessive water from casing; thick (heavy) sediment inflows up to 25'; seams; rock ledges; dirty discharge; large rocks; sockets making water; communication between open drill sites; flooding of the jobsite; spoils on the ground; and equipment damage including broken shoes, rig tilting, hammer clogging and unanticipated hammer firing."

Figure 20 – Site plan showing the clustering of forty-four (44) caisson sites where installation was met with construction difficulties associated with flowing water only (light blue symbols) and water + material outflows (dark blue symbols). The remaining caisson sites shown in red, yellow, orange, black, noncolored and purple were drilled without difficulty. Project north to top of map.

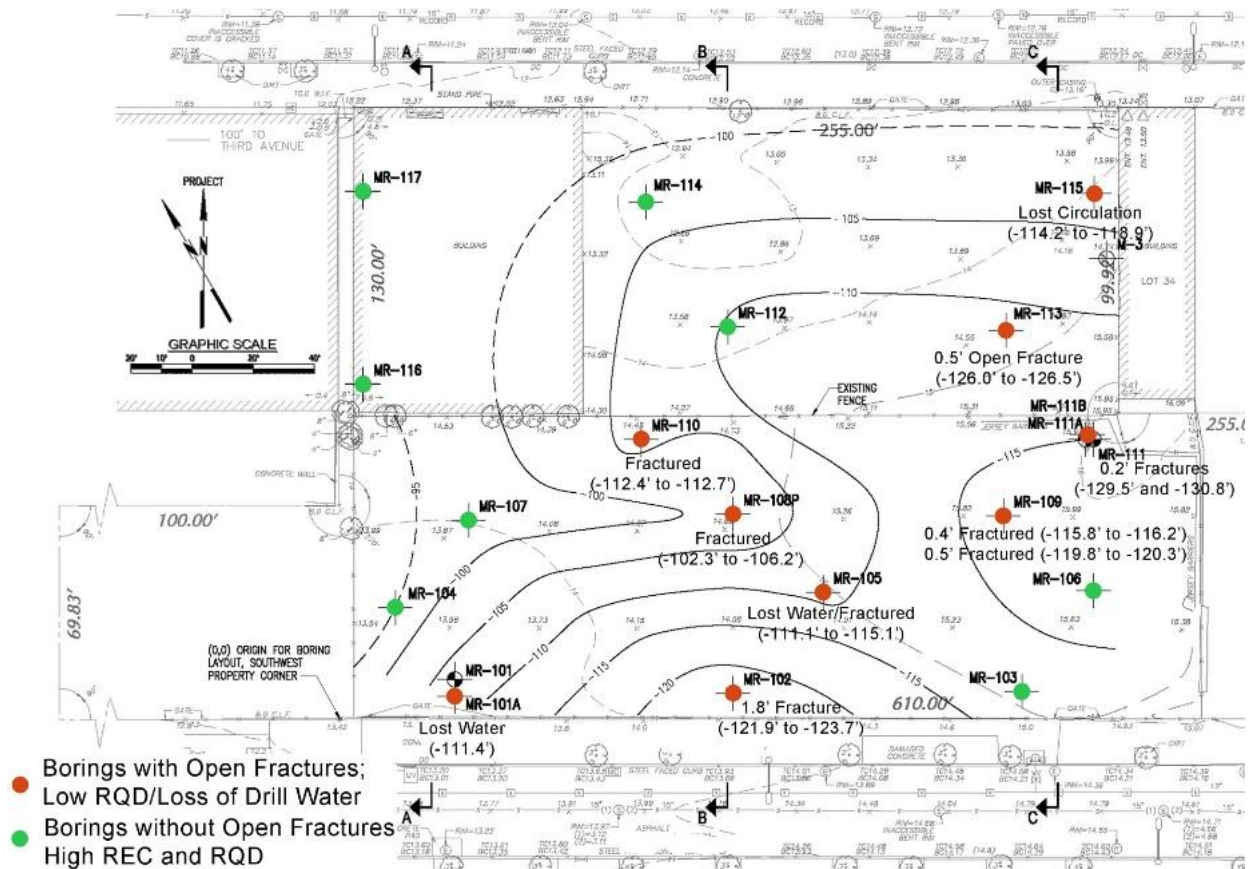
Figure 21 – Site plan map showing topographic data, annotated boring locations (MR-series) and top of rock contours within the footprint of the site. Nine borings with open fractures, low recovery and RQD values, and/or reported "loss of drill water" are shown in red. Eight competent borings without reported open fractures and with high recovery and RQD values are shown in green. Note the roughly E-W clustered trend of the red borings.

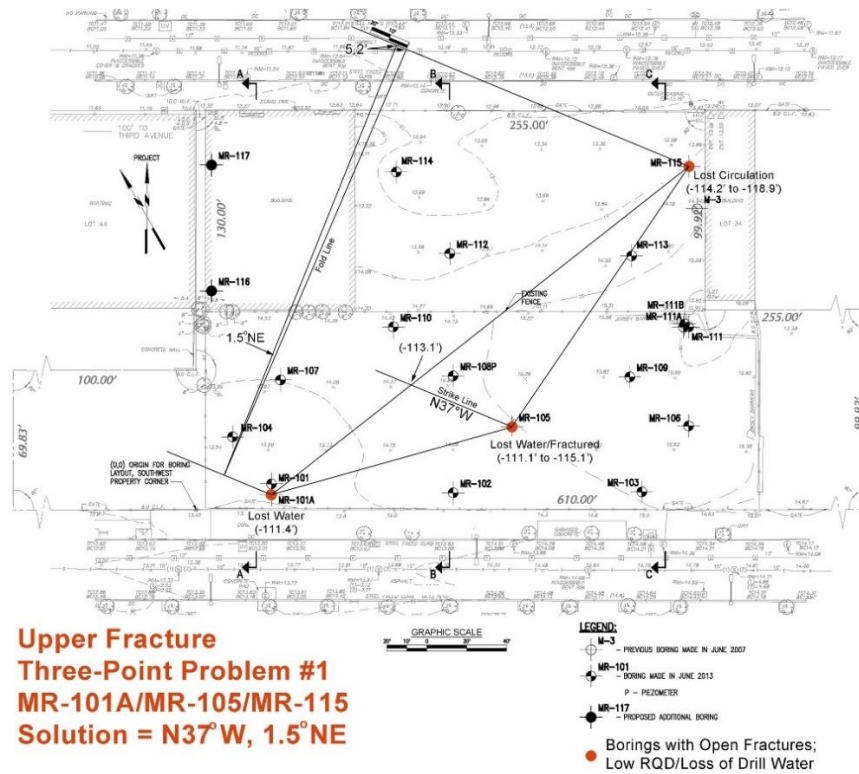
Using the method described above, Figure 22 (three-point problem solution #1) shows that three "*loss of drill water*" borings provided a solution that identifies an open fracture or fracture zone oriented N37°W, 1.5°NE. In order to test for and verify the lateral extent of the feature detected in Figure 22 we also grouped boring MR-101A, MR-105, and MR-115 as similar because of an RQD drop in Run 3C (64%) after much higher values in Runs 1C, 2C and 4C (REC and RQD % values both ranged from 95%-100% in these runs) and the logging of open (0.3') fractures. This allowed for two additional three-point solutions (Figure 23 and 24) which yielded nearly identical strike and dip solutions. (Compare Figures 22 through 24.)

Figure 22 – Solution #1 for upper fracture. (Borings MR-101A, MR-105, and MR-115.)

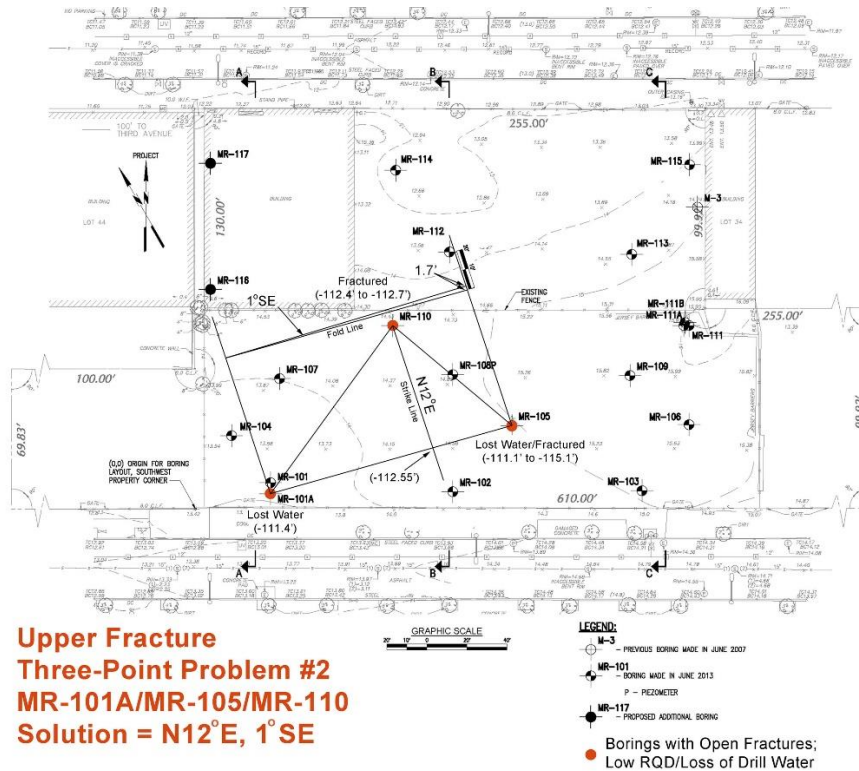
Figure 23 (three-point problem solution #2) shows an open fracture oriented N12°E, 1°SE for borings MR-101A, MR-105, and MR-110. Figure 24 (three-point problem solution #3) shows an open fracture oriented N3°W, 1.5°NE for borings MR-105, MR-110, and MR-115. Keeping in mind that strike varies greatly for very gently inclined features and is, in fact, infinite as one approaches 0° dip, all three solutions are considered to be in agreement - they define an open, through-going continuous upper fracture zone from one end of the site to the other with an approximate N-S strike and an average essentially subhorizontal eastward dip of 1.4°. Clearly, three groups of overlapping solutions that yield nearly identical orientations support the explanation and existence of the subsurface feature. In addition, the solutions provide continuity for identifying the lateral extent of the fractures below the site.

Figure 23 – Solution #2 for upper fracture. (Borings MR-101A, MR-105, and MR-110.)

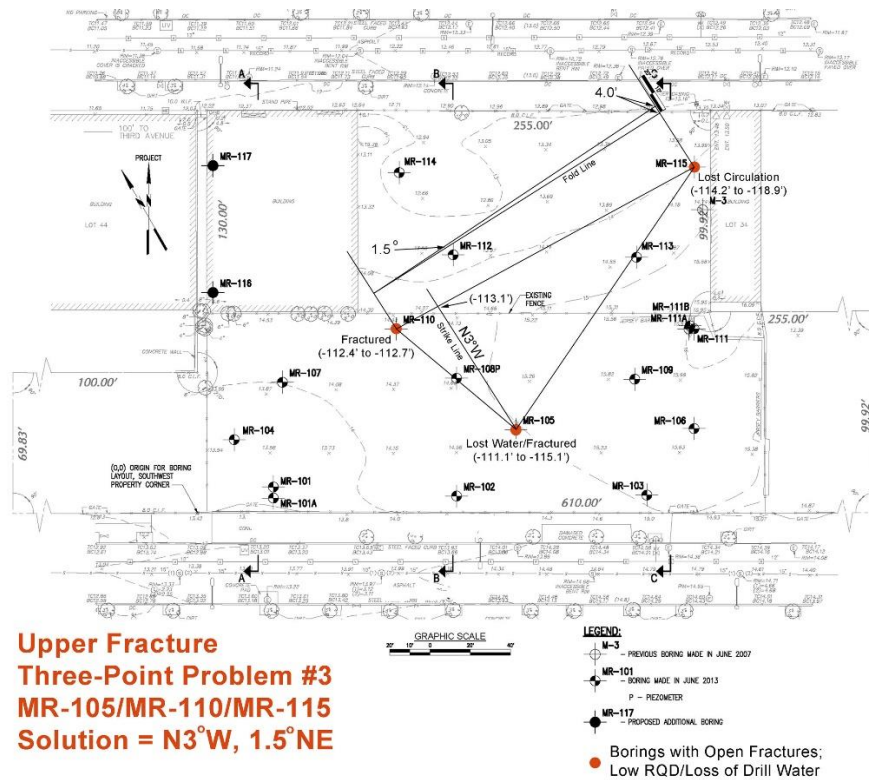
Figure 24 –Solution #3 for upper fracture. (Borings MR-105, MR-110, and MR-115.)

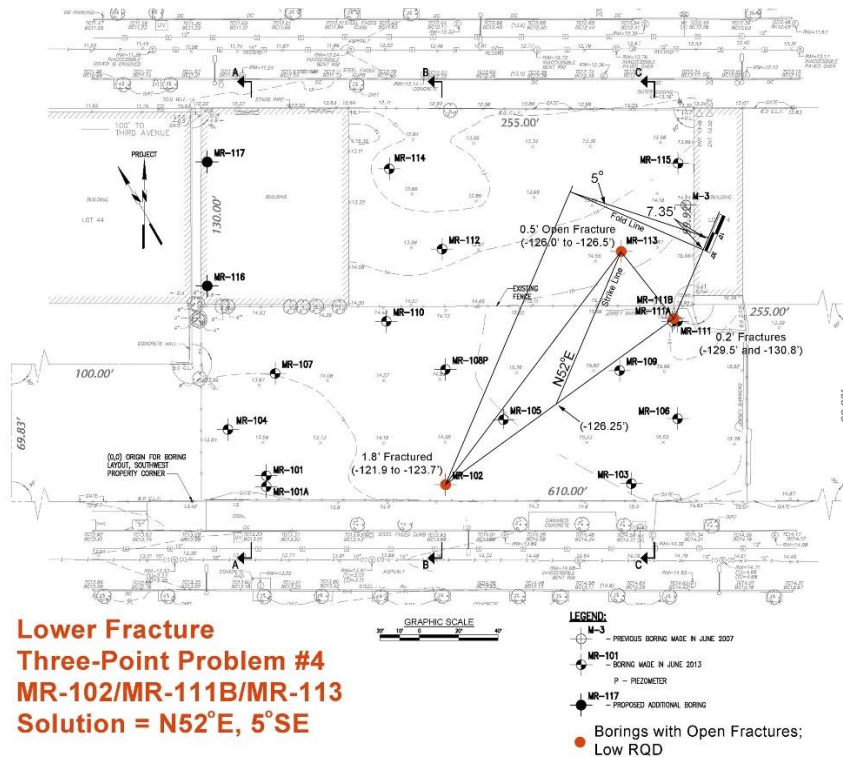
Borings MR-102, MR-111, and MR-113 show similar traits as those above in that they indicate a marked decrease of REC % and RQD % in lower core runs below a reach of competent rock. Using these data, three-point problem solution #4 shows a secondary deeper (lower) open fracture oriented N52°E and dipping 5°SE (Figure 25). The lower fracture is not as wide (0.2' to 1.8' wide) as the upper fracture and occurs 10' to 14' deeper than the upper fracture with slightly steeper dip.

Figure 25 – Solution #4 for lower fracture. (Borings MR-102, MR-111B, and MR-113.)

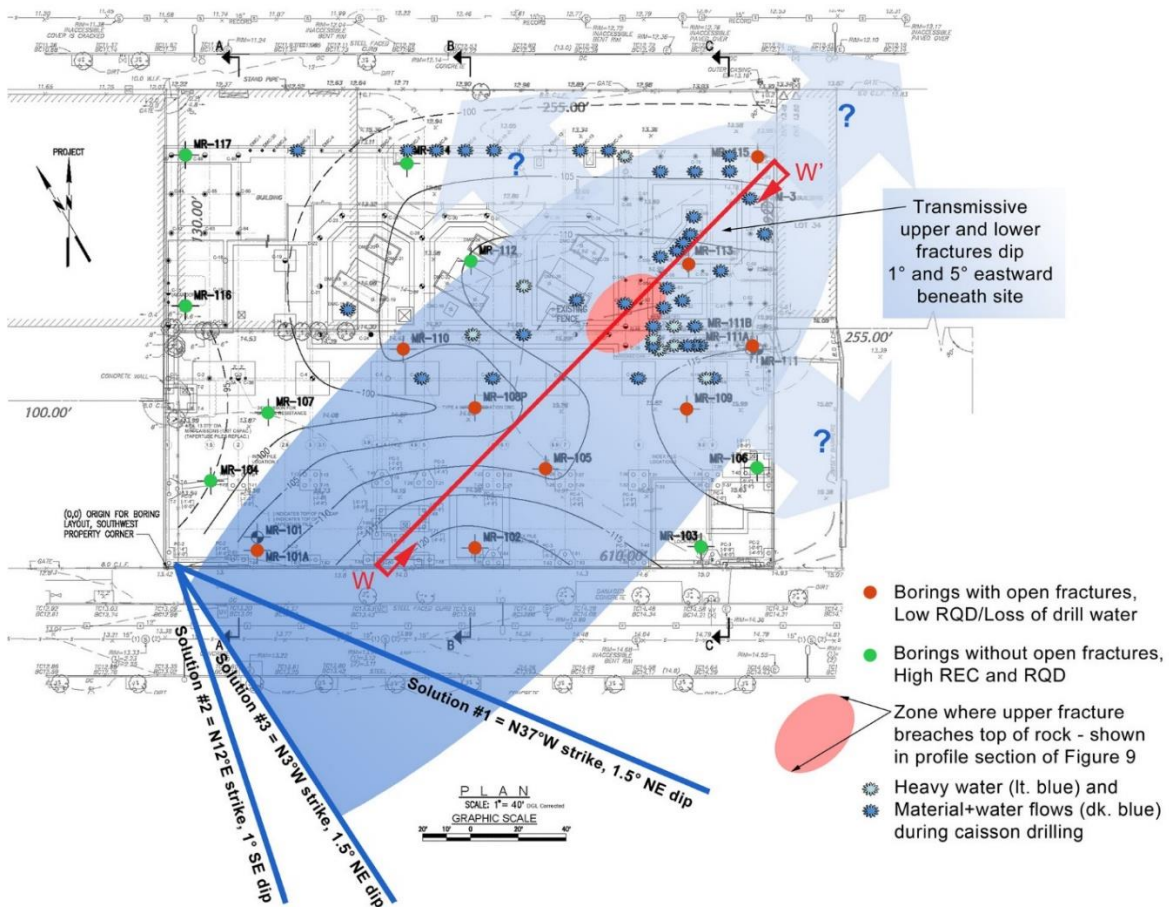
Two very gently inclined fracture zones descend below the top of rock at the job site based on the four fault plane solutions presented above. Figure 26 shows a conservative visualization of the gently east-dipping subsurface fracture system footprint (truncated blue ellipsoid) and shows a rather remarkable spatial coincidence with borings whose logs reported water loss during drilling and logs indicating fractures below more competent rock. The extended blue arrows with blue question marks are a reminder that the fractures certainly extend for some distance along strike and dip and may extend well beyond the zones shown in blue.

Figure 26 – Simplified plan map showing the three strike solution results of the three-point analyses presented in Figures 22 through 25 (dark blue lines) and the borings showing open fractures, low REC/RQD % and reported loss of drill water (red dots). Note the spatial coincidence of these borings with the projected footprint of the transmissive upper and lower fracture zones (eastward dipping blue ellipsoid) and their possible extensions down-dip and along strike (extended blue arrows). Also projected upward into plan view is the breached zone shown below in Figure 27 where the upper fracture zone is at or near the top of rock (pink ellipse).

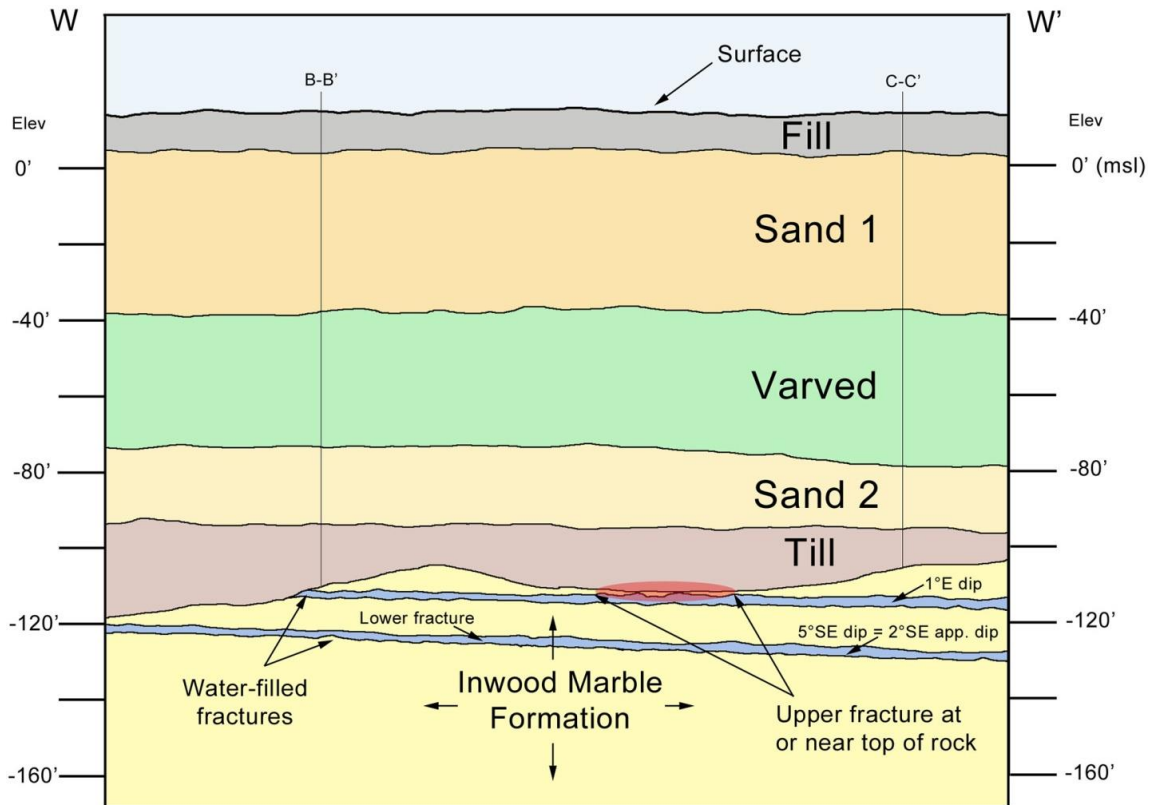
Line of section W-W' depicts a vertical profile section of the subsurface condition that led to excessive water (Figure 27). The section was drawn using data provided by the geotechnical report, including the core logs, topographic map, depth to bedrock map and soil profiles and our three-point analyses. The upper fracture varies in width up to a potential maximum of 4.7' and slopes $\sim 1^\circ$ eastward across the site between -111' to -116' (elev.). The lower fracture slopes from -121' to -129' (elev.) southeasterly at 5° based on one fault plane solution (See Figure 25.) and strikes N52°E but shows similar traits. It appears to dip at 2° in the line of section (W-W' in Figure 27) since it would depict an apparent dip given the non-orthogonal angle between the strike and line of section. The strike for the upper fracture, as determined from the three-point problem solutions provided in Figures 22 through 24 ranges from N37°W to N12°E and thus averages roughly N-S as shown by the blue strike lines in Figure 26. Remember that strike varies greatly in sub-horizontal features. Clearly, the strike orientation of the lower fracture is not as well constrained given the solitary solution however we do not question its existence.

Figure 27 – Roughly west to east profile section (W-W') keyed to Figure 26 showing water-saturated overburden strata and Inwood Marble bedrock containing water-filled fracture zones (blue) detected beneath site using three-point problem solutions. Section is drawn roughly perpendicular to N-S strike of the upper bedrock fracture. Water-filled transmissive bedrock fractures from three-point solutions are based on our interpretation of data from boring logs and by using the top of rock contour map and geological sections provided by the geotechnical report for control. Note the unique bedrock to saturated overburden (water table $\sim +0.7'$ elev.) plumbing system provided by the open-aperture subsurface fracture zones that intercept the top of rock in a few places. (Drafted without vertical exaggeration.)

The profile section shows that the upper fracture zone intercepts the buried top of rock near borings MR-101A and MR-102. It intercepts and connects directly with the till unit of the regolith. Here, at the western corner of the site where top of rock slopes down, the lower fracture will also intercept the top of rock, but off-site.
