# Geological Solutions for Providing a Scientific Basis for Differing Site Condition Claims (DSC)

**Charles Merguerian**  
**Mickey Merguerian\***  
**Dukelabs**  
**Stone Ridge, NY**

**Stonybrook 29<sup>th</sup>**  
**Metro NY Conference**  
**09 April 2022**

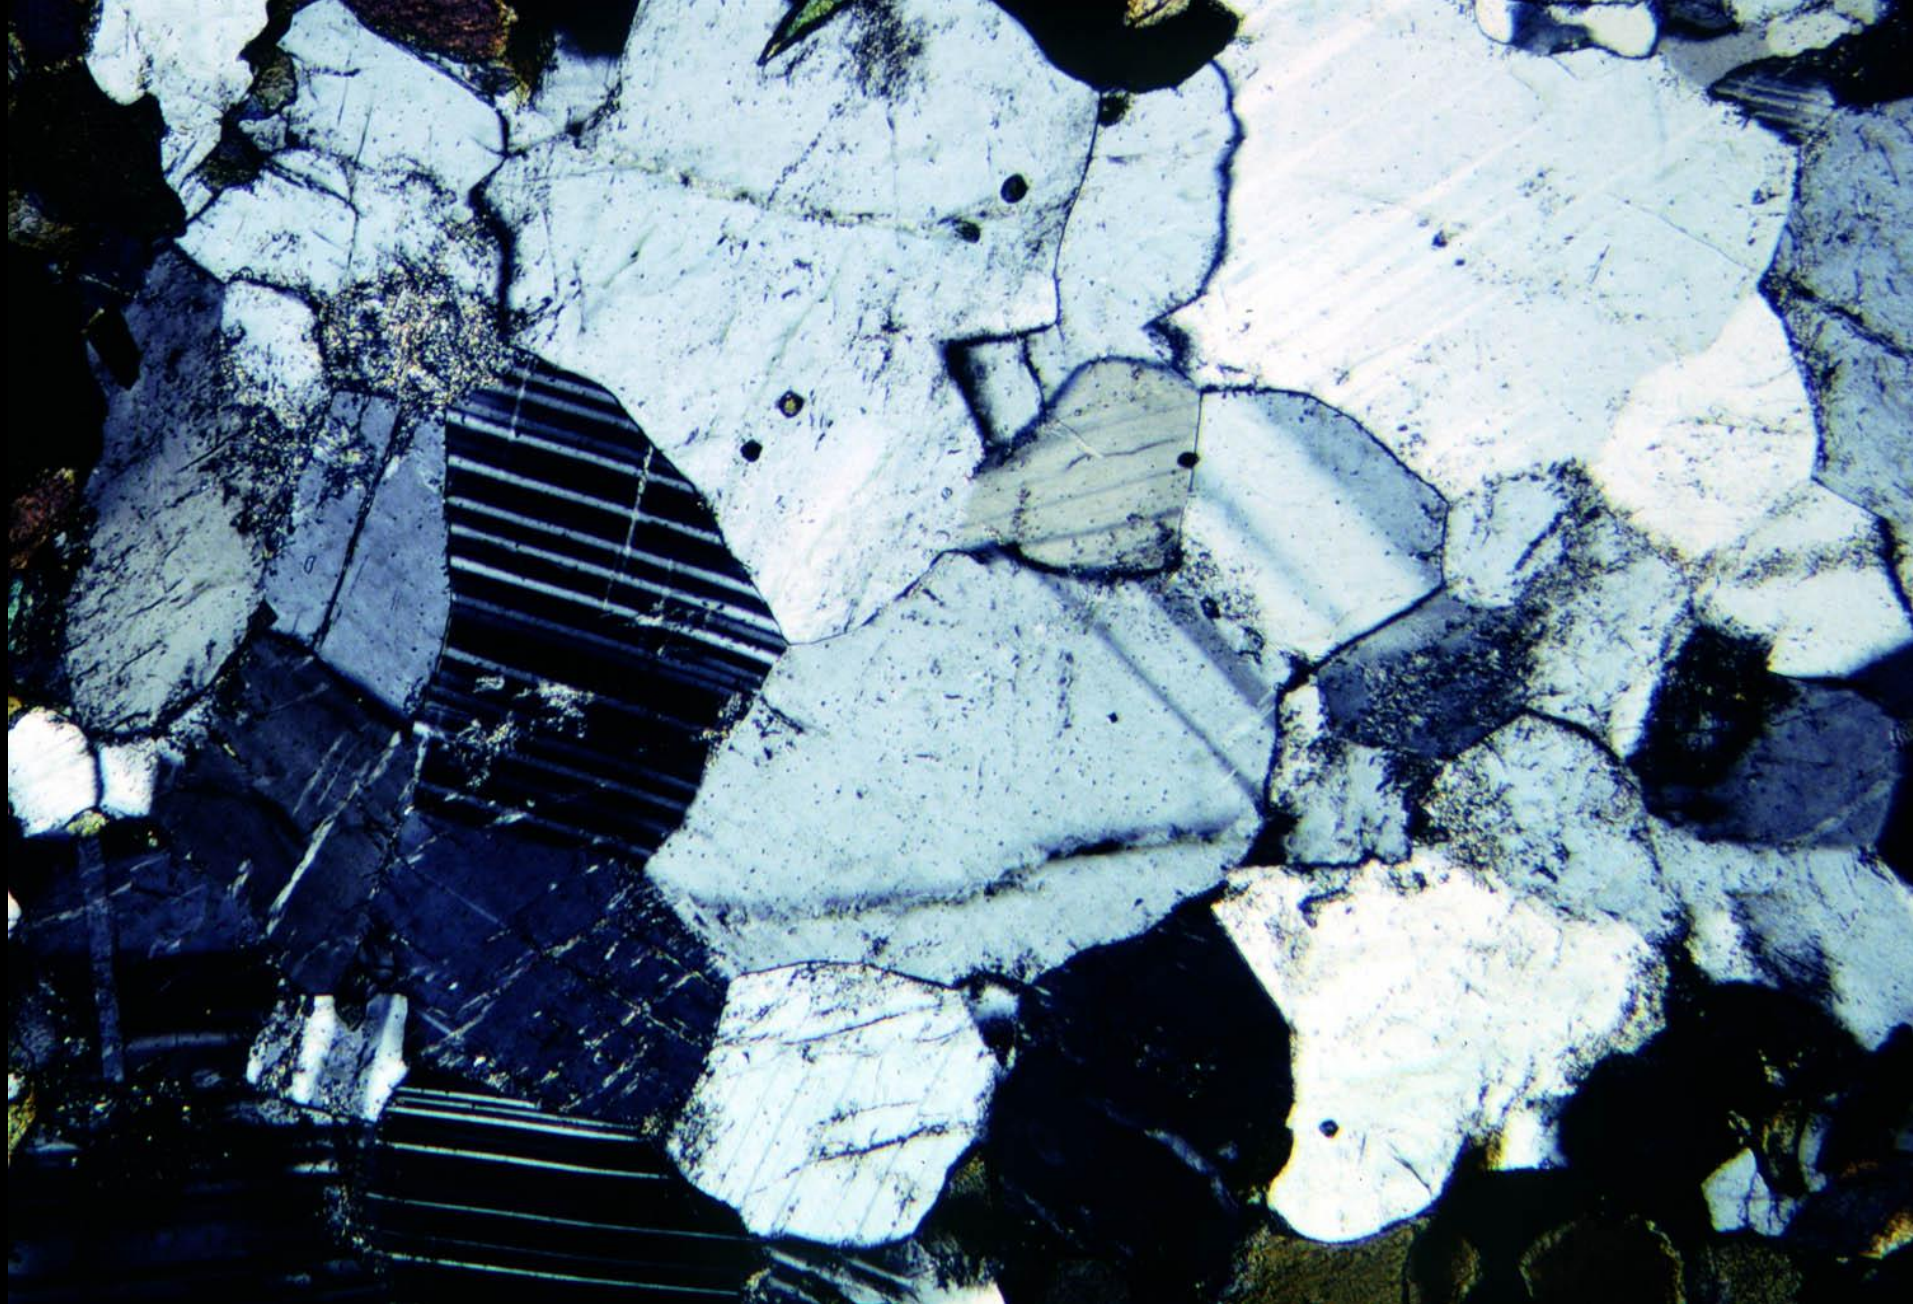
**Foliated Textures Anticipated**

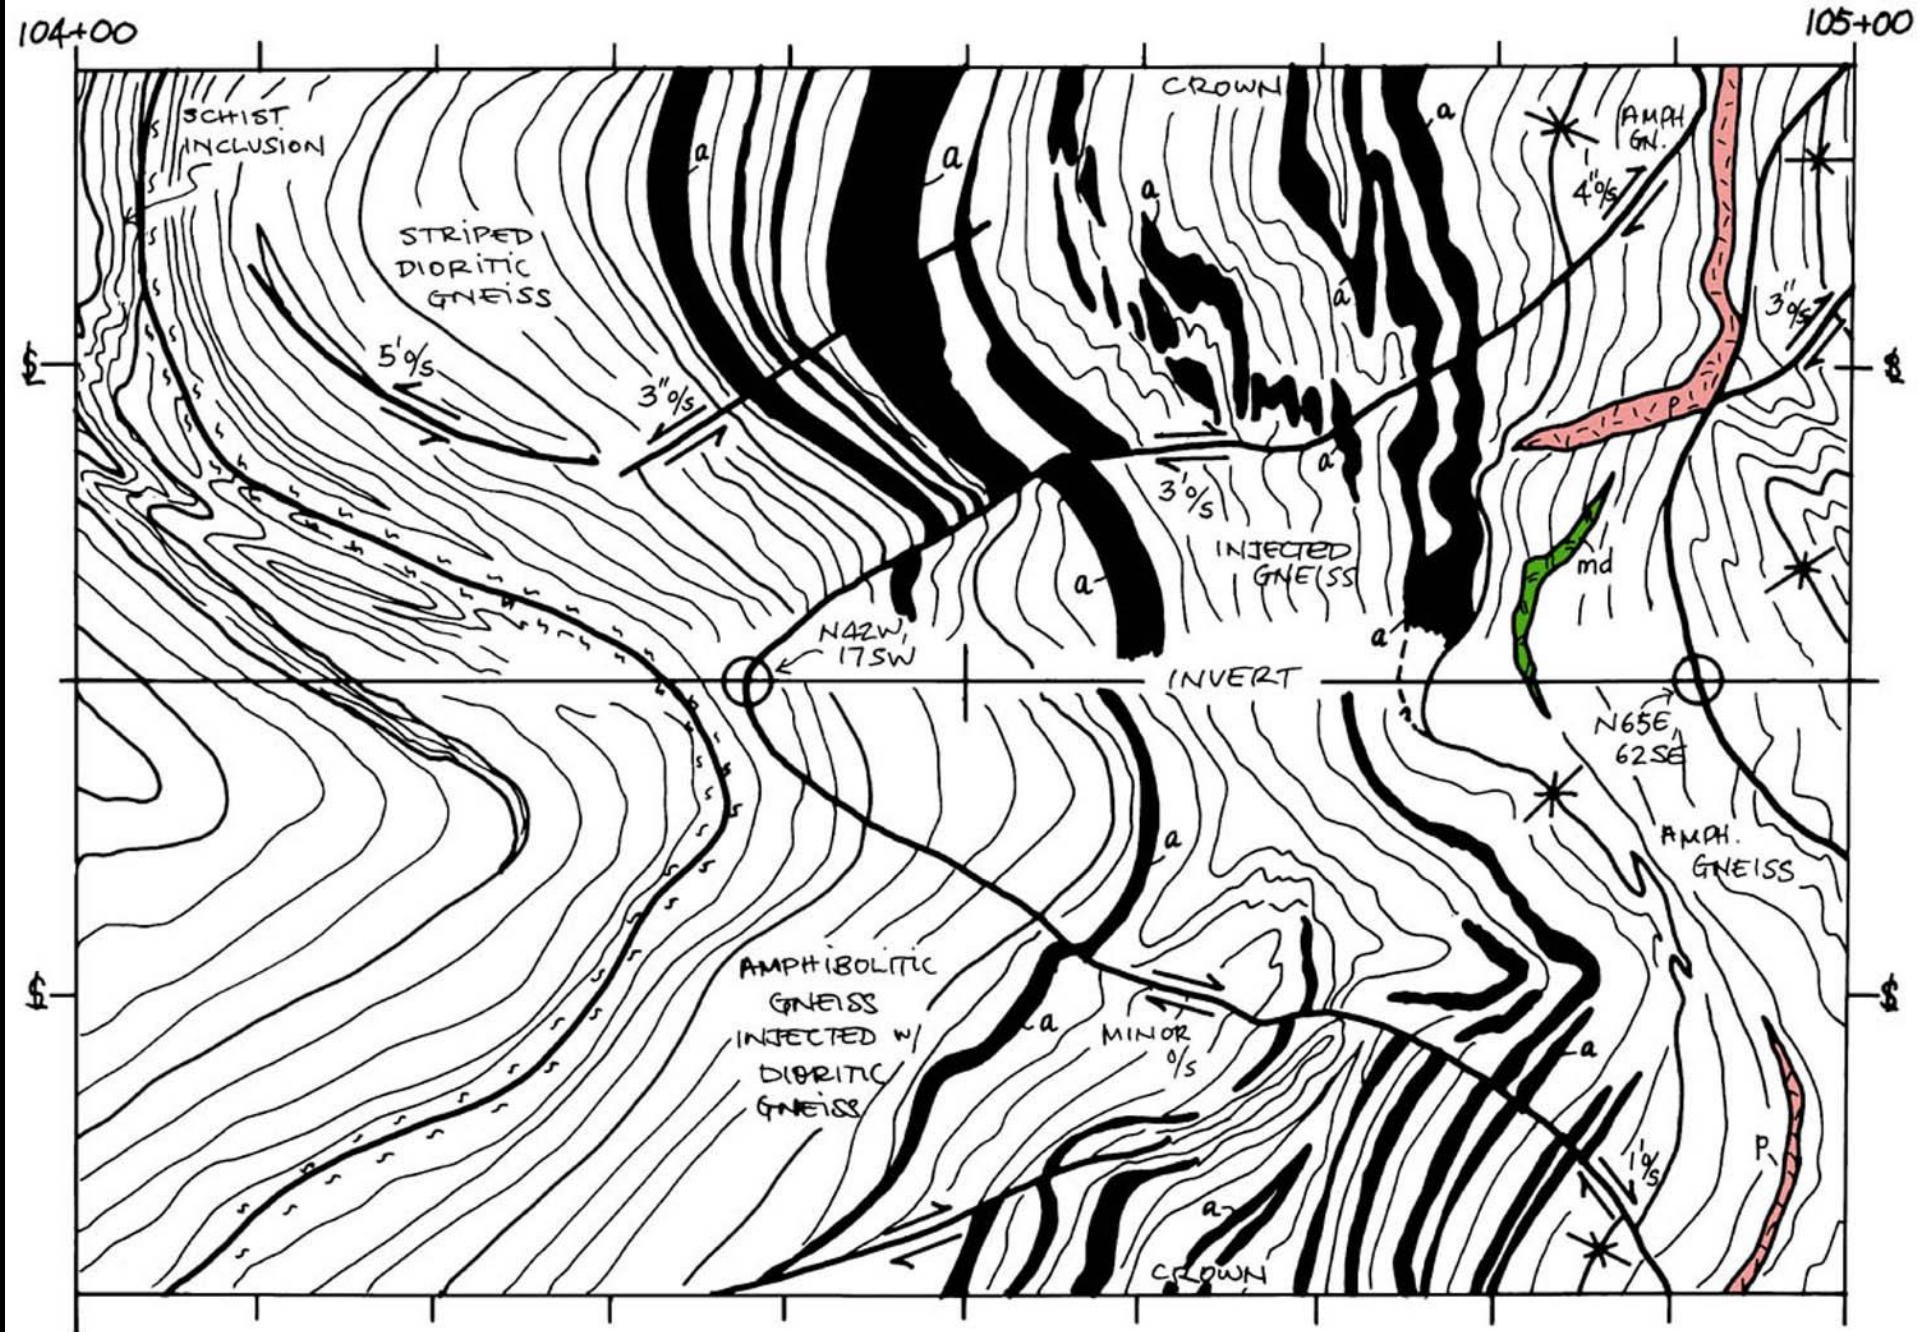
**Tough, Granoblastic Textures Encountered**

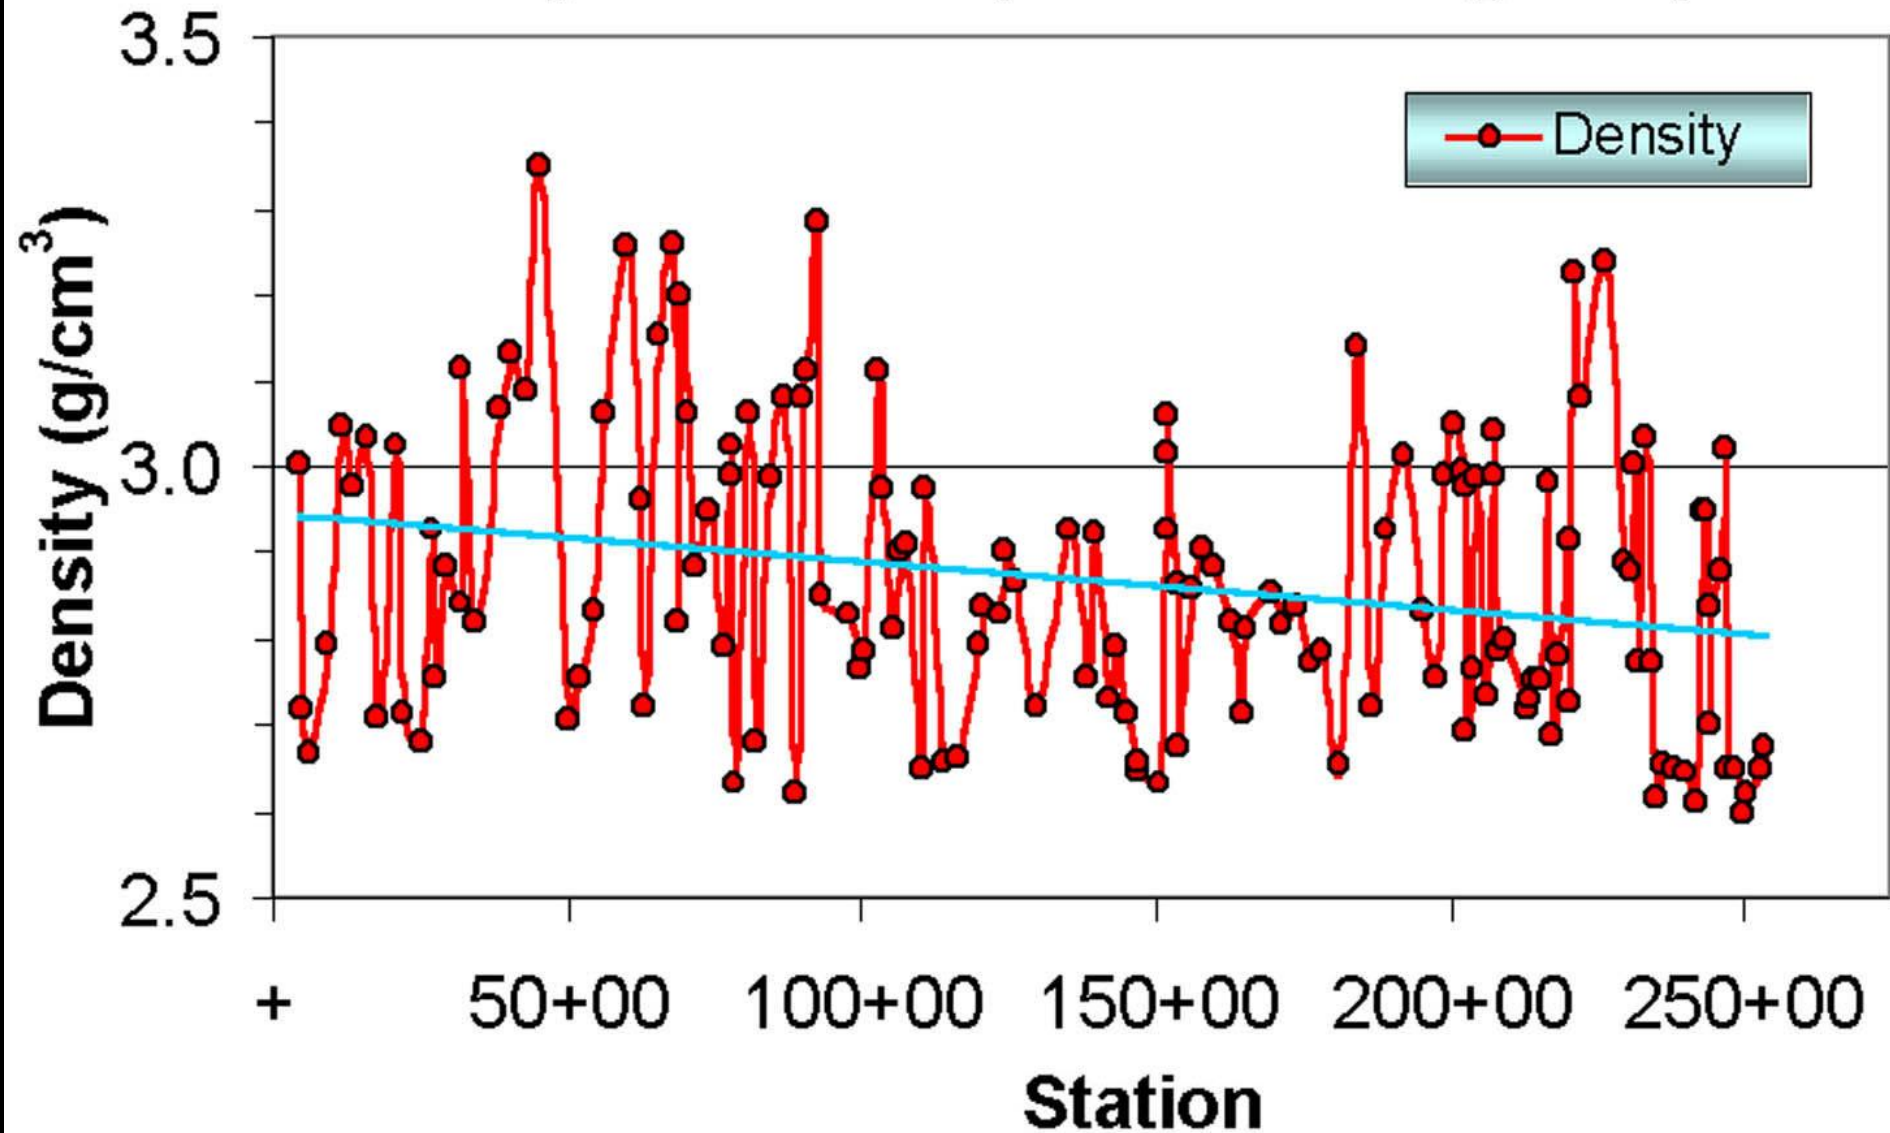
## Density Tunnel #1 (Mean = 2.87 g/cm<sup>3</sup>)

**Density Analysis >> Anticipation (~2.5-2.6)**

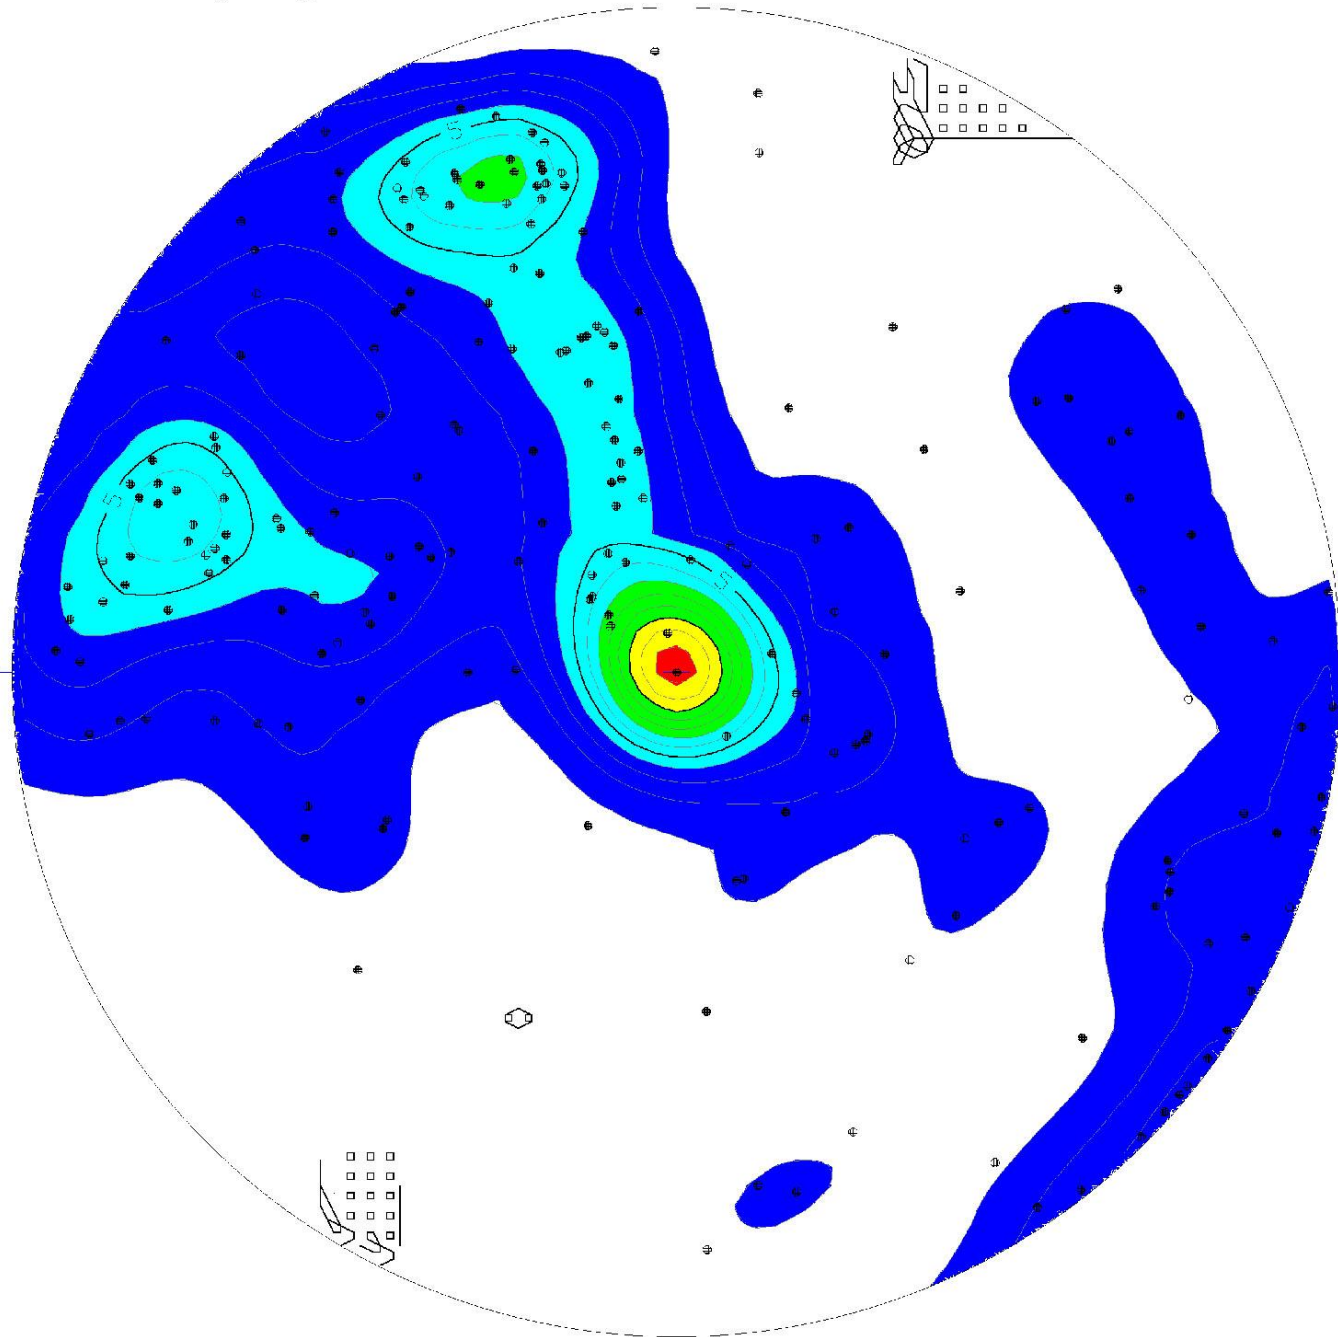
**Pre-bid Data =**  
**NE-trending**  
**Steep SE Dip**  
**of Foliation**  
**Very Favorable**  
**Tunnel Drive**  
**Orientation!!**

**Instead:**  
**11% ~ 0°**  
**27% <30°**  
**38% Gentle Dips**  
**Very Unfavorable**  
**TBM Tunnel Drive**  
**Orientation!!**

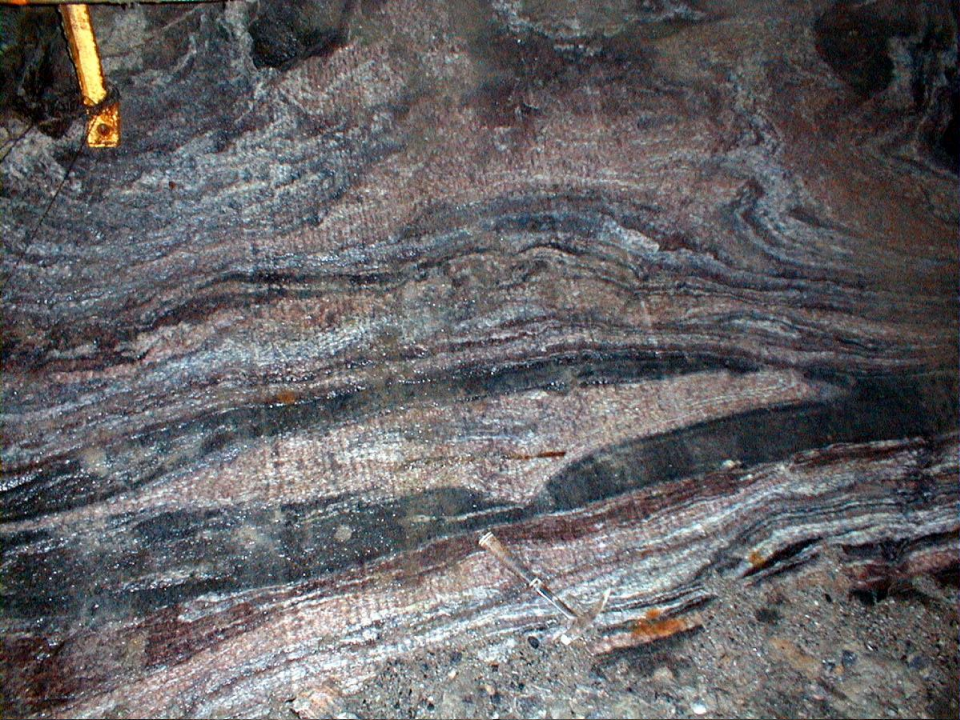
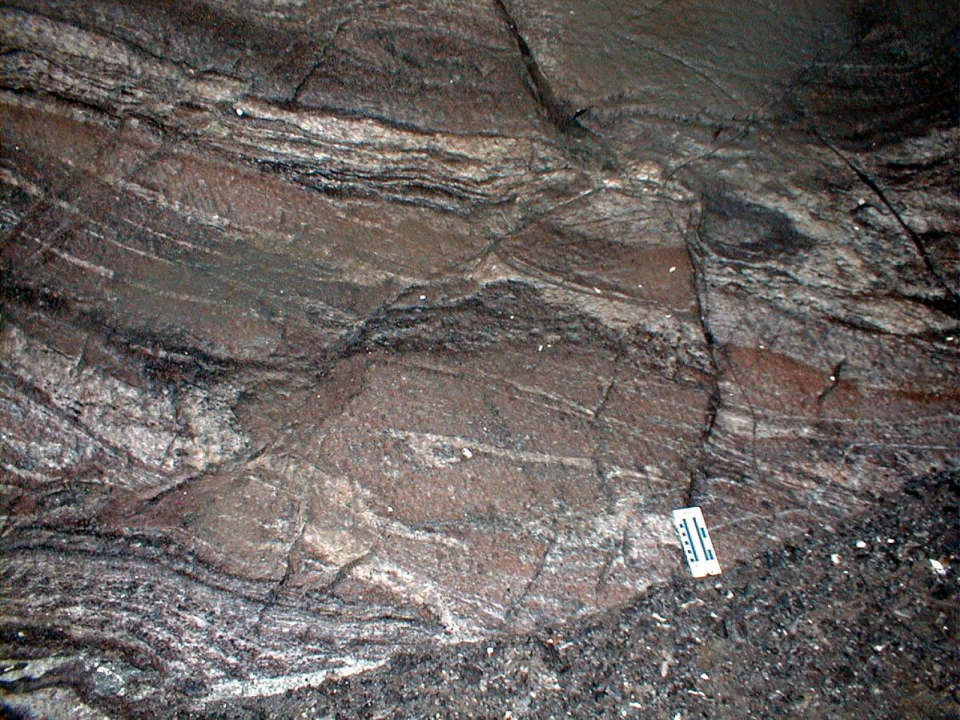
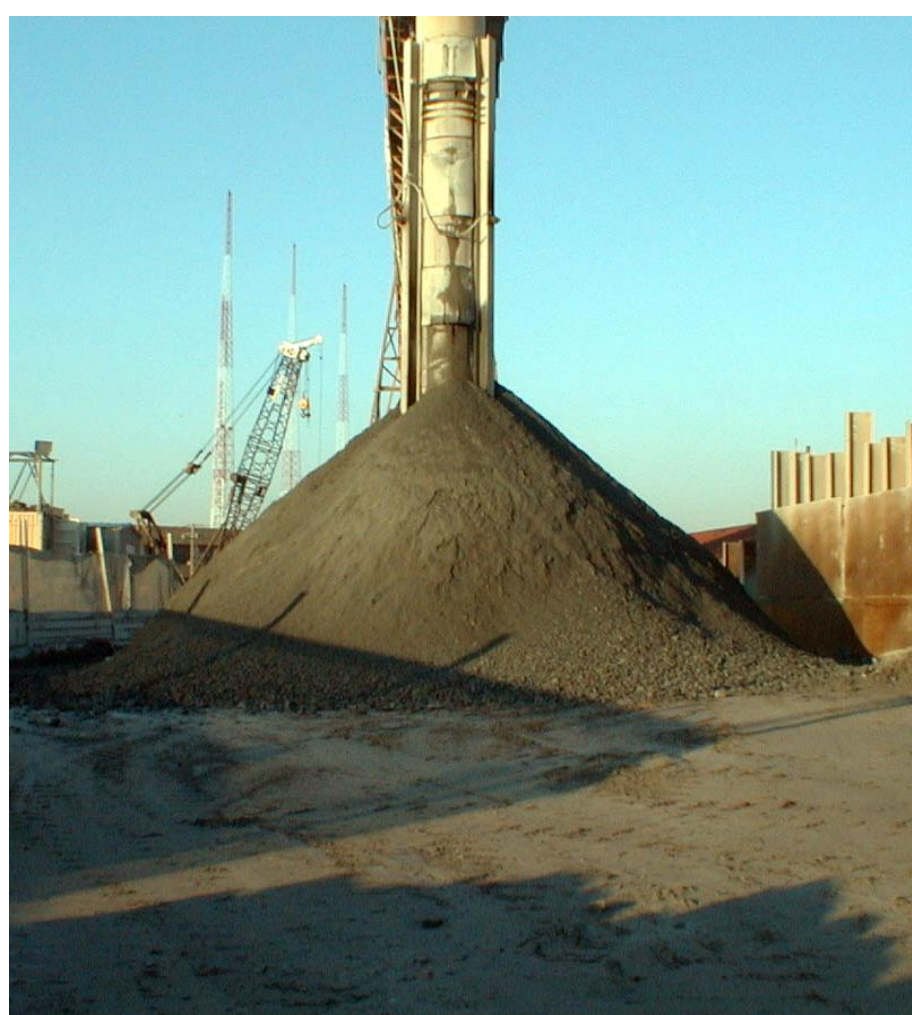
**~11% of Tunnel up to 50% Garnet  
in 32 Zones (Ore Deposit!!!)  
Abrasive, Tough Granoblastic Rock Mass =  
Low Penetration Rate of <6'/hour vs.  
9'/hour Anticipated and Excessive Fines**

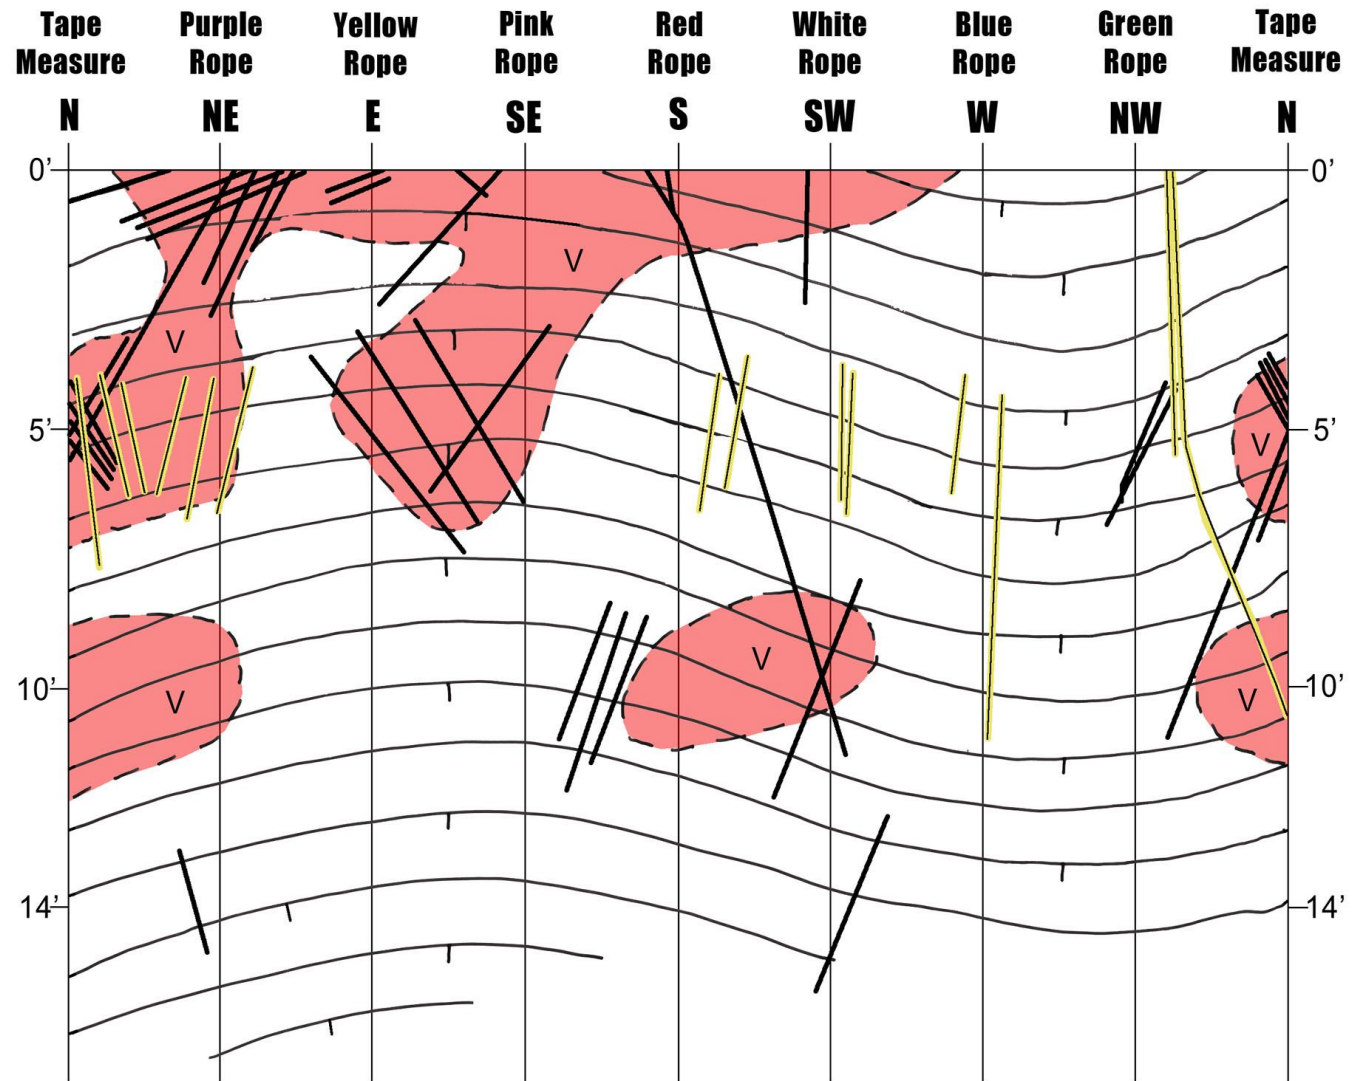
# CIRCUMFERENTIAL MAP - SHAFT 23 ROCK SOCKET PASSAIC RIVER BRIDGE

Geology Mapped By C. Merguerian  
From 22 July 2013 Video Calibrated  
with Tape Measure and Oriented Rope

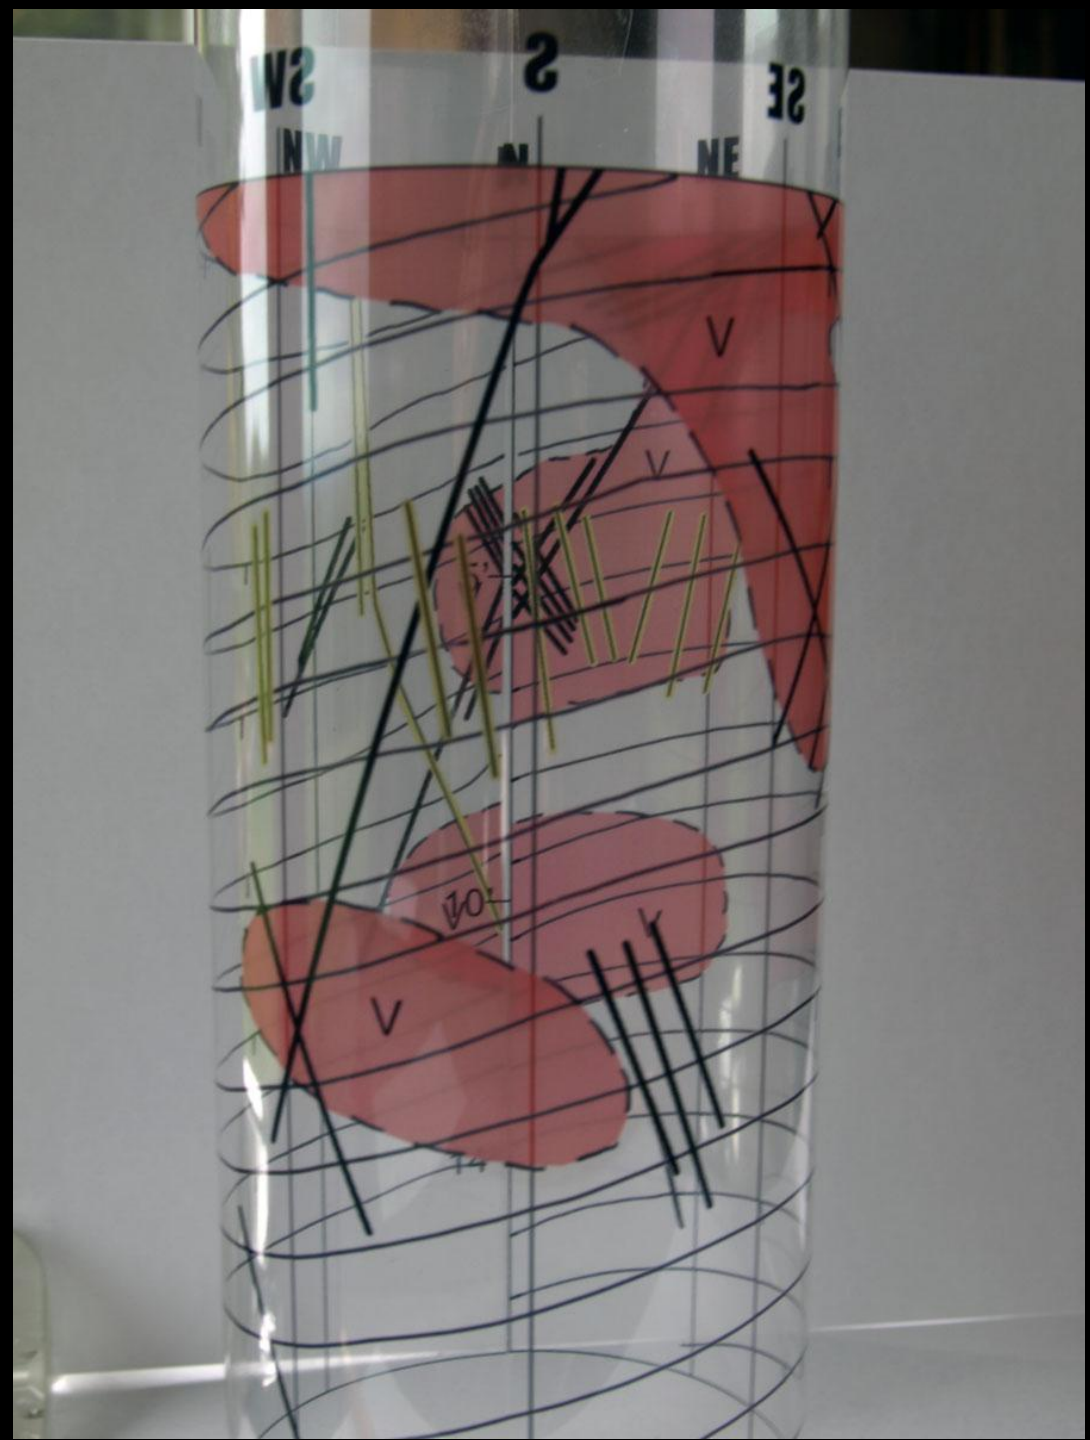
# Shaft 23 – Curled 3-D Map on Acetate Detected Three Intersecting Fault Systems

1)  $N35^{\circ}E, 75^{\circ}NW$

2)  $N25^{\circ}E, 80^{\circ}SE - 80^{\circ}NW$   
Conjugate Set

3)  $N40^{\circ}W, 70^{\circ}NE$

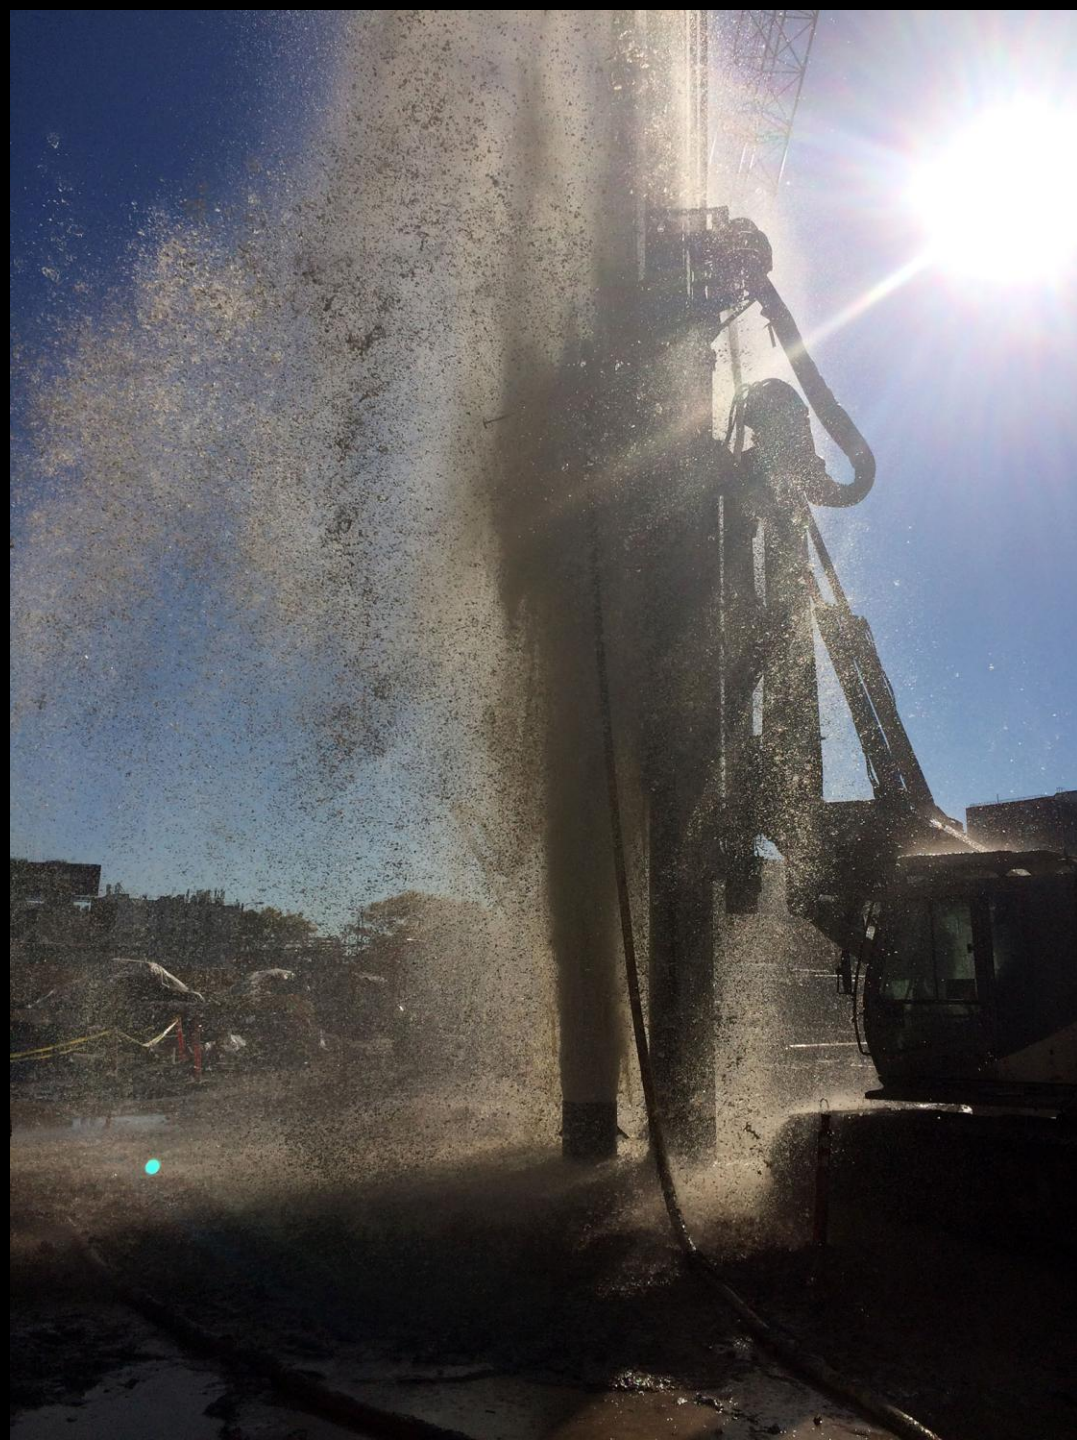
- "heavy water, sand, and rock"
- "excessive water from casing"
- "thick (heavy) sediment inflows up to 25 feet"
- "seams and rock ledges"
- "large rocks and dirty discharge"
- "socket making water"
- "communication between open drill sites"
- "flooding of the jobsite"
- "spoils on the ground"
- "equipment damage including broken shoes, rig tilting, hammer clogging and unanticipated hammer firing"

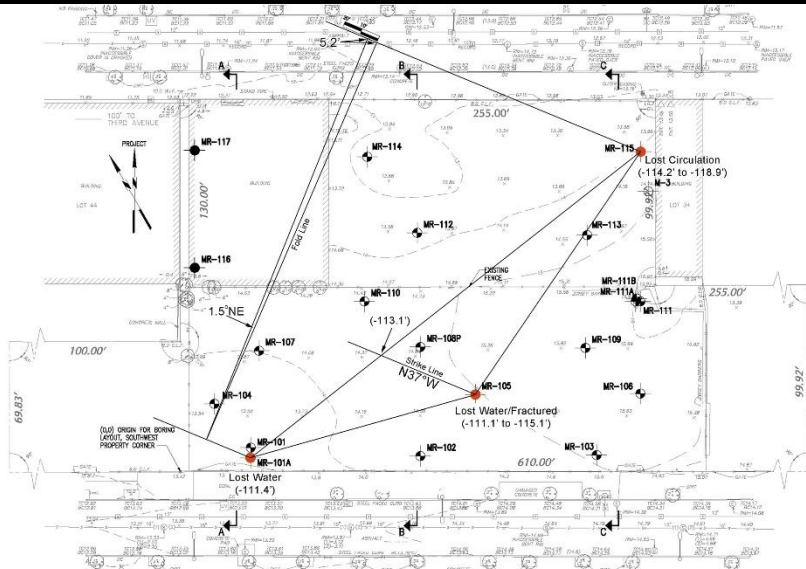
**Upper Fracture  
Three-Point Problem #1  
MR-101A/MR-105/MR-115  
Solution = N37°W, 1.5°NE**

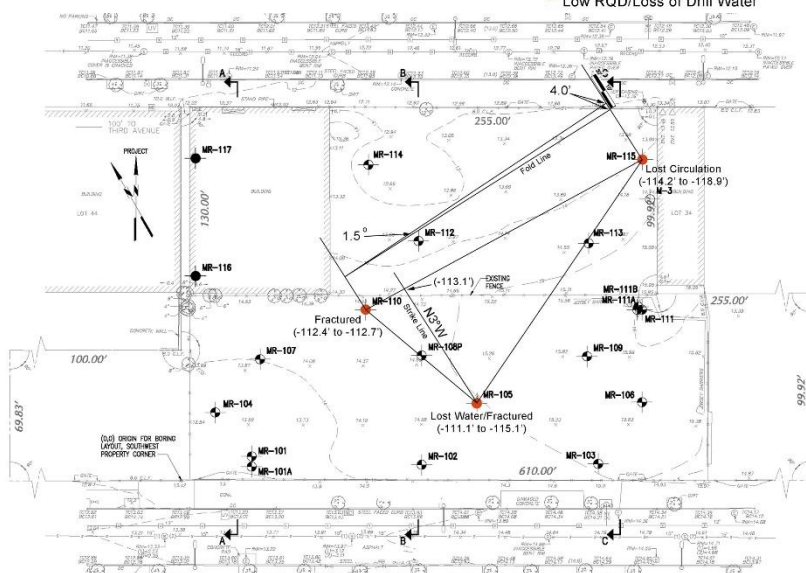
**Upper Fracture  
Three-Point Problem #3  
MR-105/MR-110/MR-115  
Solution = N3°W, 1.5°NE**

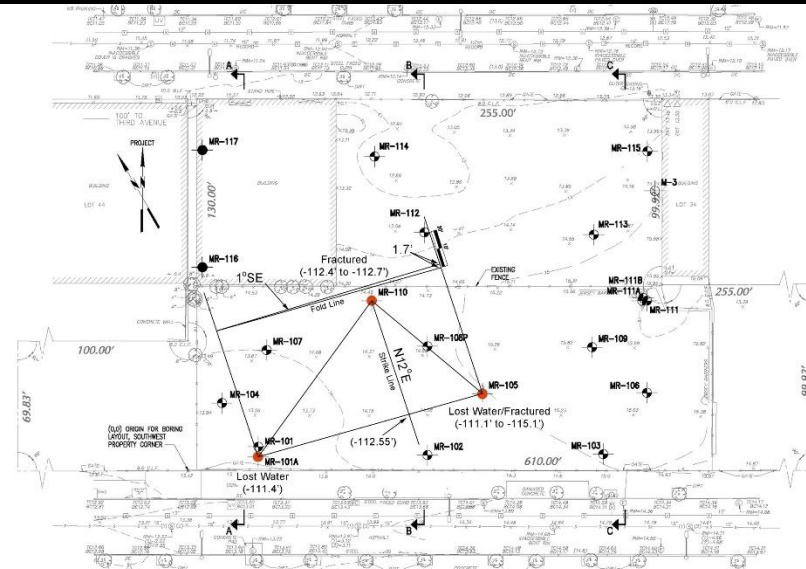
**Upper Fracture  
Three-Point Problem #2  
MR-101A/MR-105/MR-110  
Solution = N12°E, 1°SE**

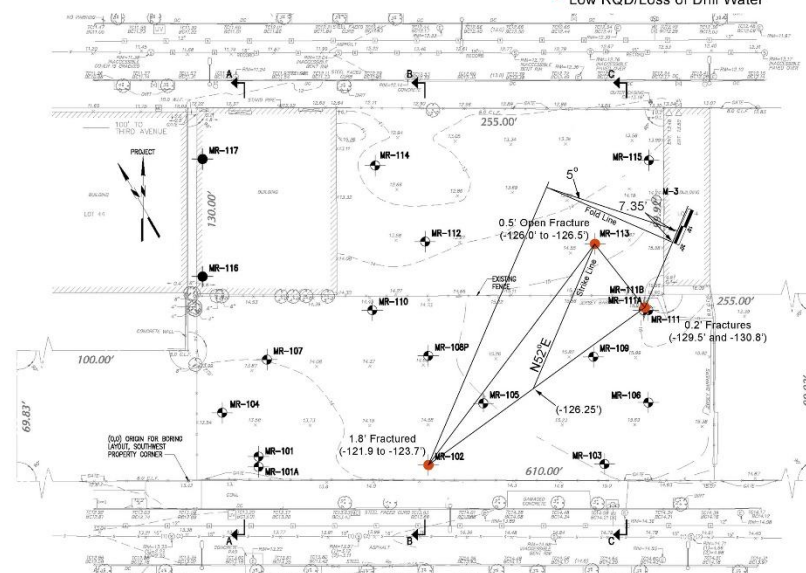
**Lower Fracture  
Three-Point Problem #4  
MR-102/MR-111B/MR-113  
Solution = N52°E, 5°SE**
