Brittle Fault Chronology of New York City

Charles Merguerian

Queens Tunnel Mapping Program: 1998-2000

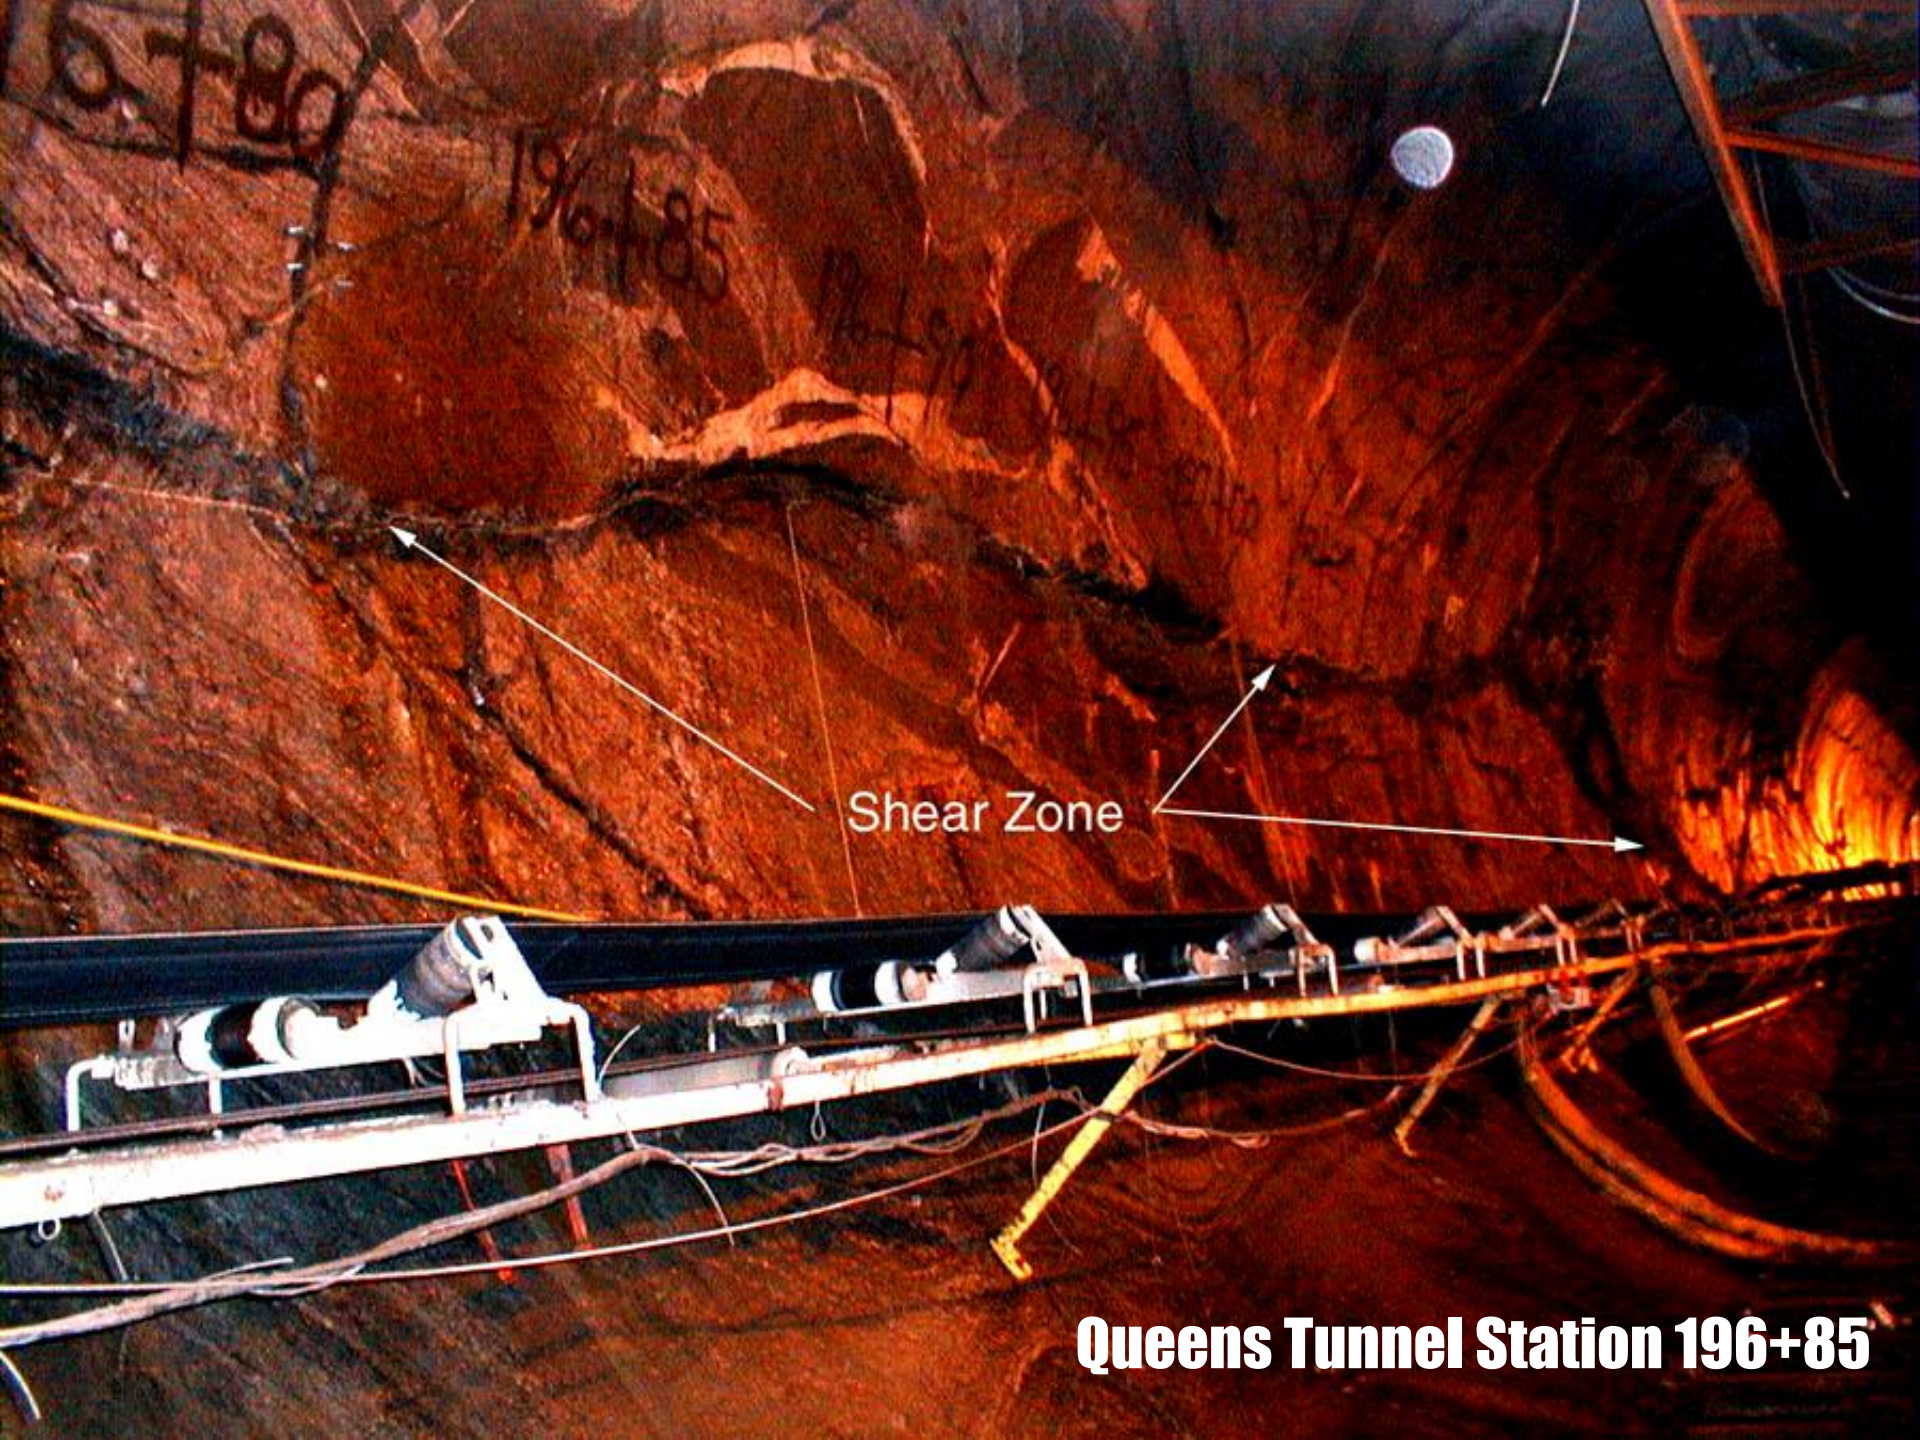
Queens Tunnel Station 196+85

Steeply-dipping Brittle Faults of Group B

- ENE strike and steep NW and SE dips
- Reactivate Group A faults and older ductile shears
- Thin zones of fault breccia and crush zones
- Cut by subhorizontal fractures (Group C) and younger faults

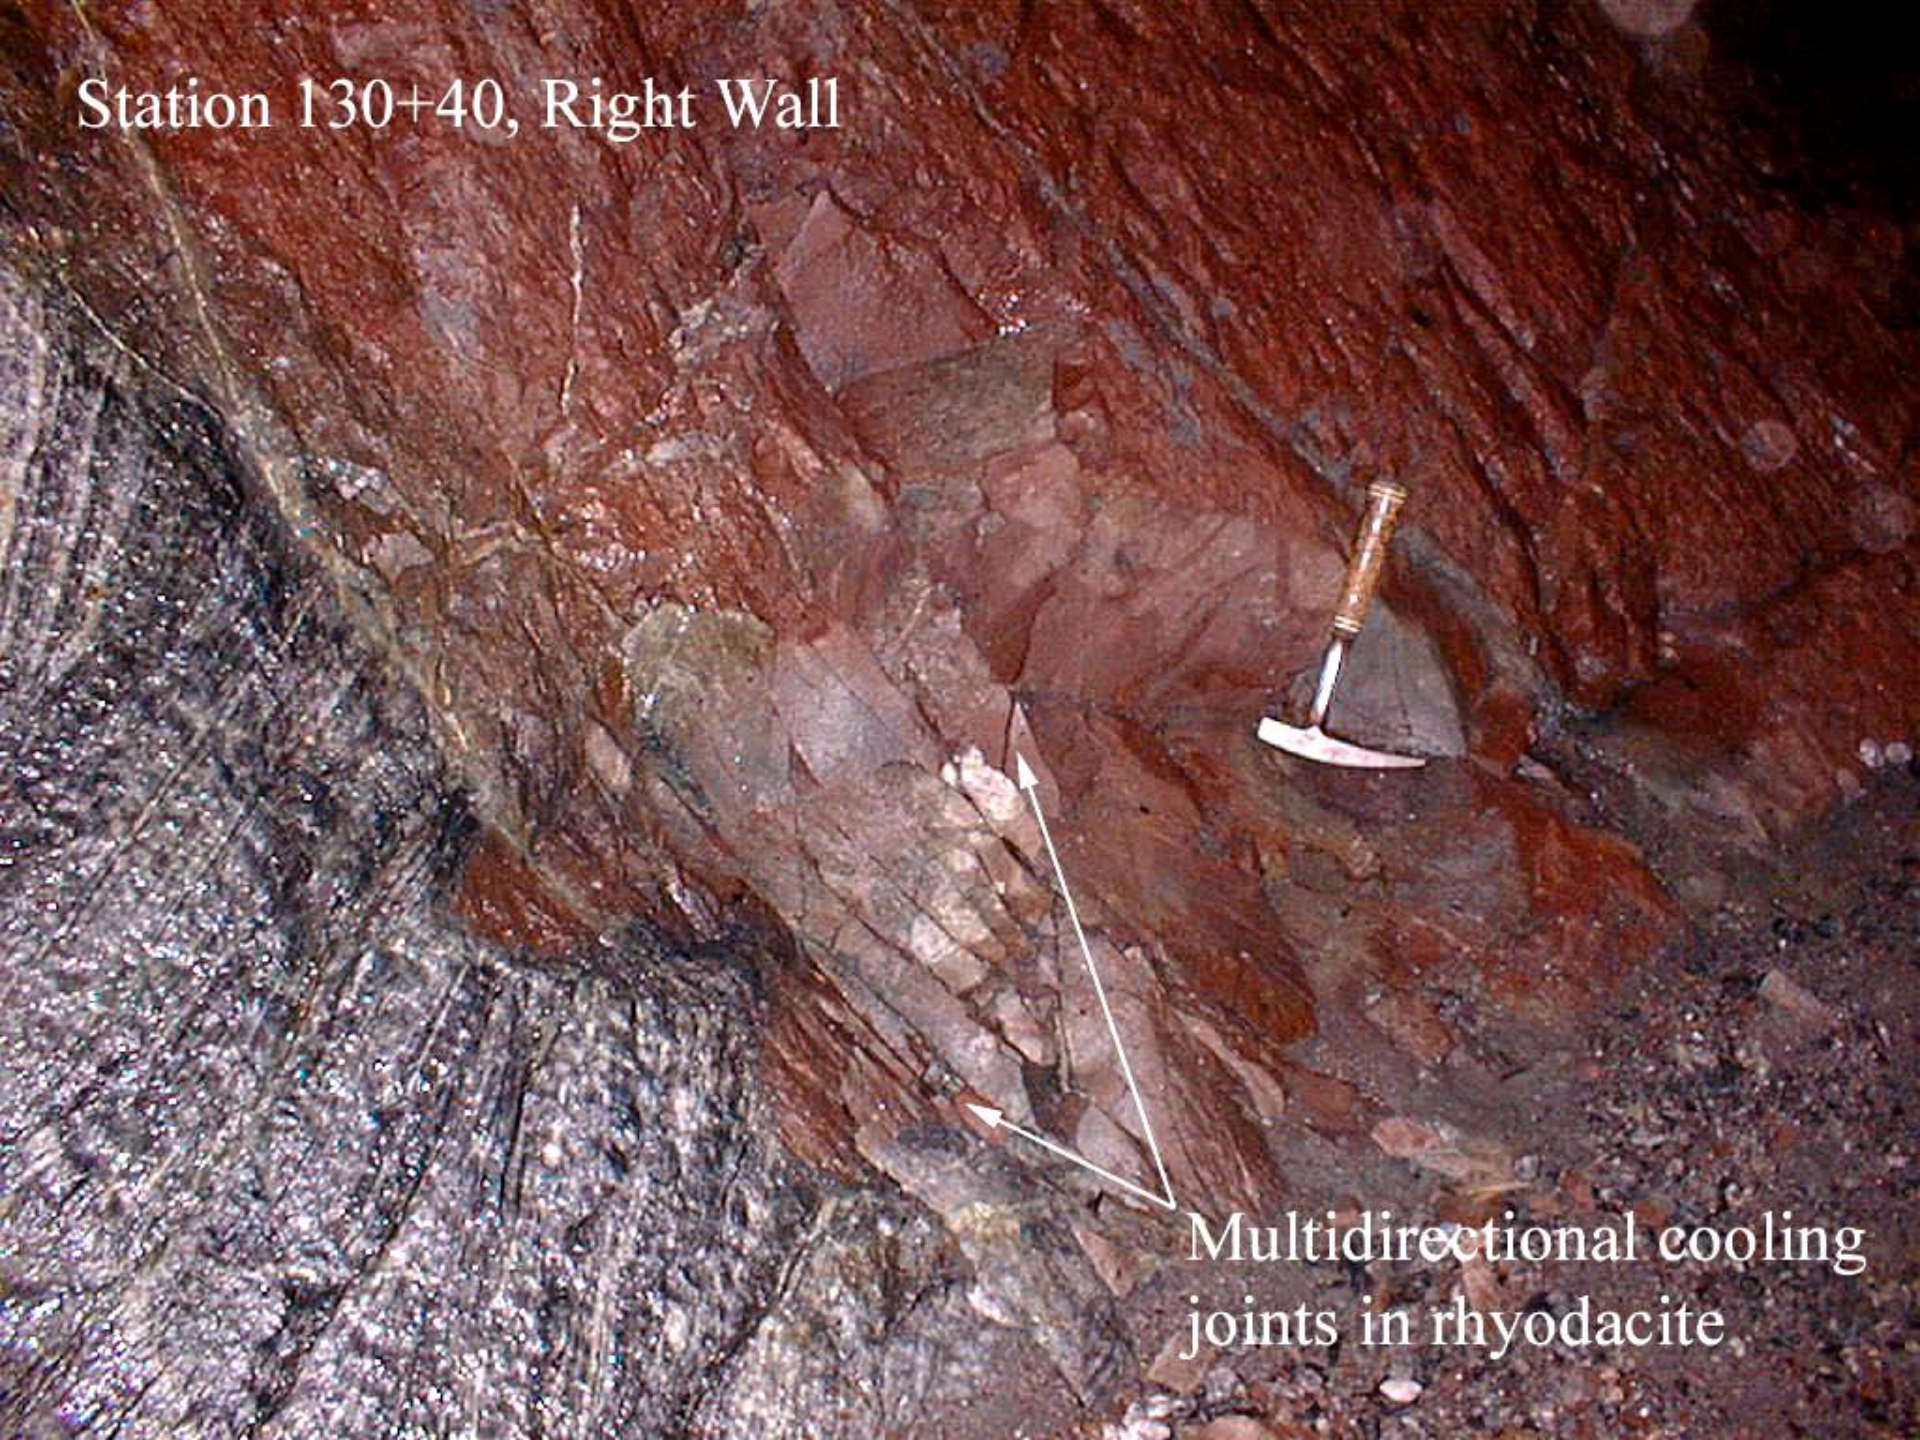
Station 130+40, Right Wall

Multidirectional cooling
joints in rhyodacite

Rhyodacite dikes intruded into Group A, cut B

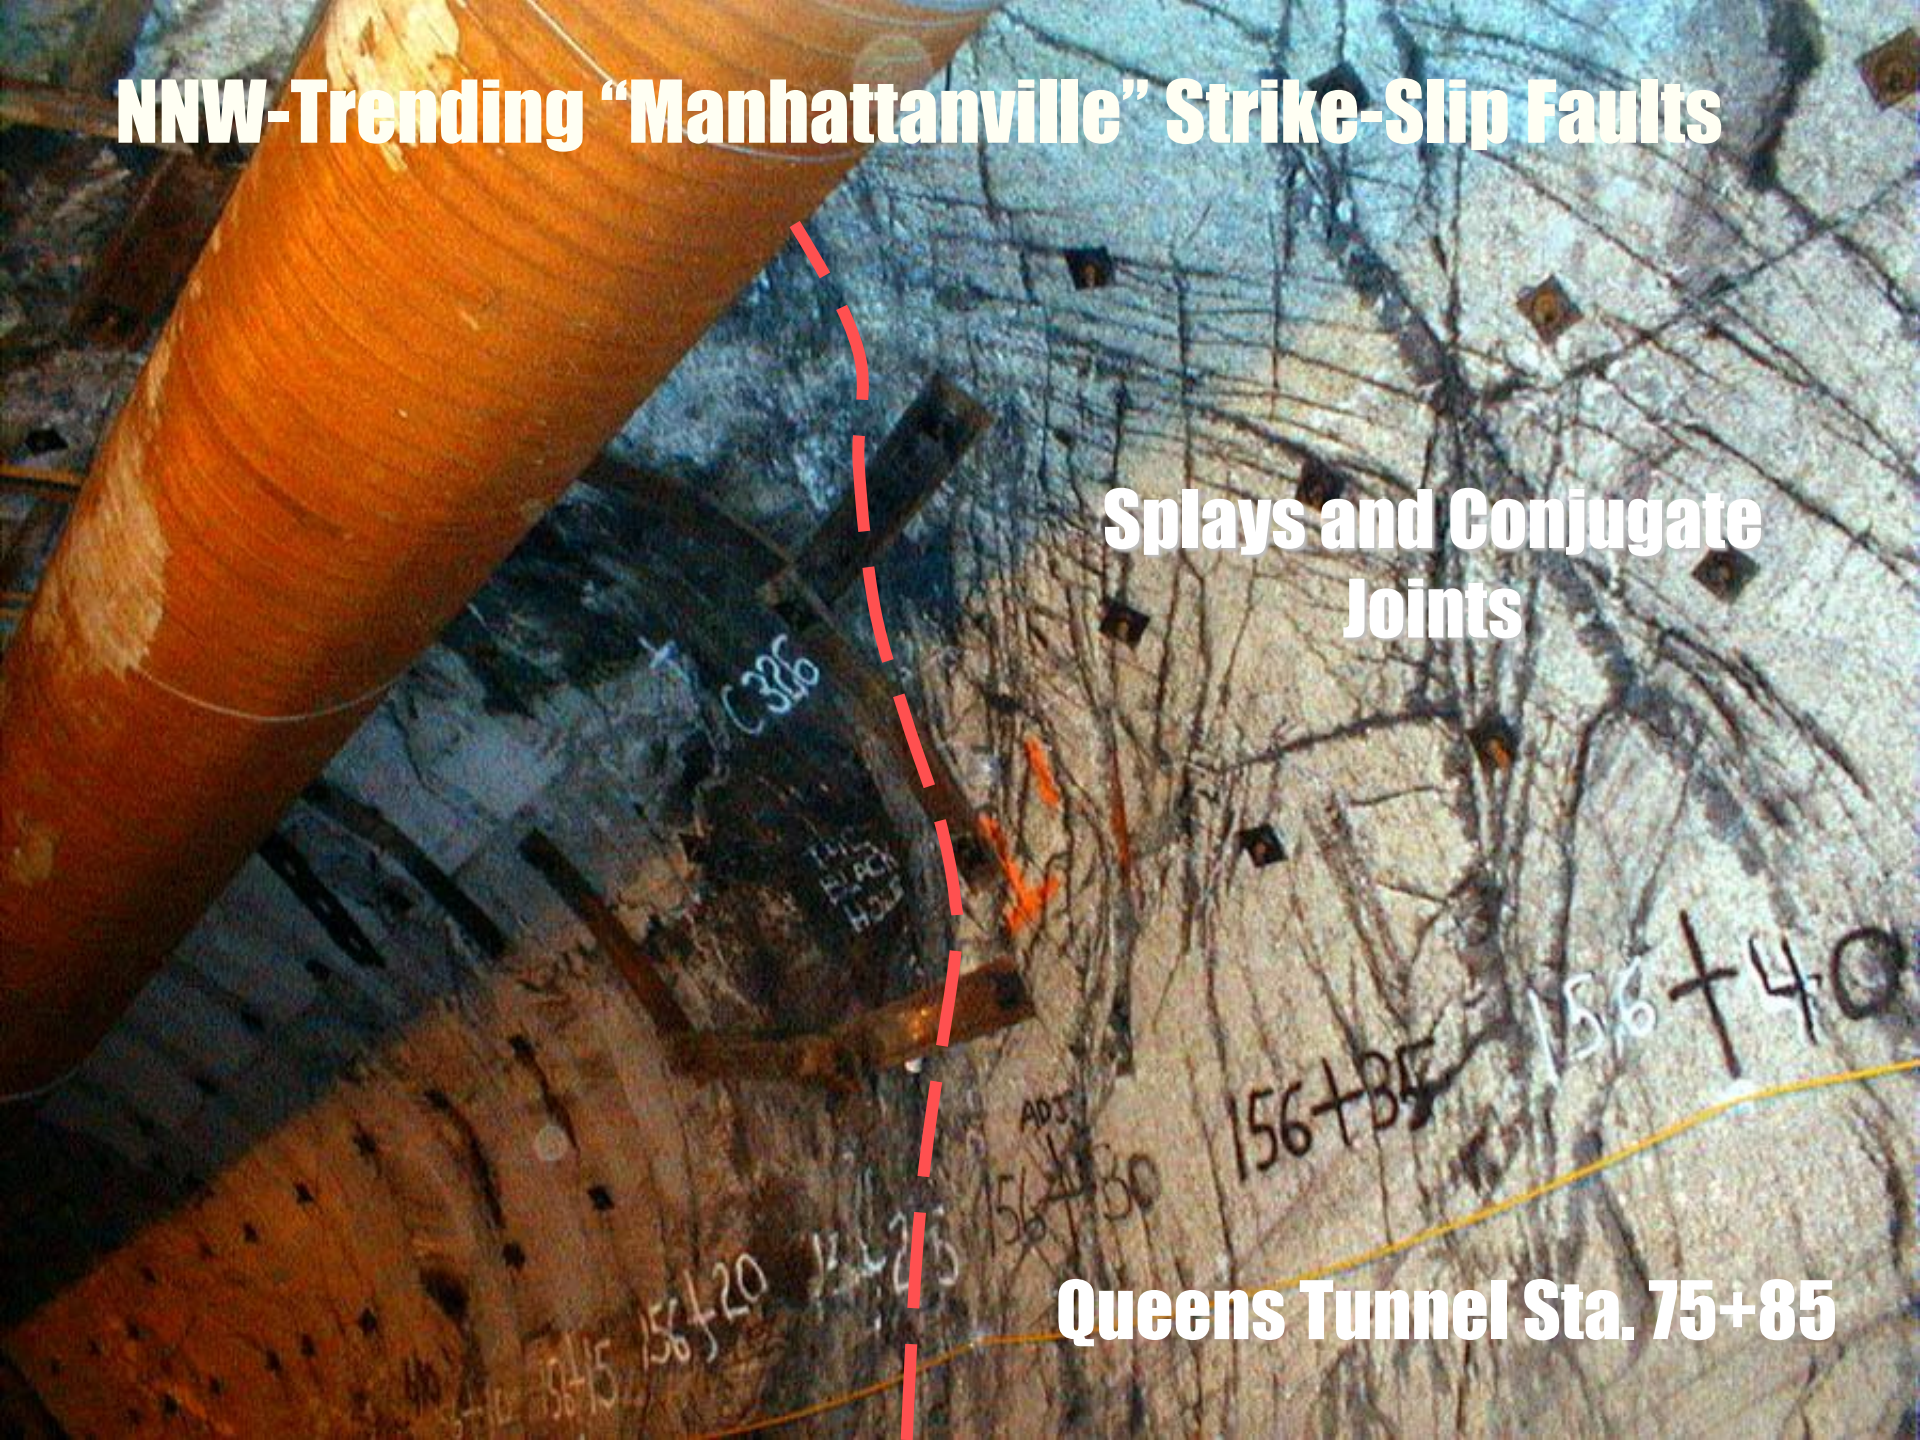
Queens Tunnel Sta. 75+85

Group B cut by Group E

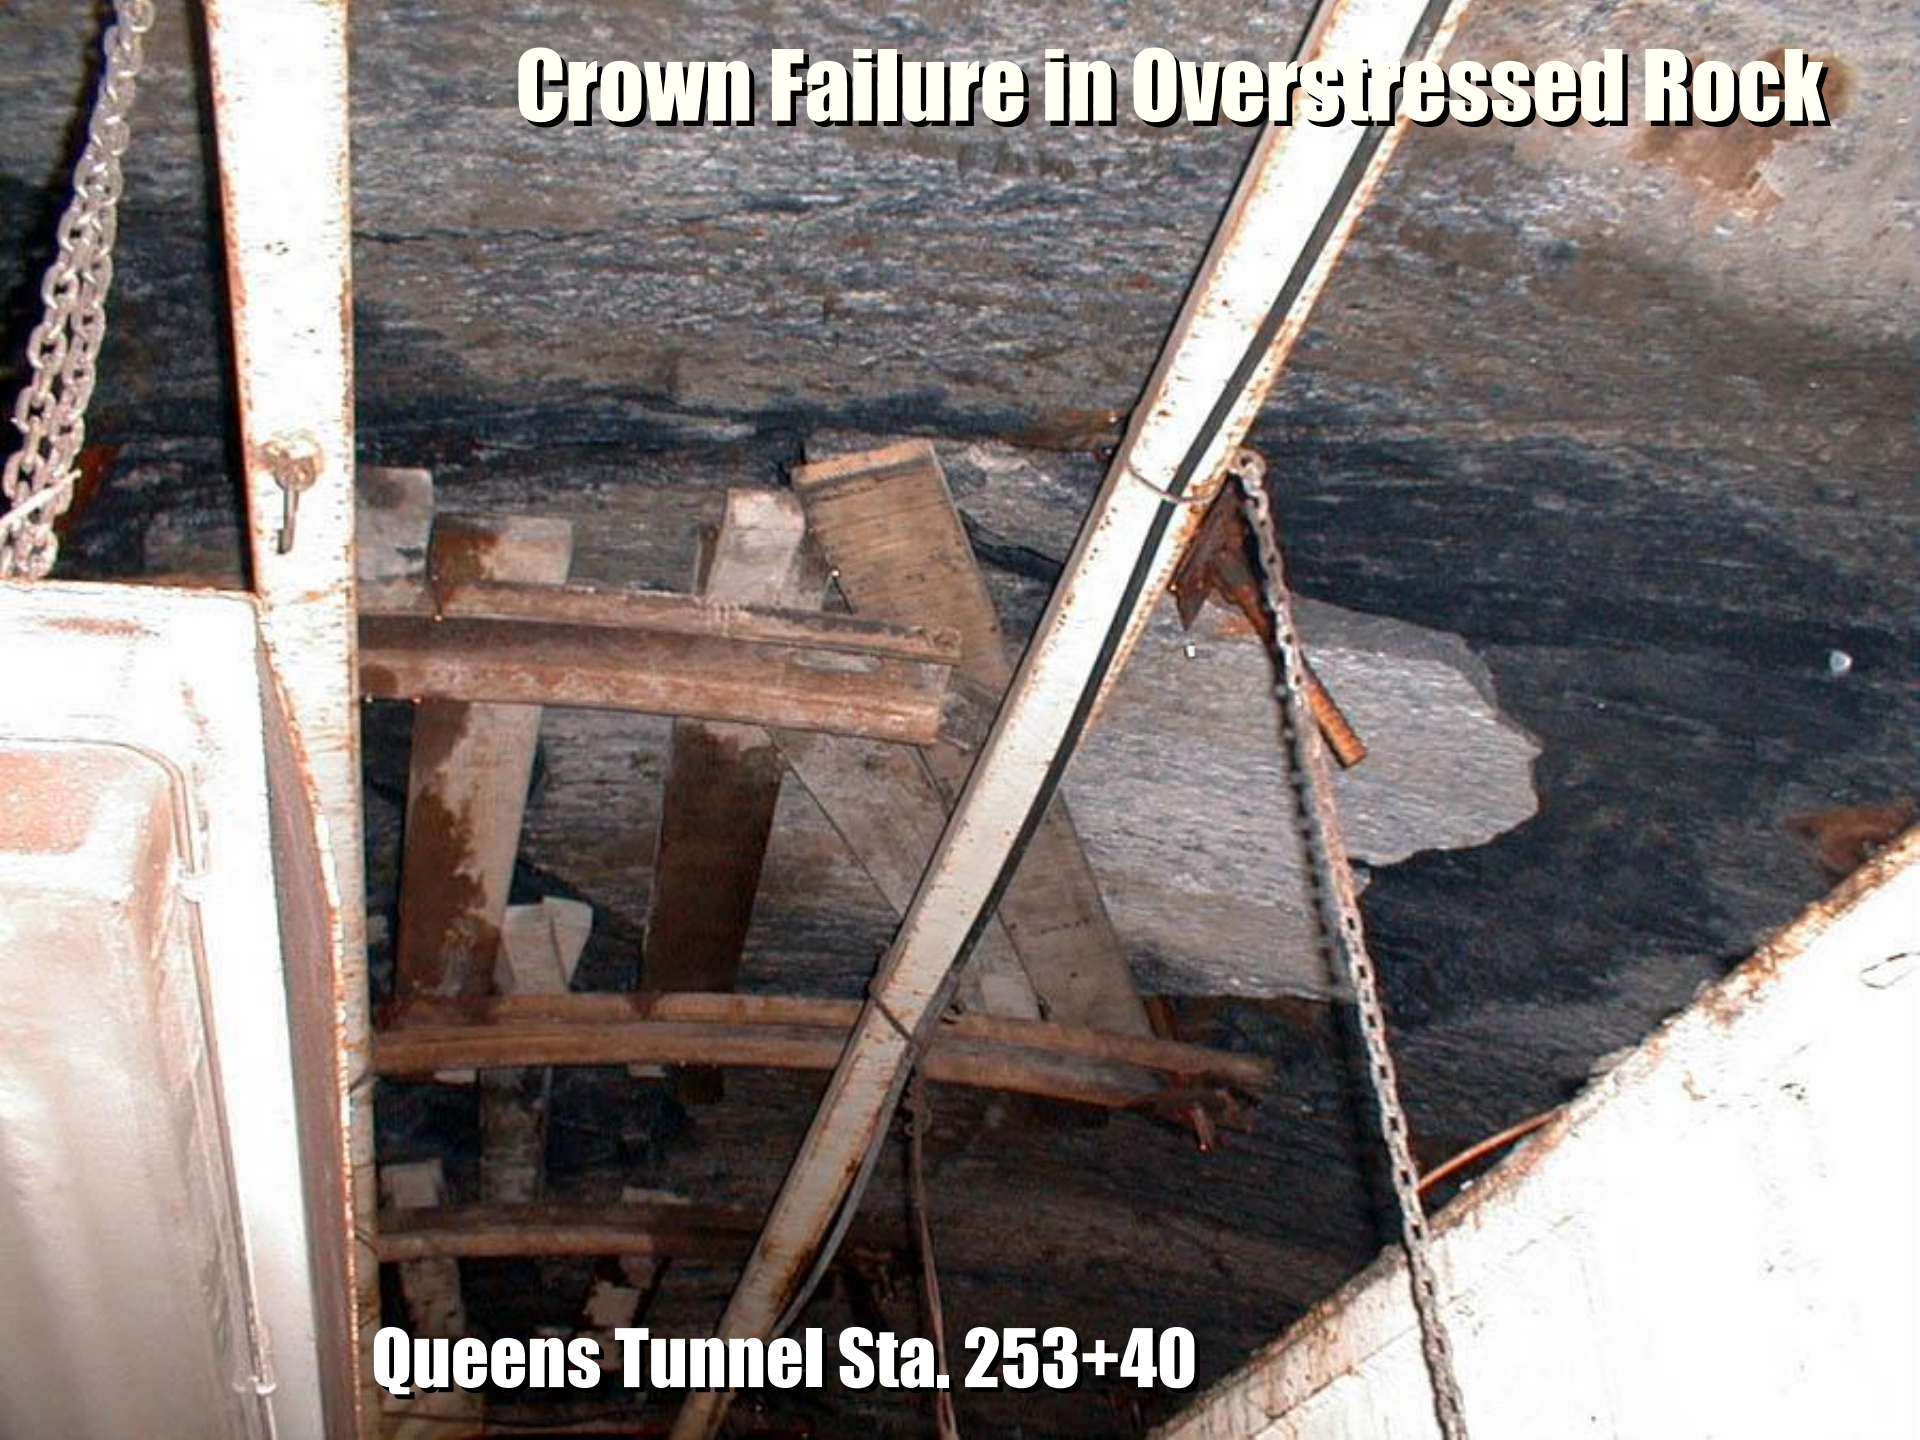
Queens Tunnel Sta. 253+40

Crown Failure in Overstressed Rock

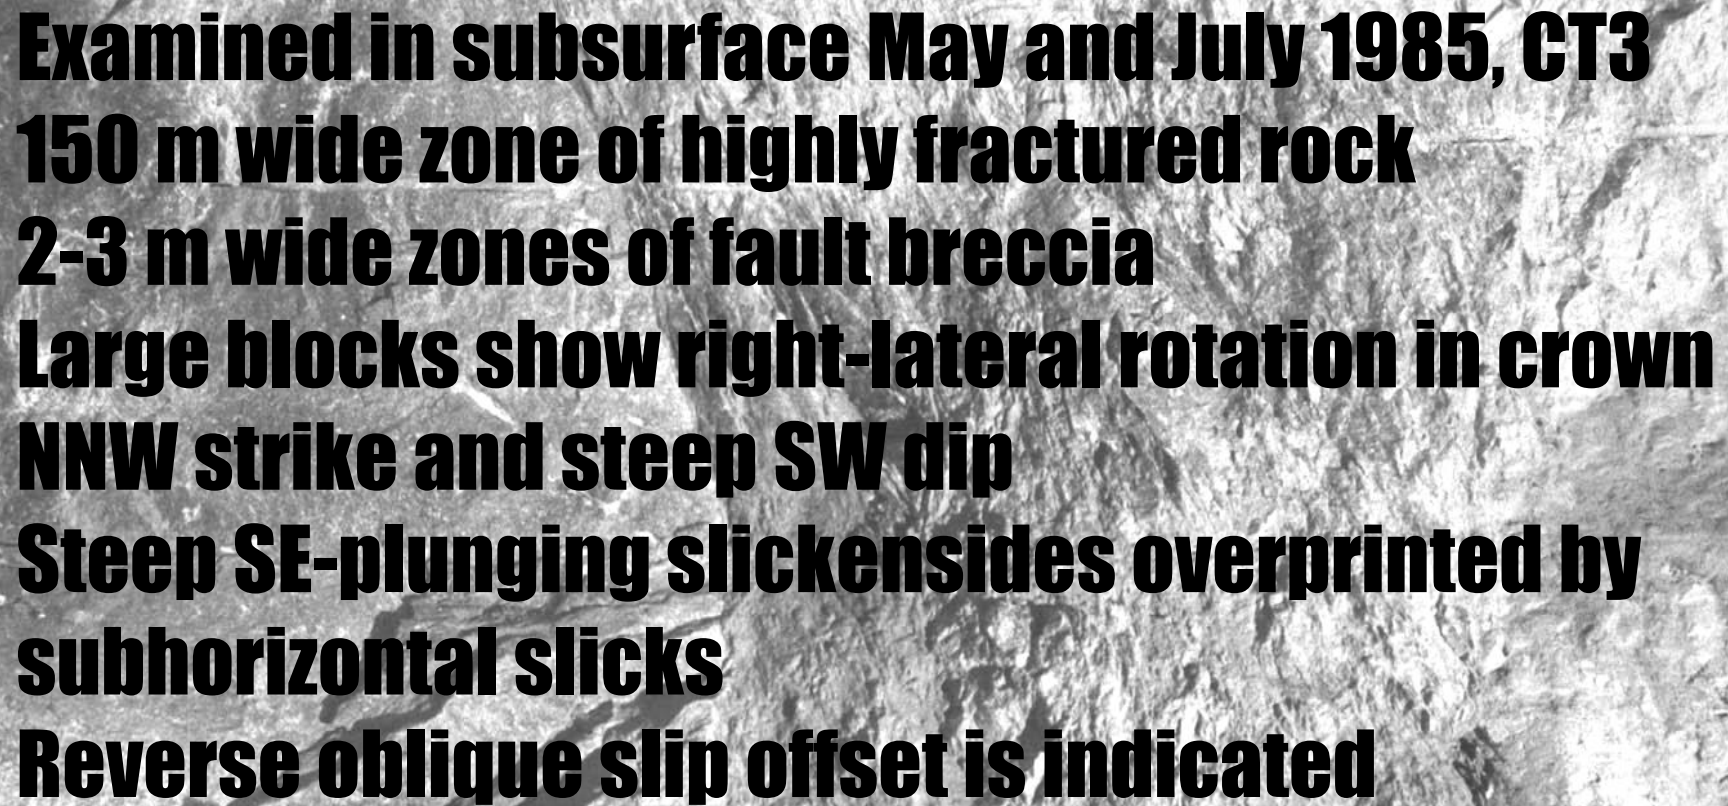
125th Street Fault, CT3, Stage 1

Examined in subsurface May and July 1985, CT3
150 m wide zone of highly fractured rock
2-3 m wide zones of fault breccia
Large blocks show right-lateral rotation in crown
NNW strike and steep SW dip
Steep SE-plunging slickensides overprinted by
subhorizontal slicks
Reverse oblique slip offset is indicated

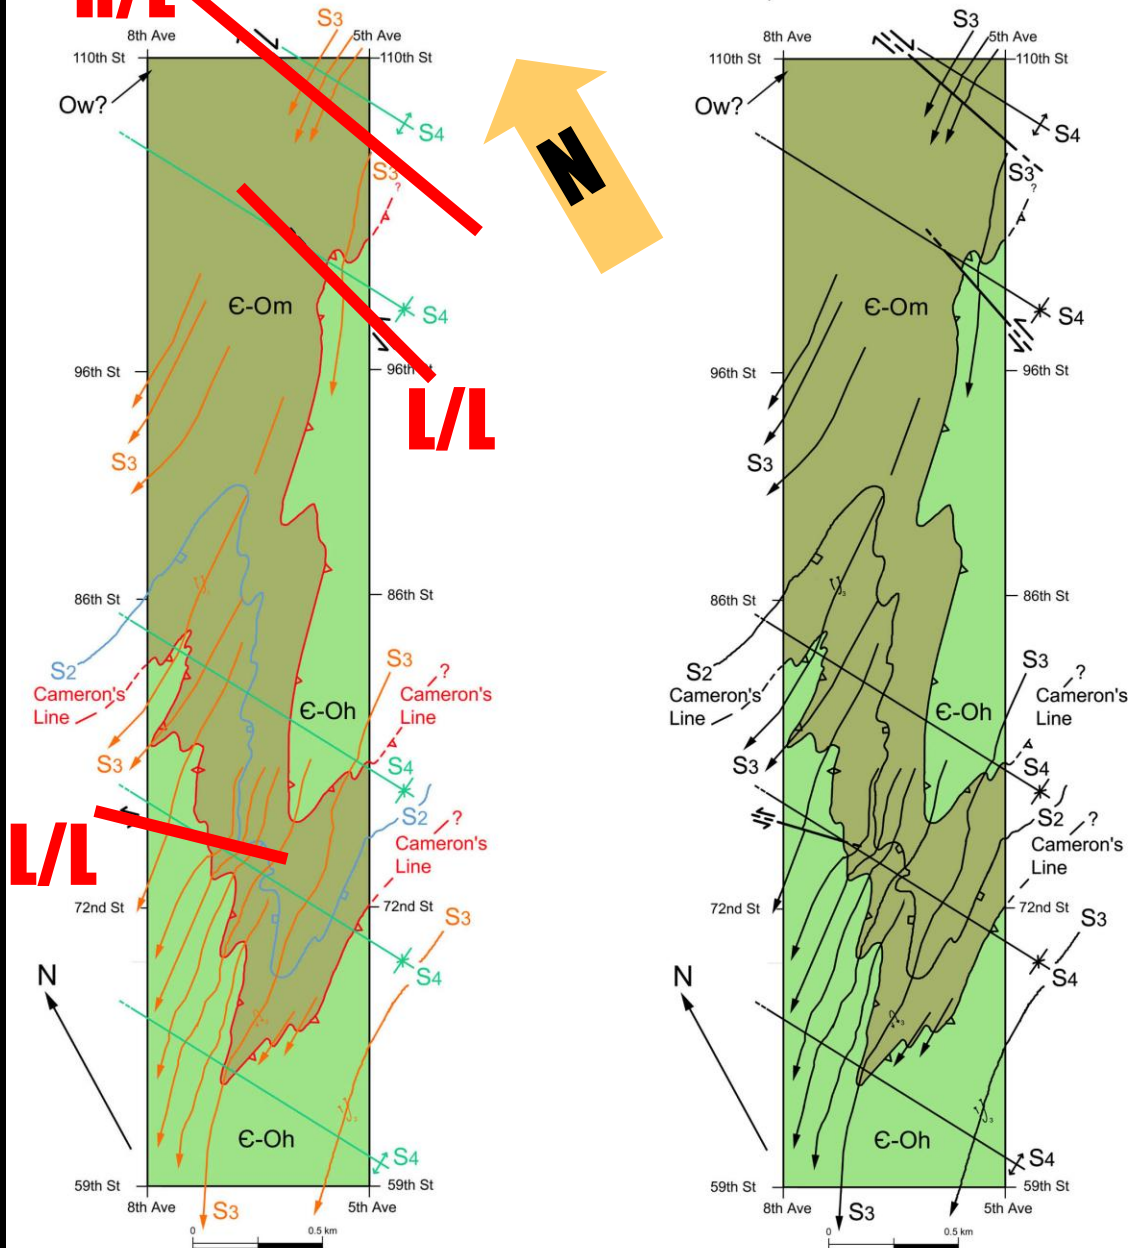
PRELIMINARY GEOLOGICAL MAP OF CENTRAL PARK, NYC

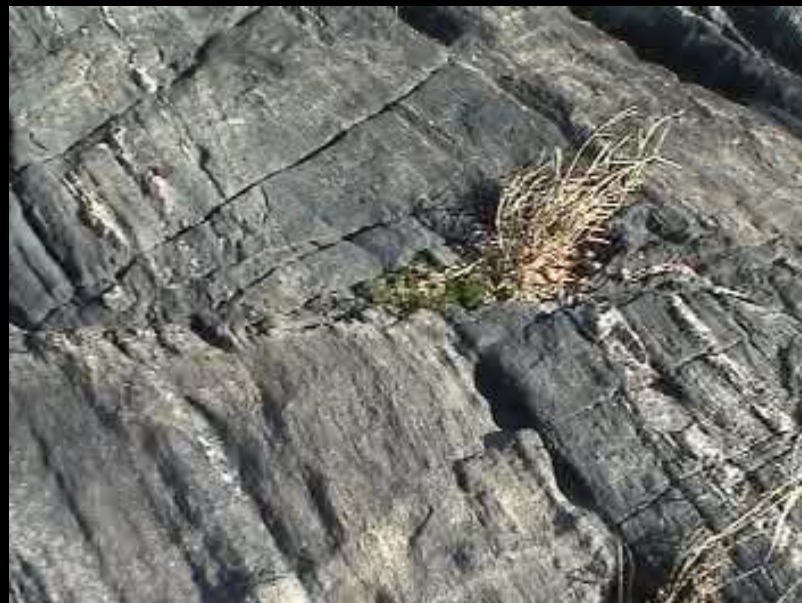
N537

**Offsets F_3
Syncline**

Group E - N12°W, L/L Fault

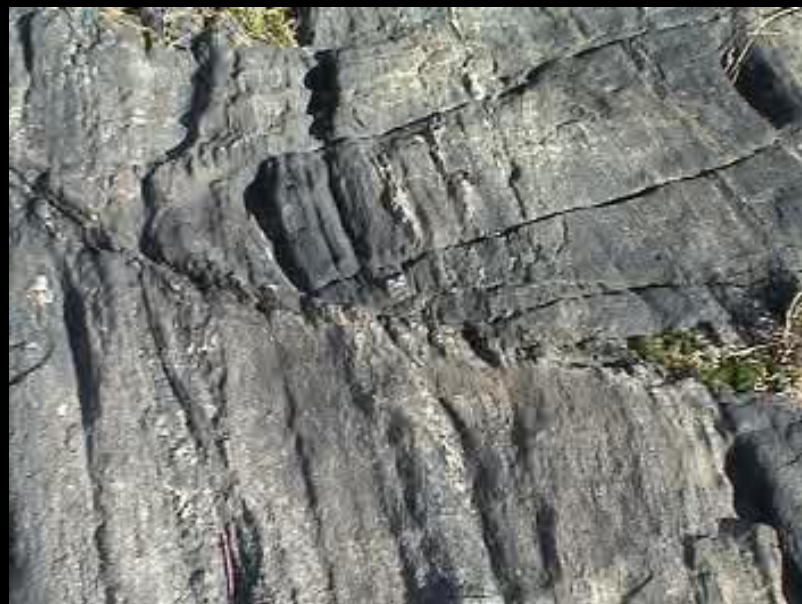
N296

Group E - N45°W, 80°S L/L Fault
