REDEFINING THE SOUTHERN TERMINUS OF THE INTRUSIVE CONTACT BETWEEN THE YONKERS AND FORDHAM GNEISS IN VAN CORTLANDT PARK, NEW YORK CITY, NEW YORK

**ISLER, Douglas, E.,
VELLONE, Daniel, A.,
MERGUERIAN, Charles; and
MERGUERIAN, J. Mickey**

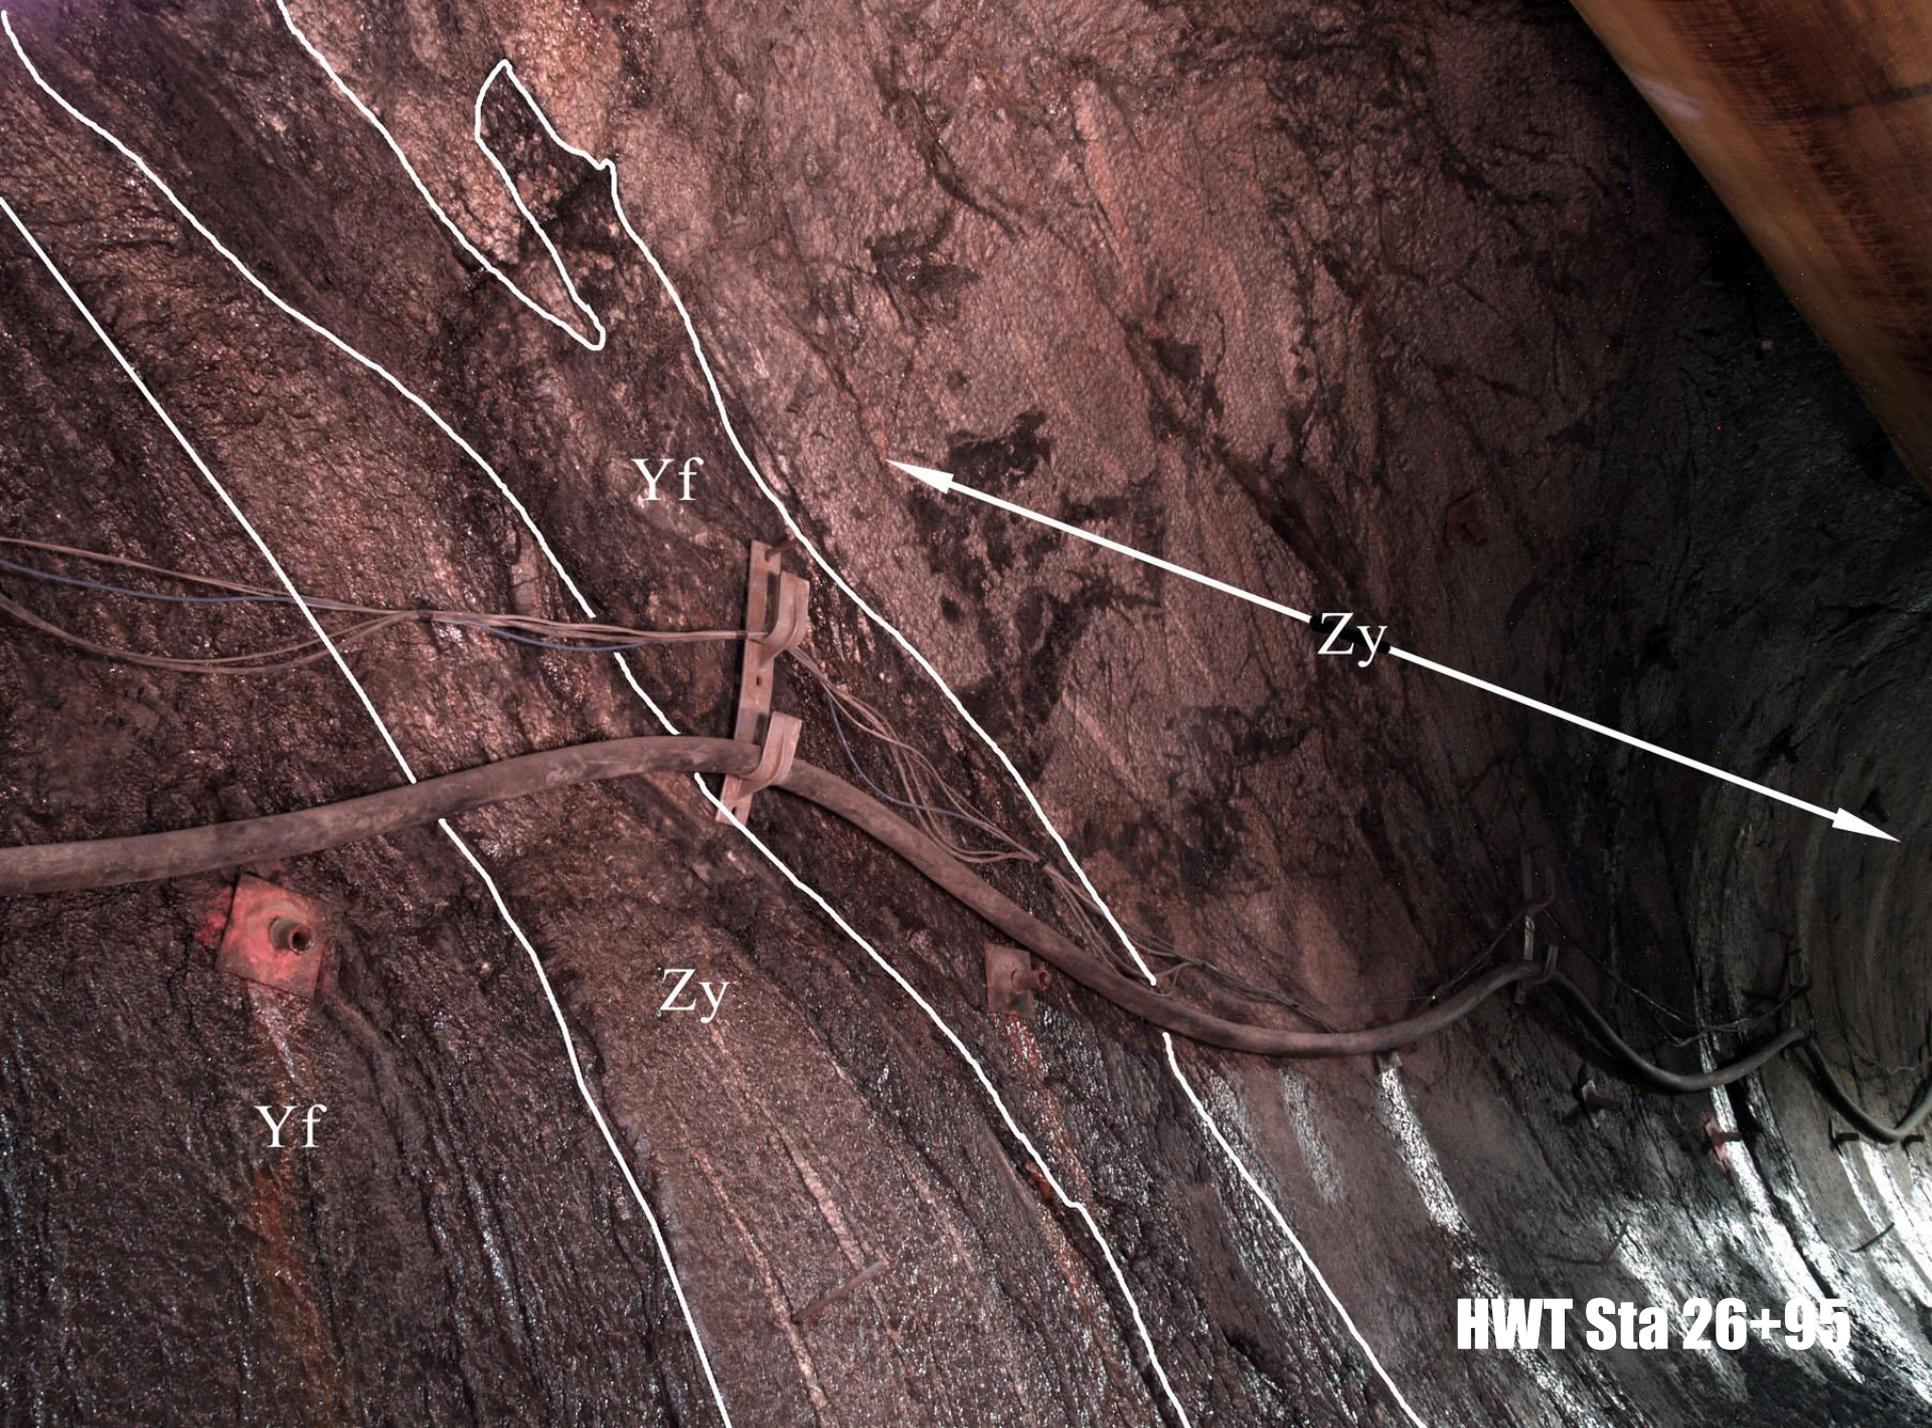
HWT Sta 26+95

Mosholu Fault

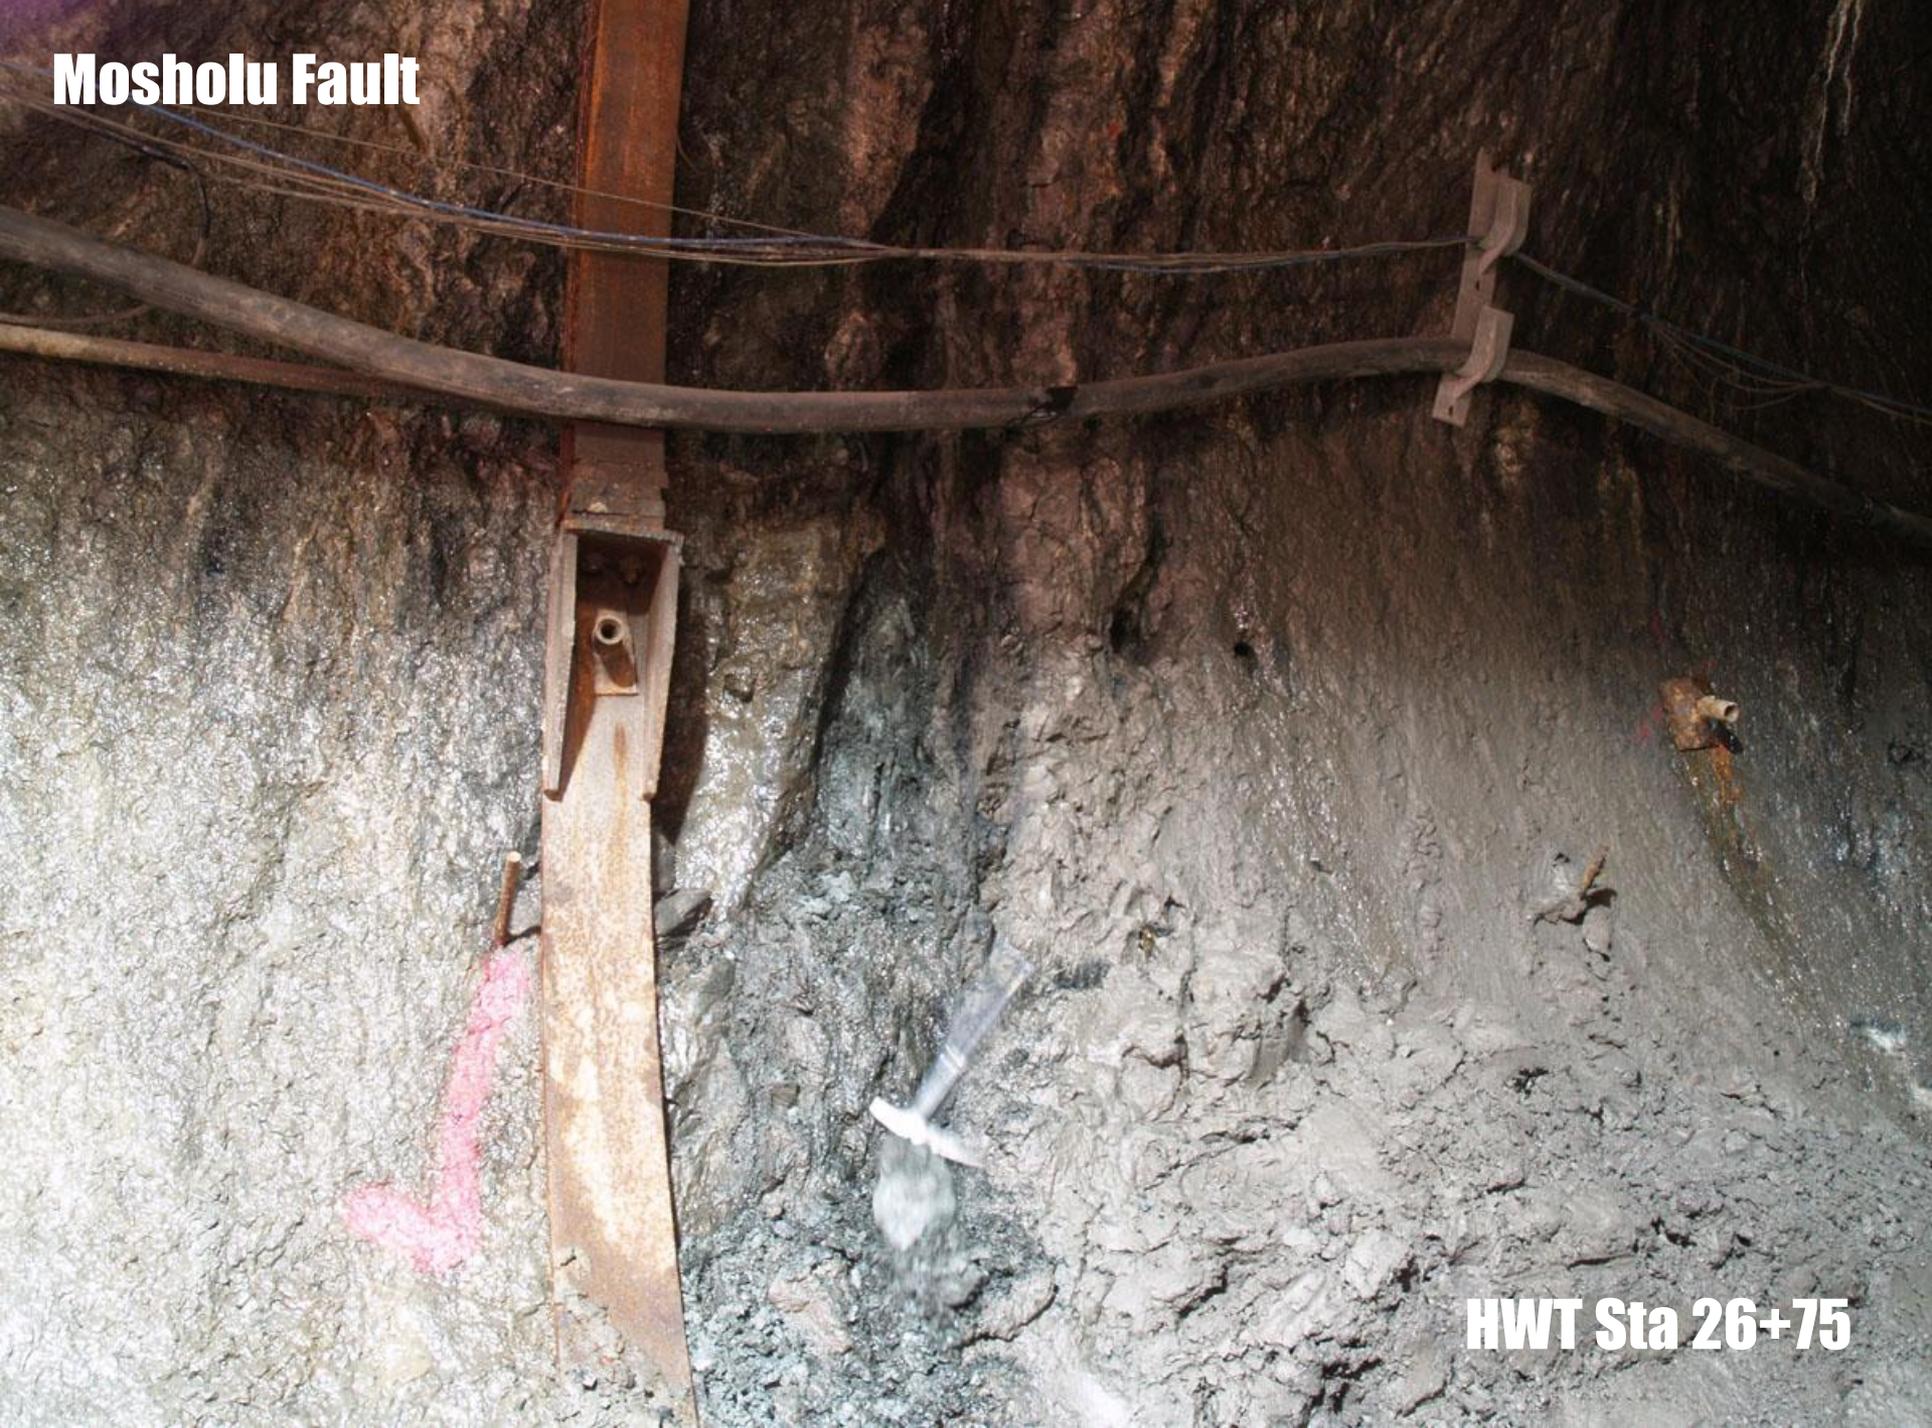
HWT Sta 26+75

Mosholu Fault – Sta 26+75 HWT

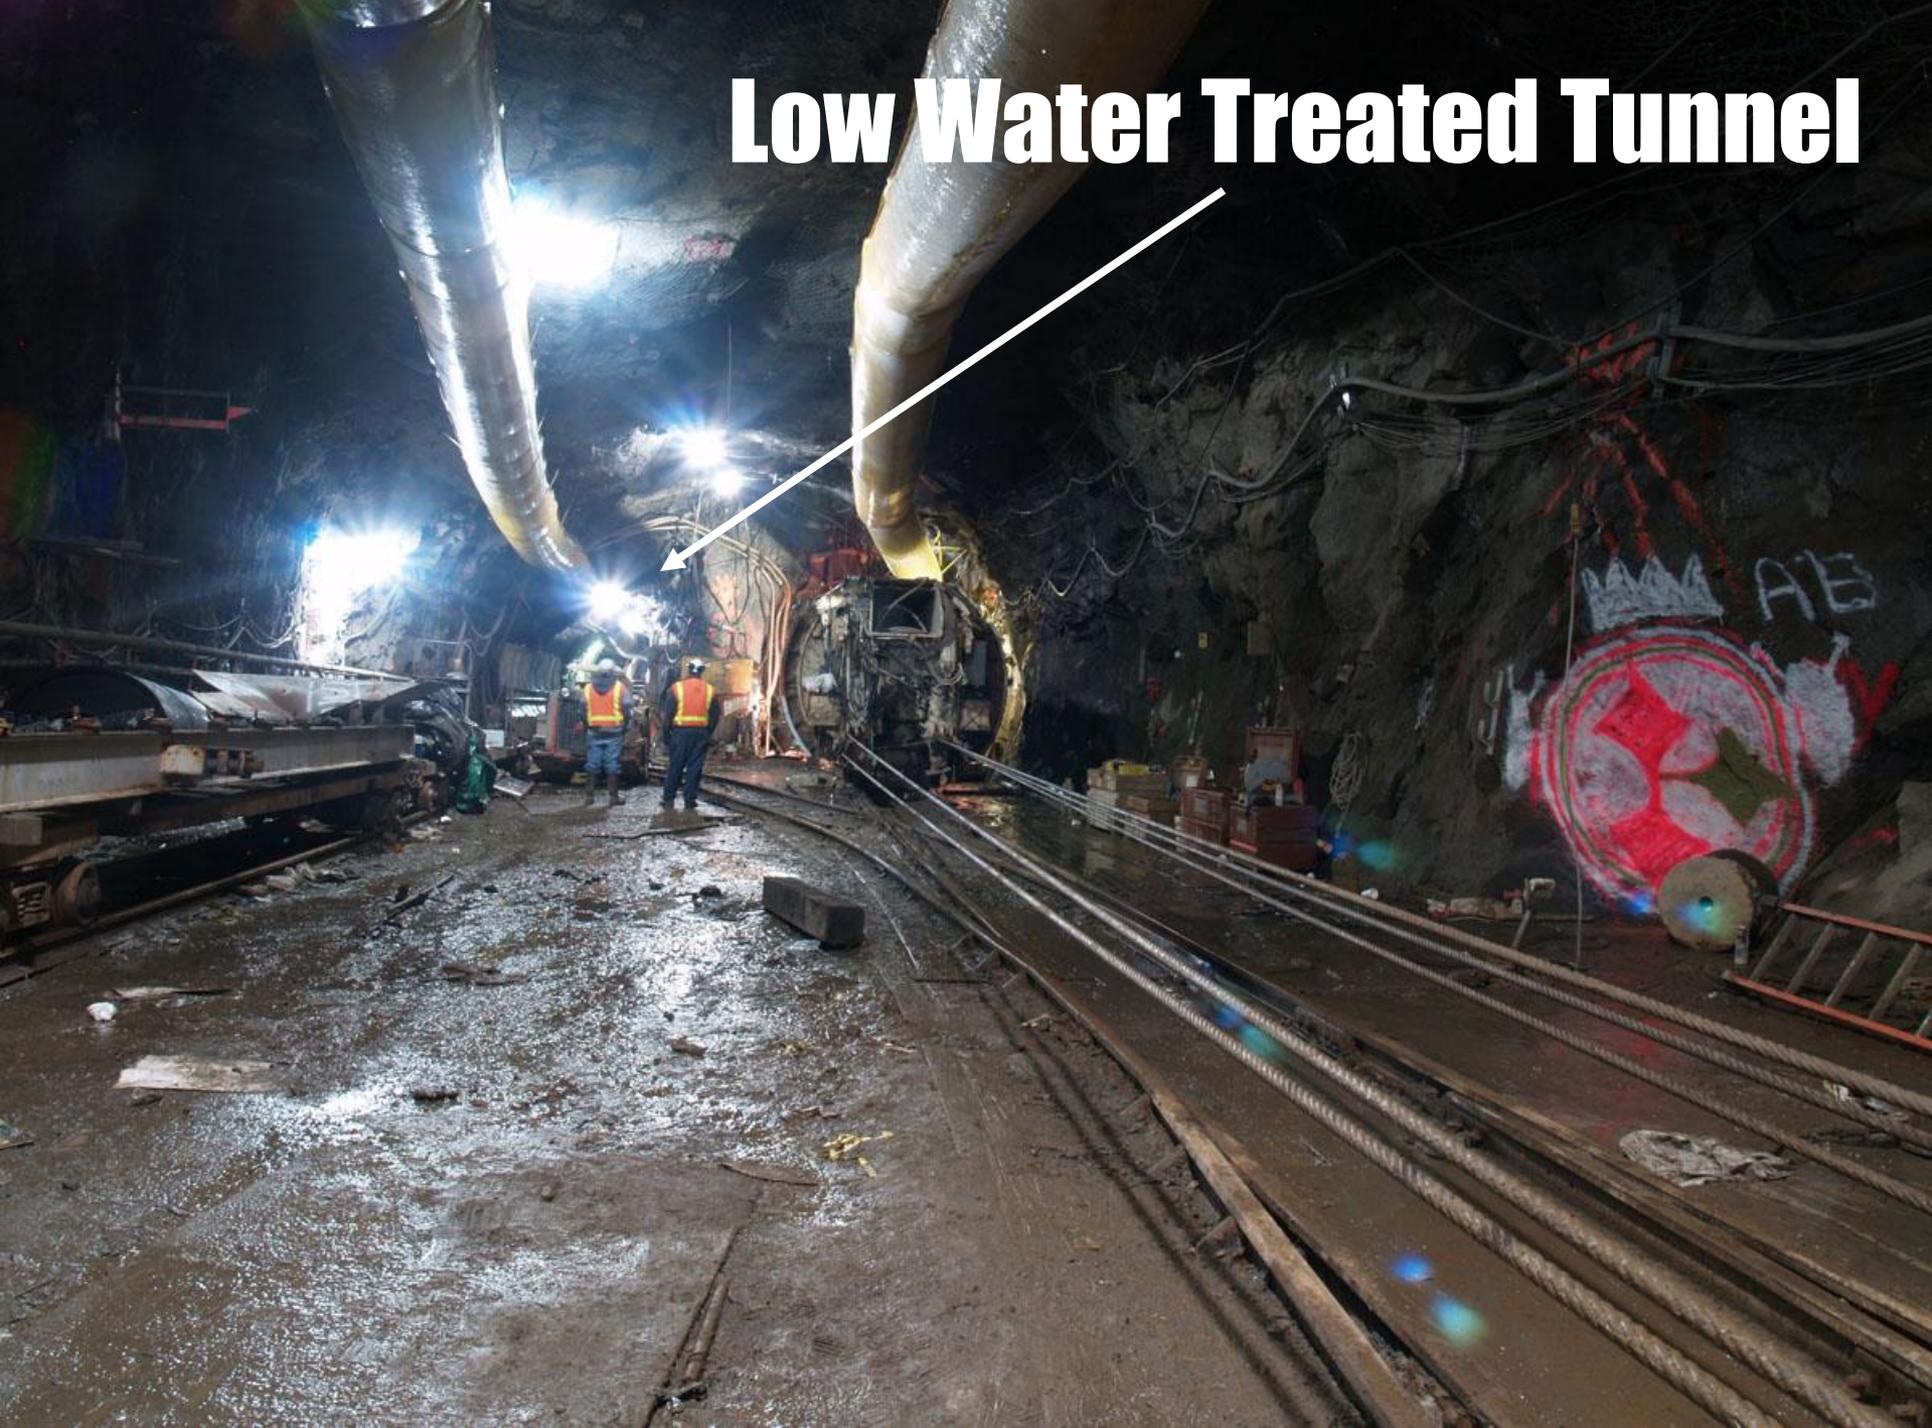
Geologic Sketch No. : 1
Beginning Station (ft.): 37+30
End Station (ft.): 36+40

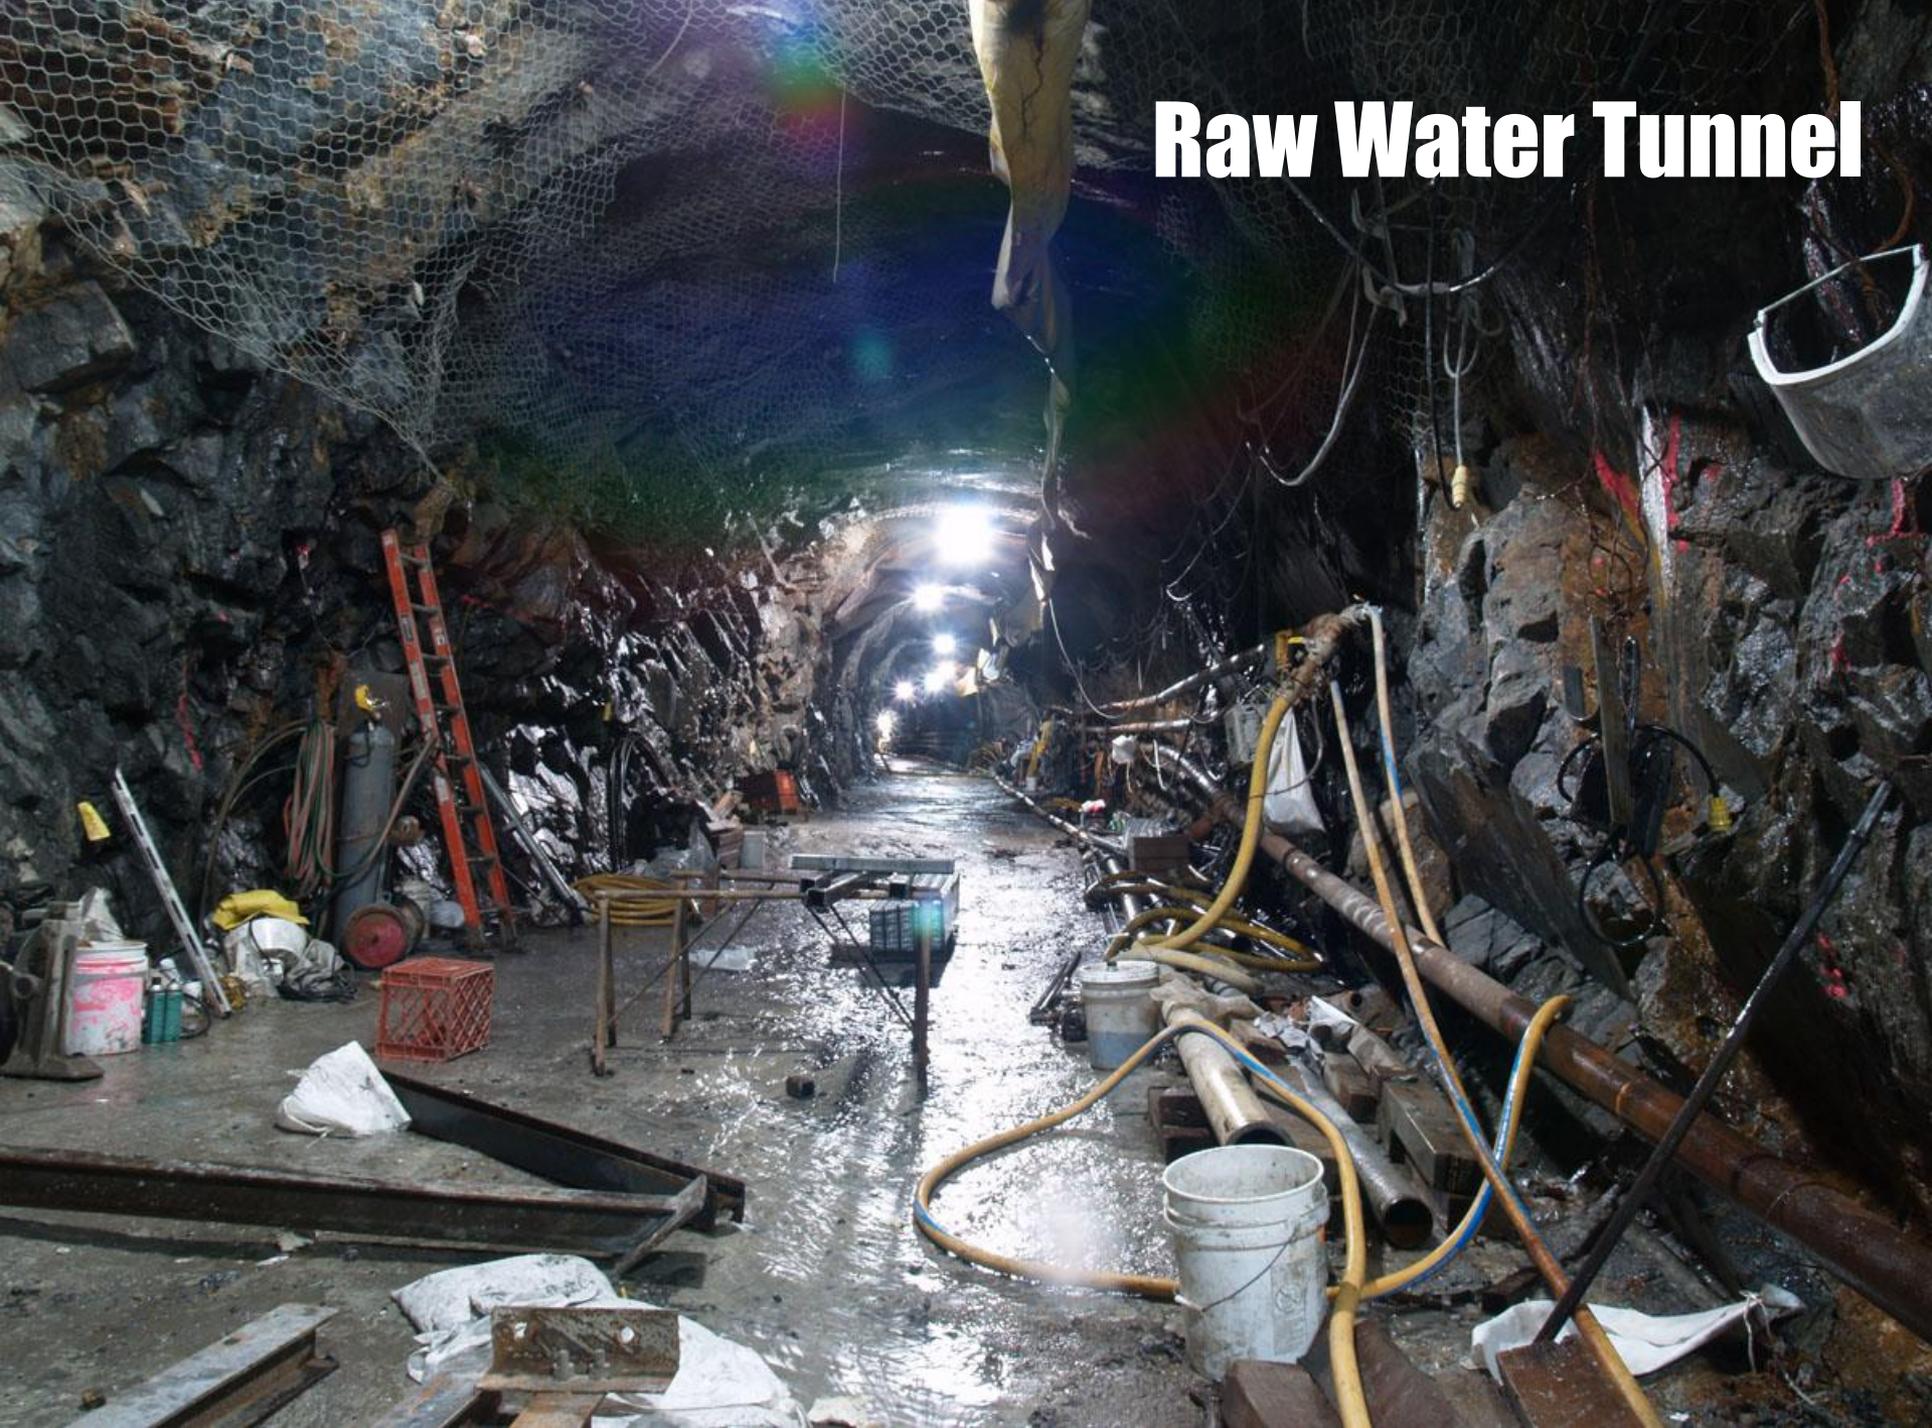
New Croton Water Treatment Plant, Bronx New York - North Wall Raw Water Tunnel, Stations 4+50 to 6+65

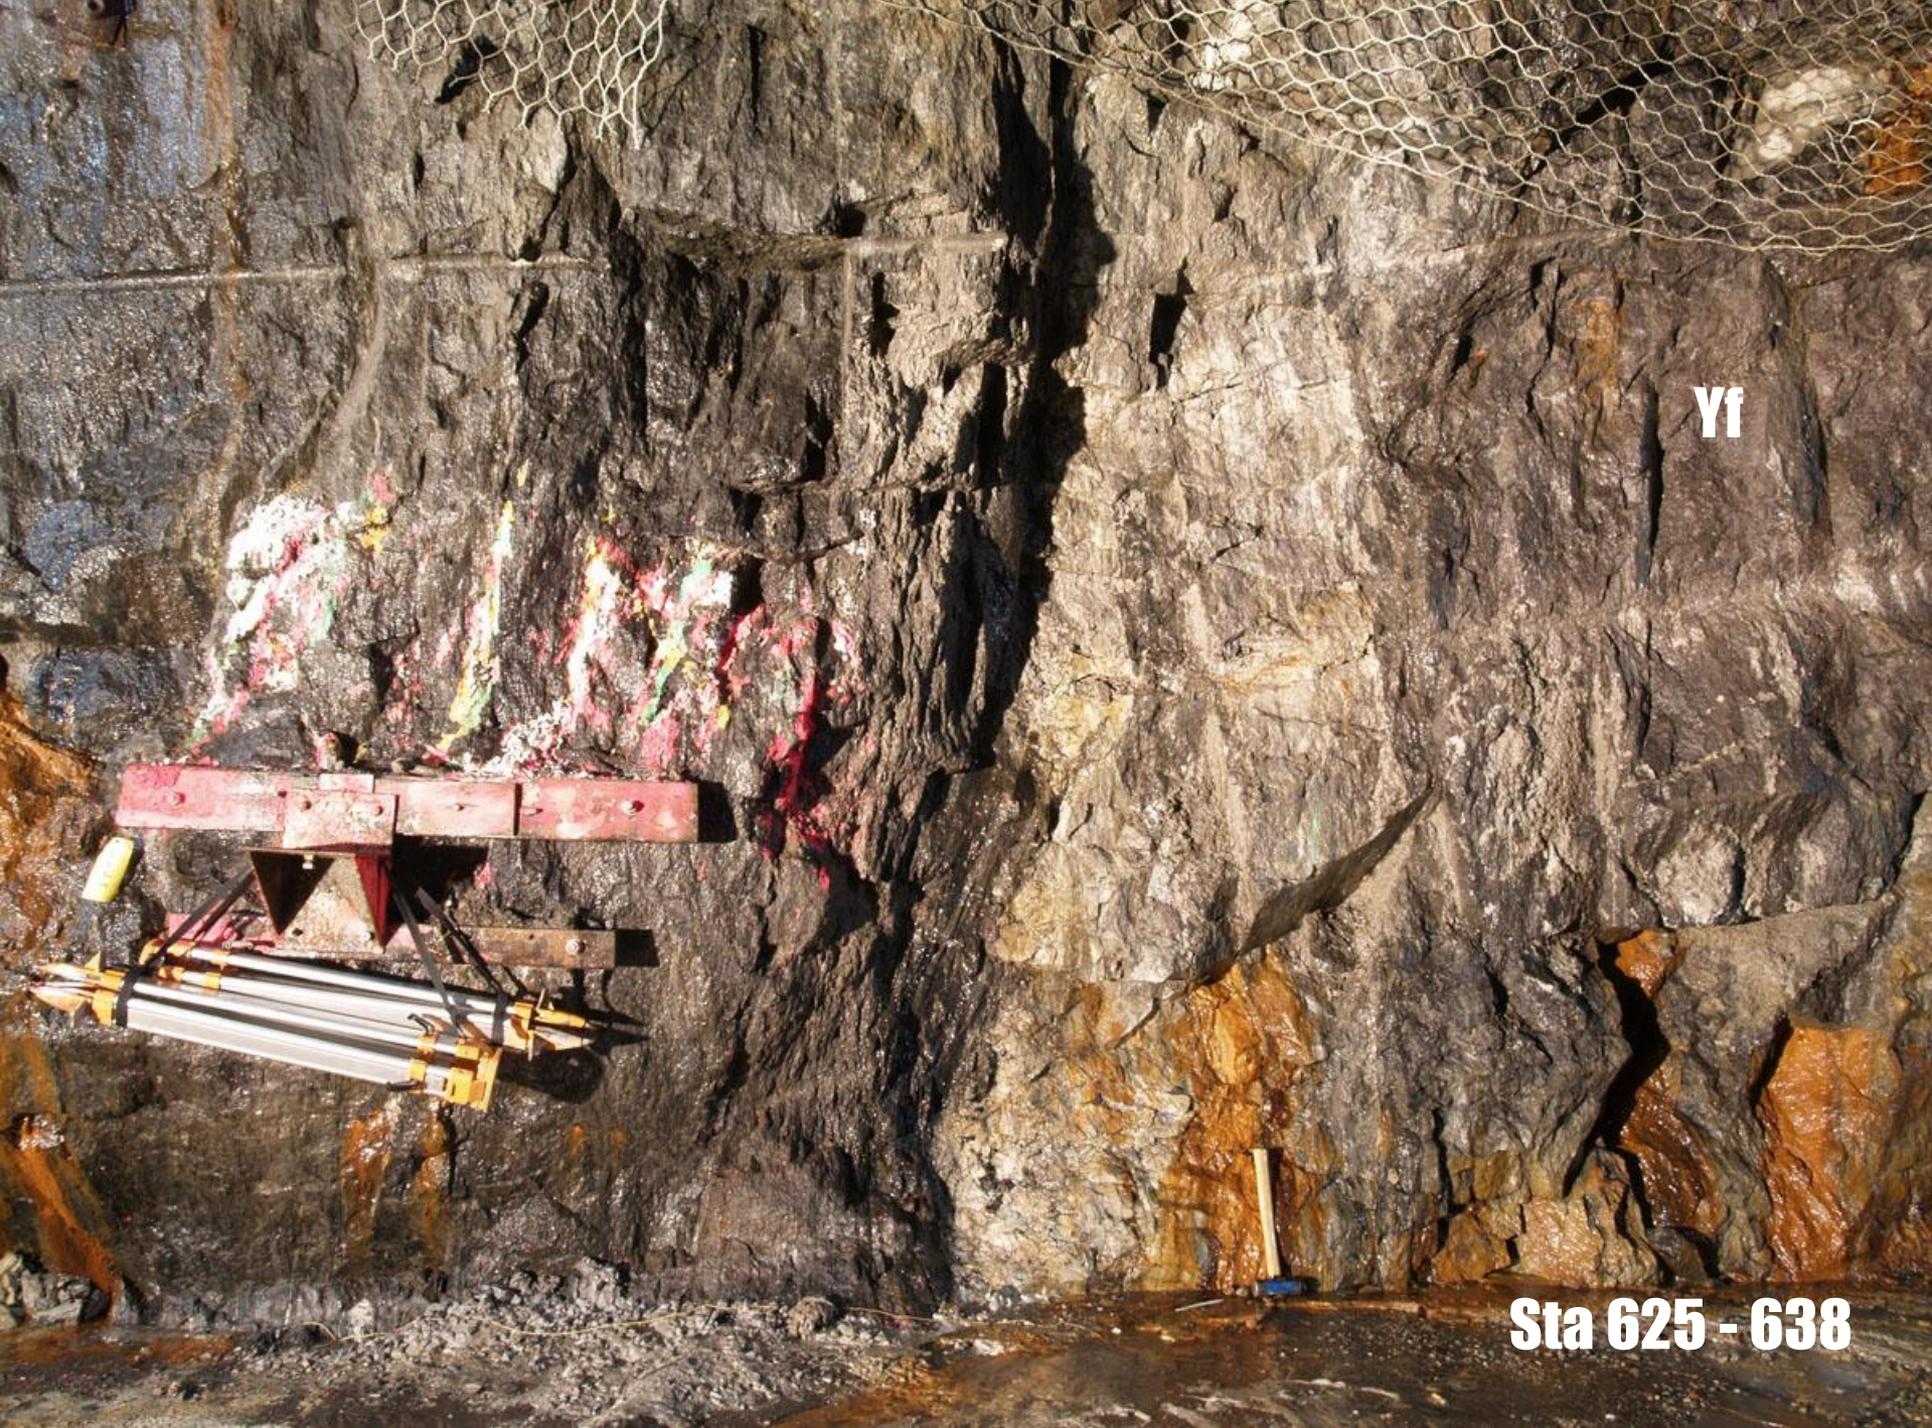
Sta 625 - 638

A photograph of a rock face in a tunnel. The rock is dark grey and brown, with some reddish and yellowish staining. A white mesh is visible at the top. On the left, there is a red metal structure and a bundle of pipes. The text 'Yf' is on the right, and 'Sta 625 - 638' is at the bottom right.
