Geological Controls on Megaconstruction Projects, NYC

Charles Merguerian

25 April 2013

Penetration Destiny TBM Tunnelling in NYC

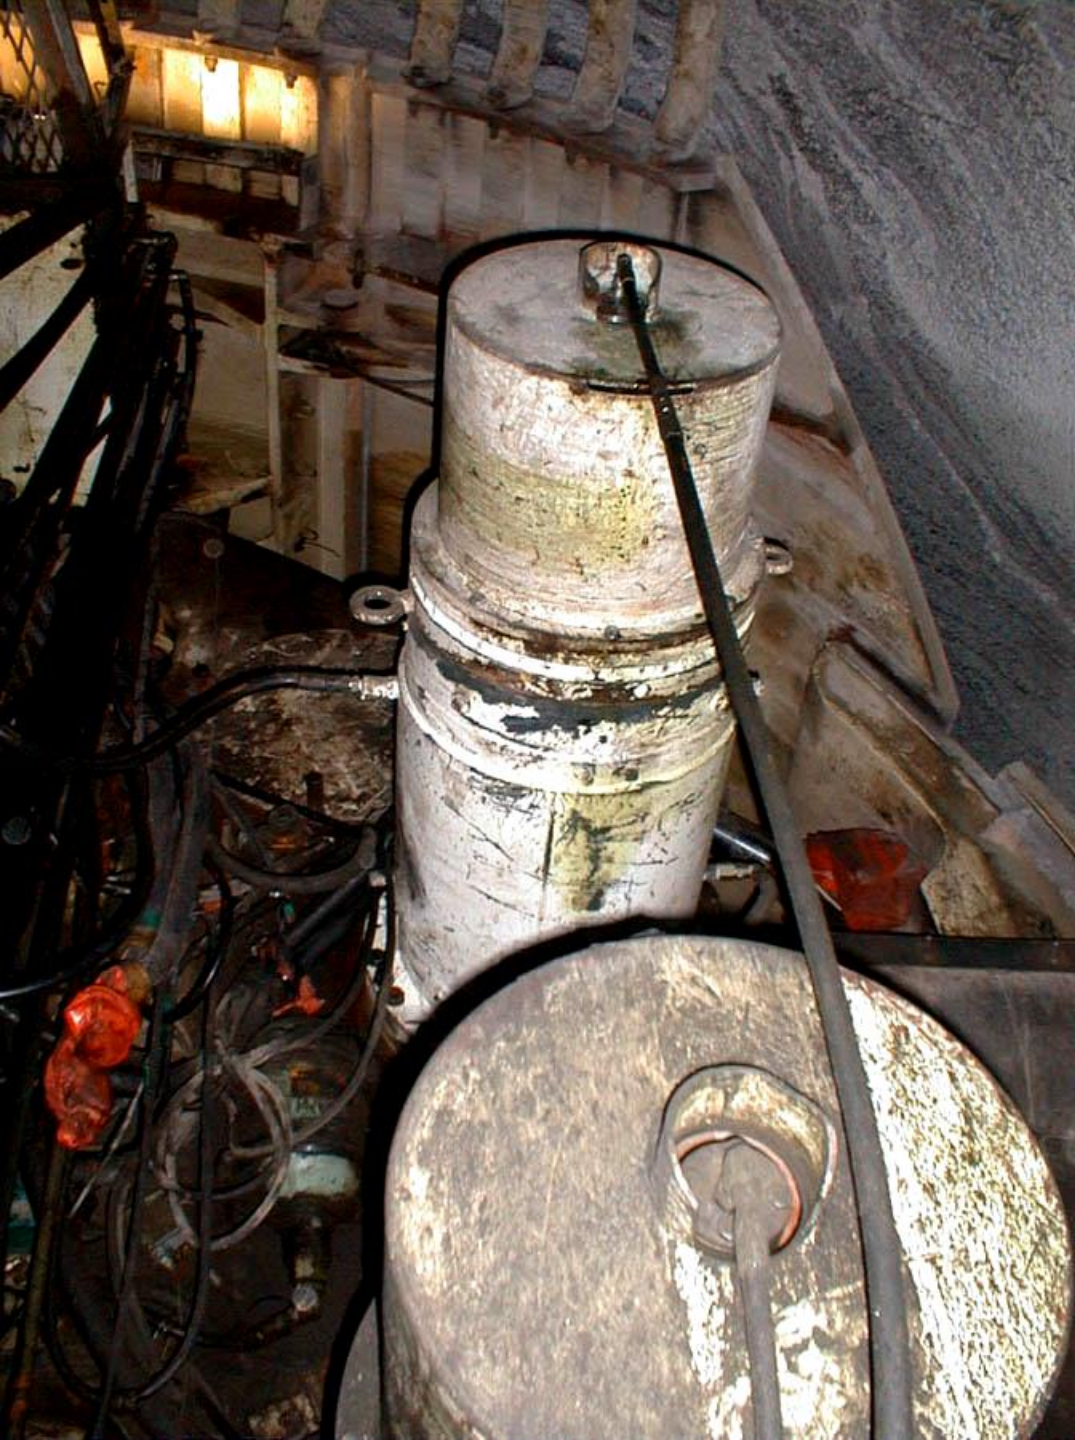
**Queens Tunnel TBM
422 HP Electric
Water Cooled,
Three Phase Motors**

**10 Motors Total
Usually 8 Online
Rotated Cutterhead
at 8.3 Rev/Min**

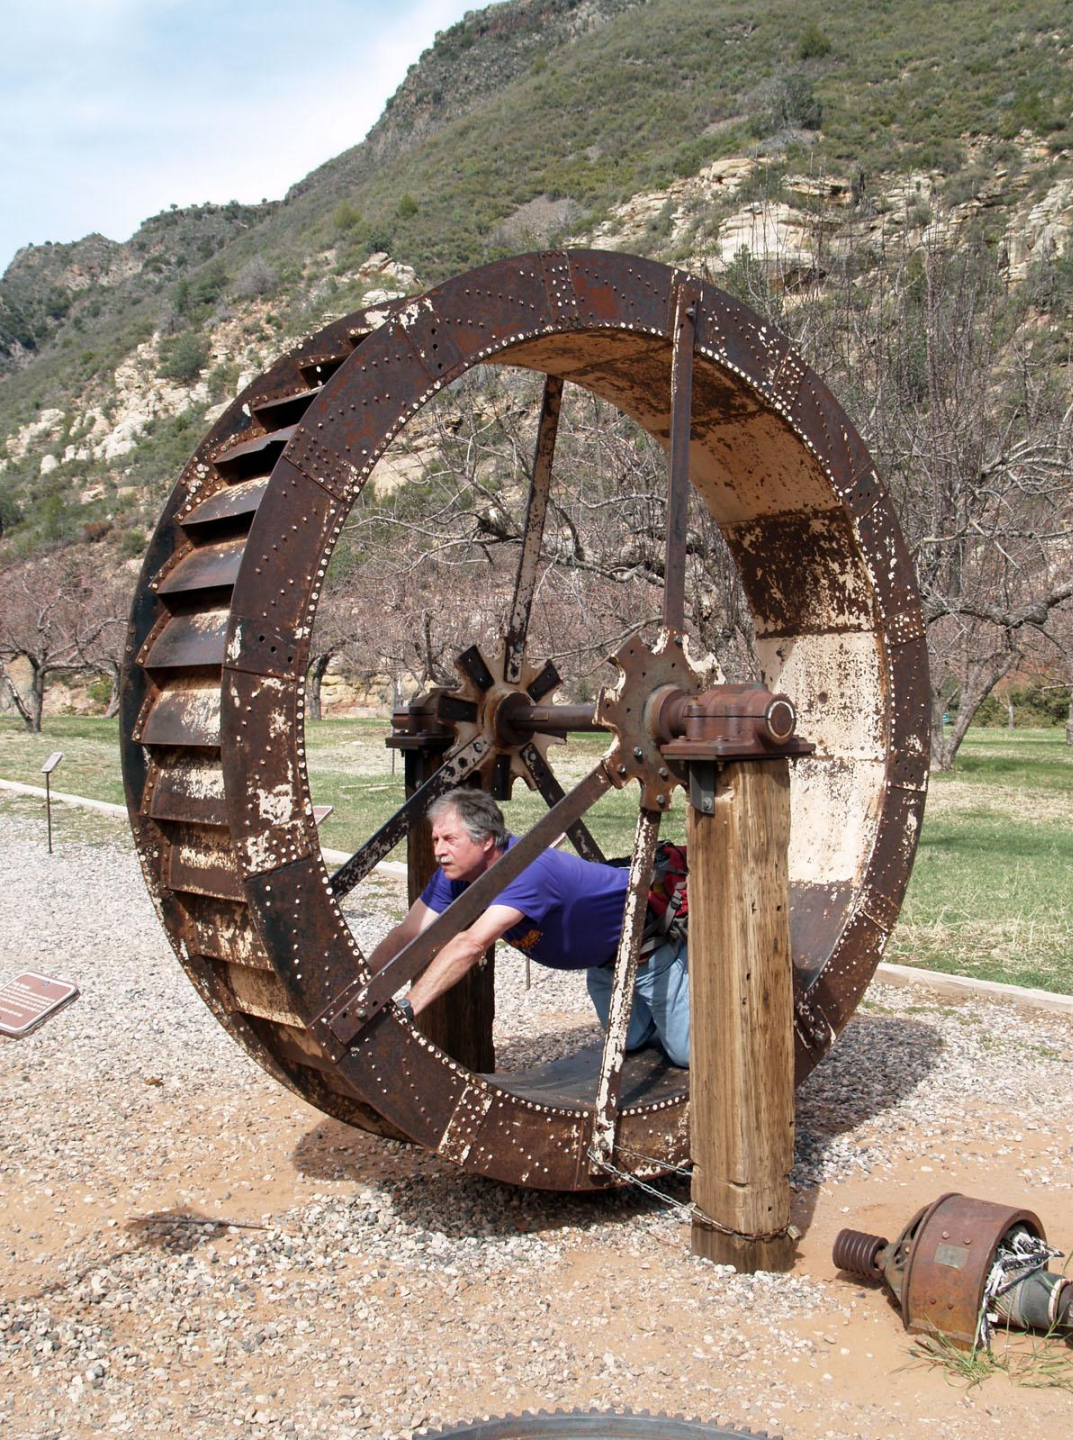
The background of the slide is a grayscale photograph of a Tunnel Boring Machine (TBM) cutterhead. The image shows the complex arrangement of scrapers and scrapers with scrapers, which are used to break up rock and remove debris from the tunnel face. The cutterhead is a large, circular structure with various mechanical components visible.

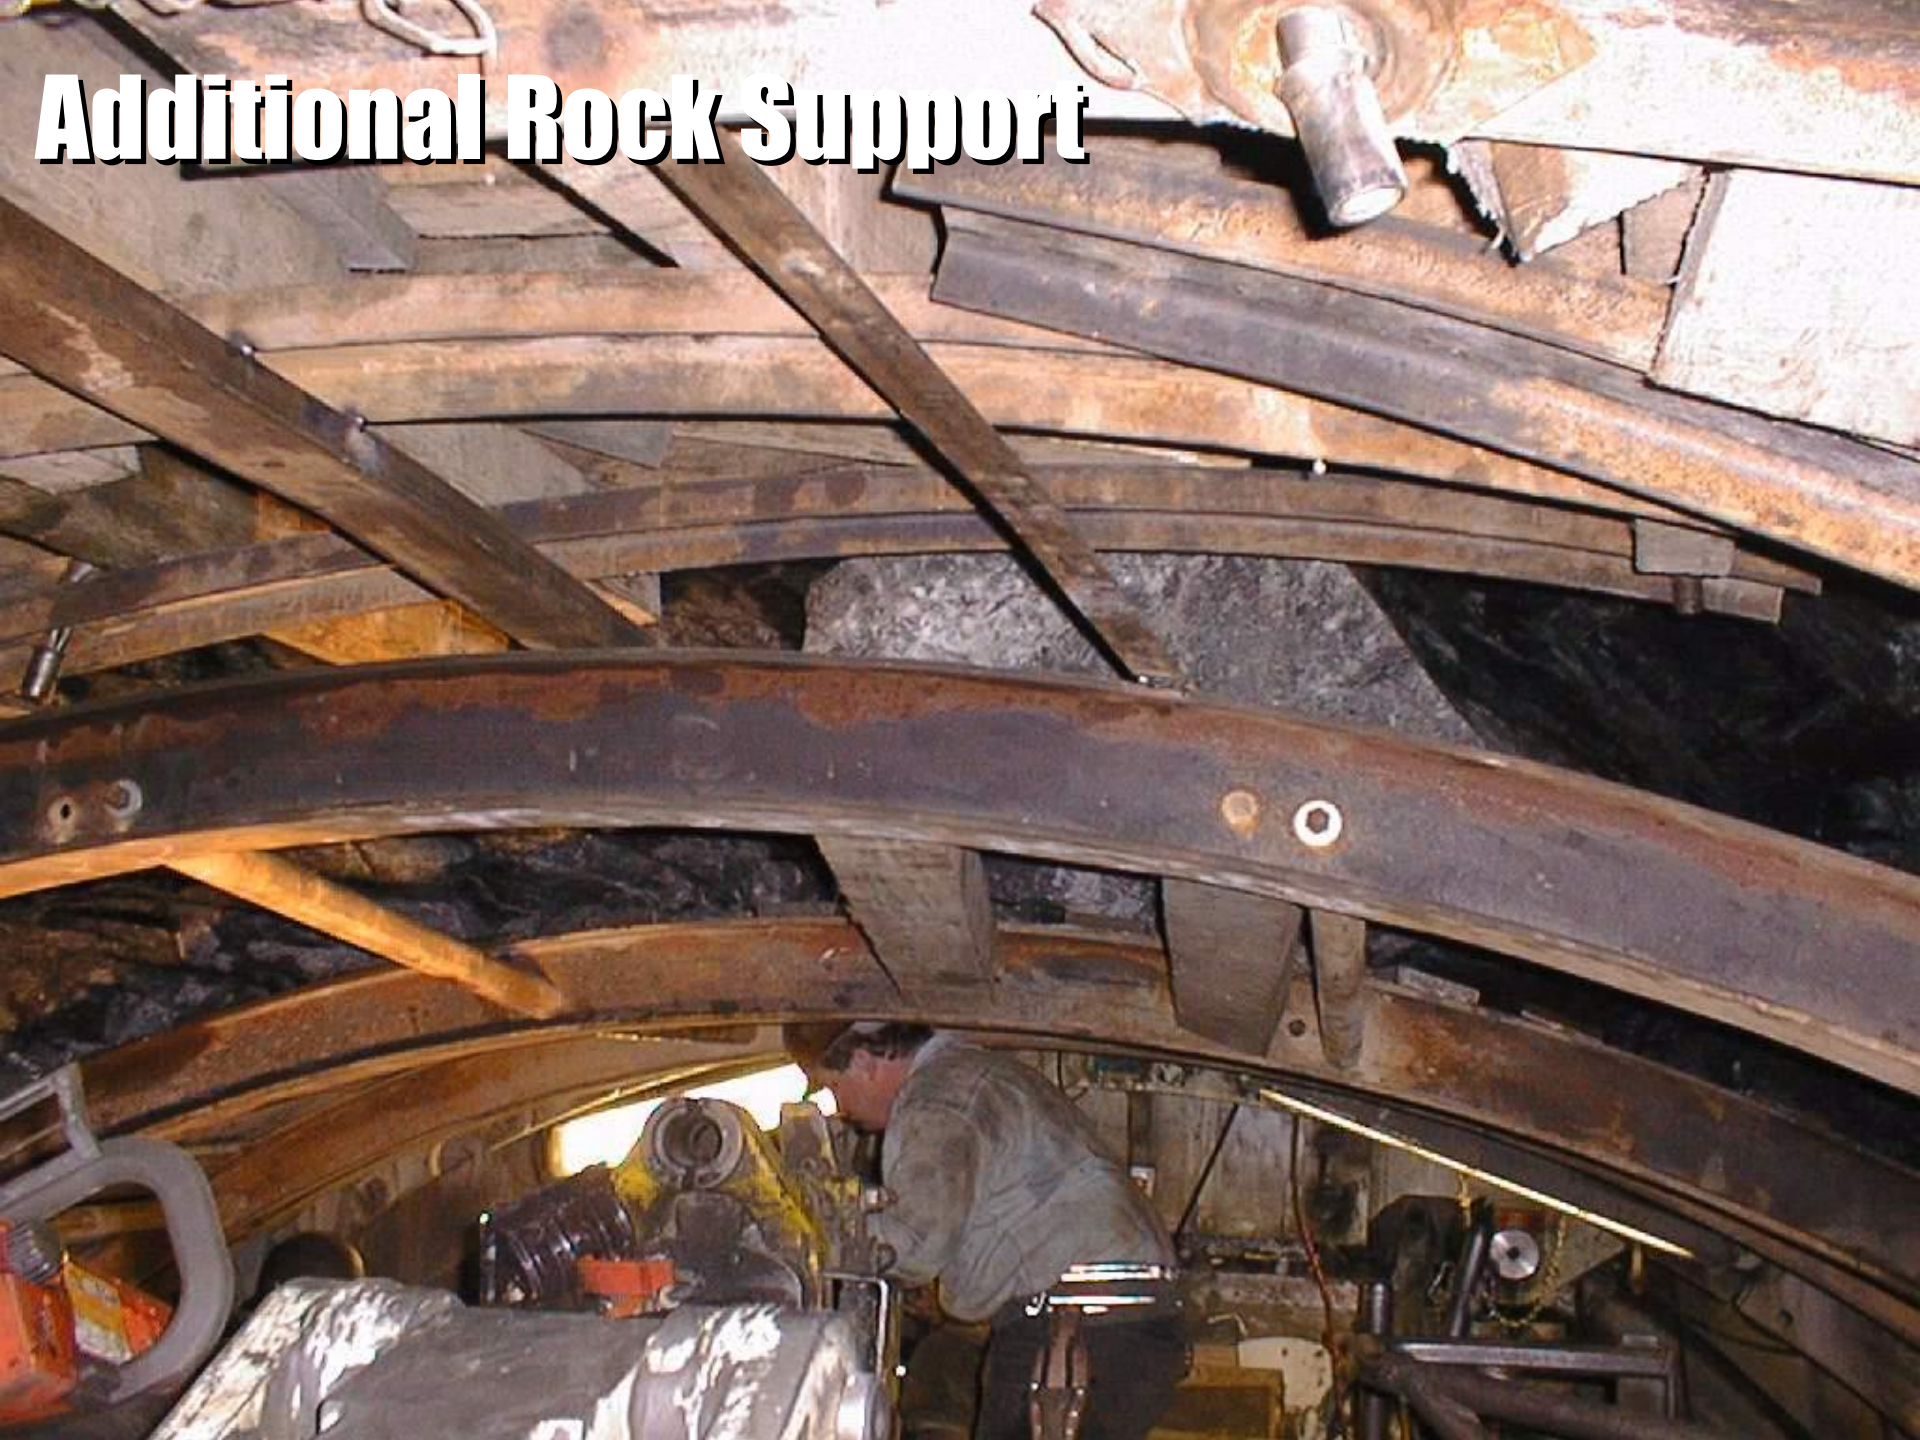
Station 153+30

Short Stand-up Times

Additional Rock Support

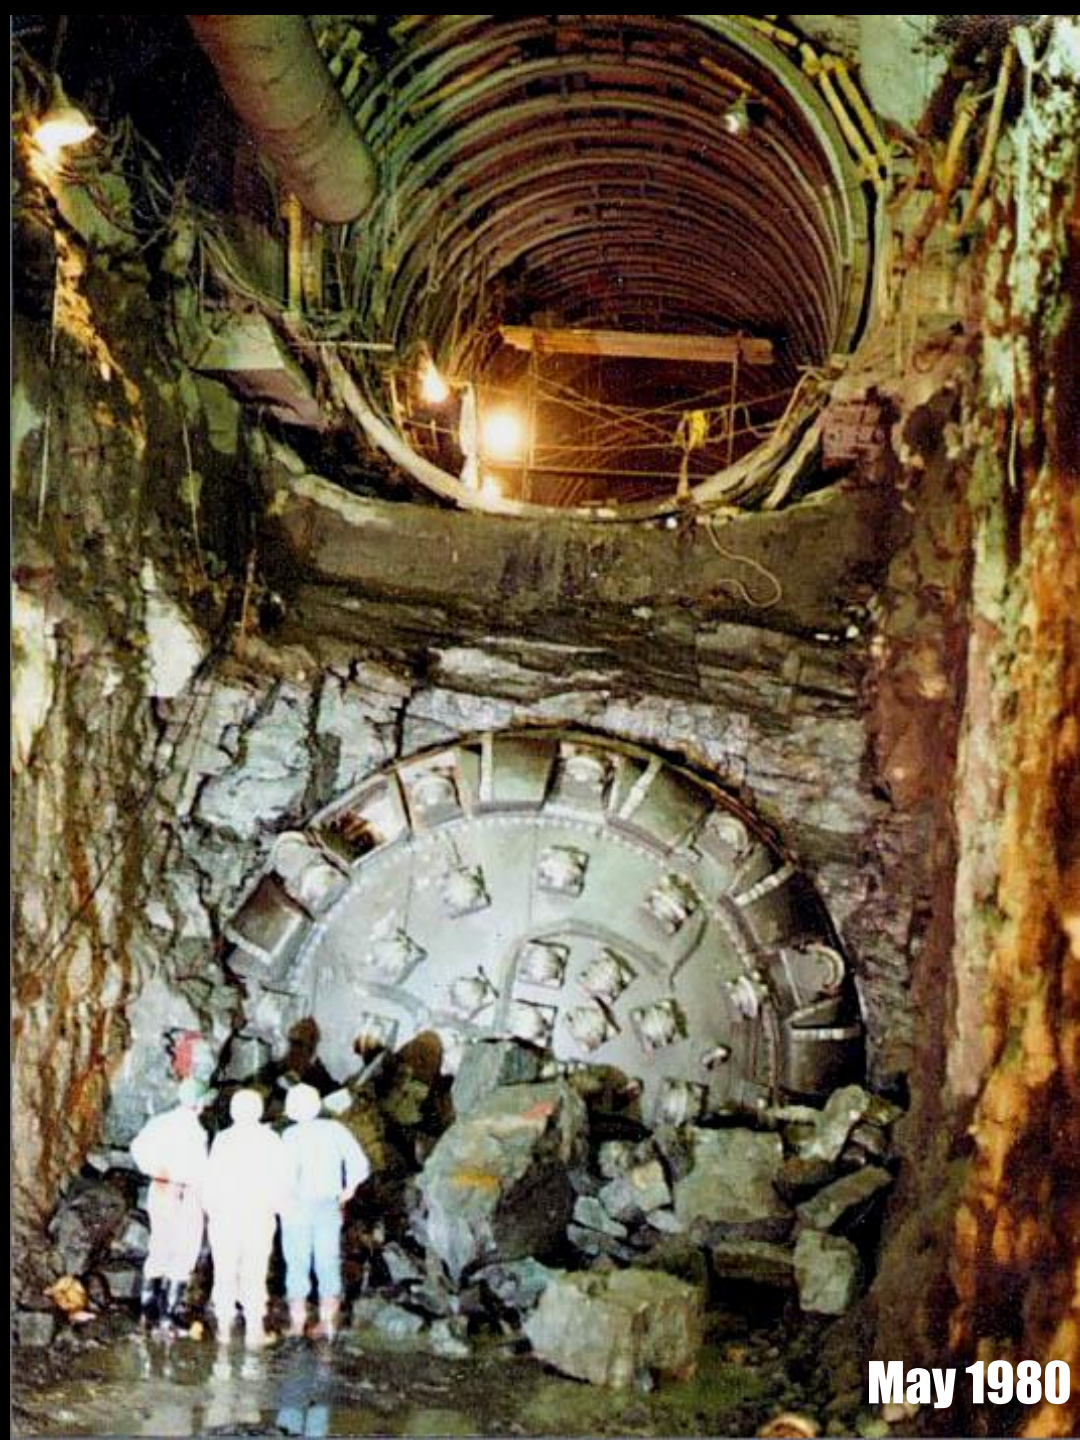
63rd Street Tunnels

- Twin Tunnels - 4 Tracks
- Robbins 203-205 TBM
- Diameters 20.17'/22'
- Feb 1980 - May 1980
- Immersed Tube First
- Lower Level for LIRR
- Fordham Gneiss and Hartland Formation
- **Penetration = 4.31'/Hr**

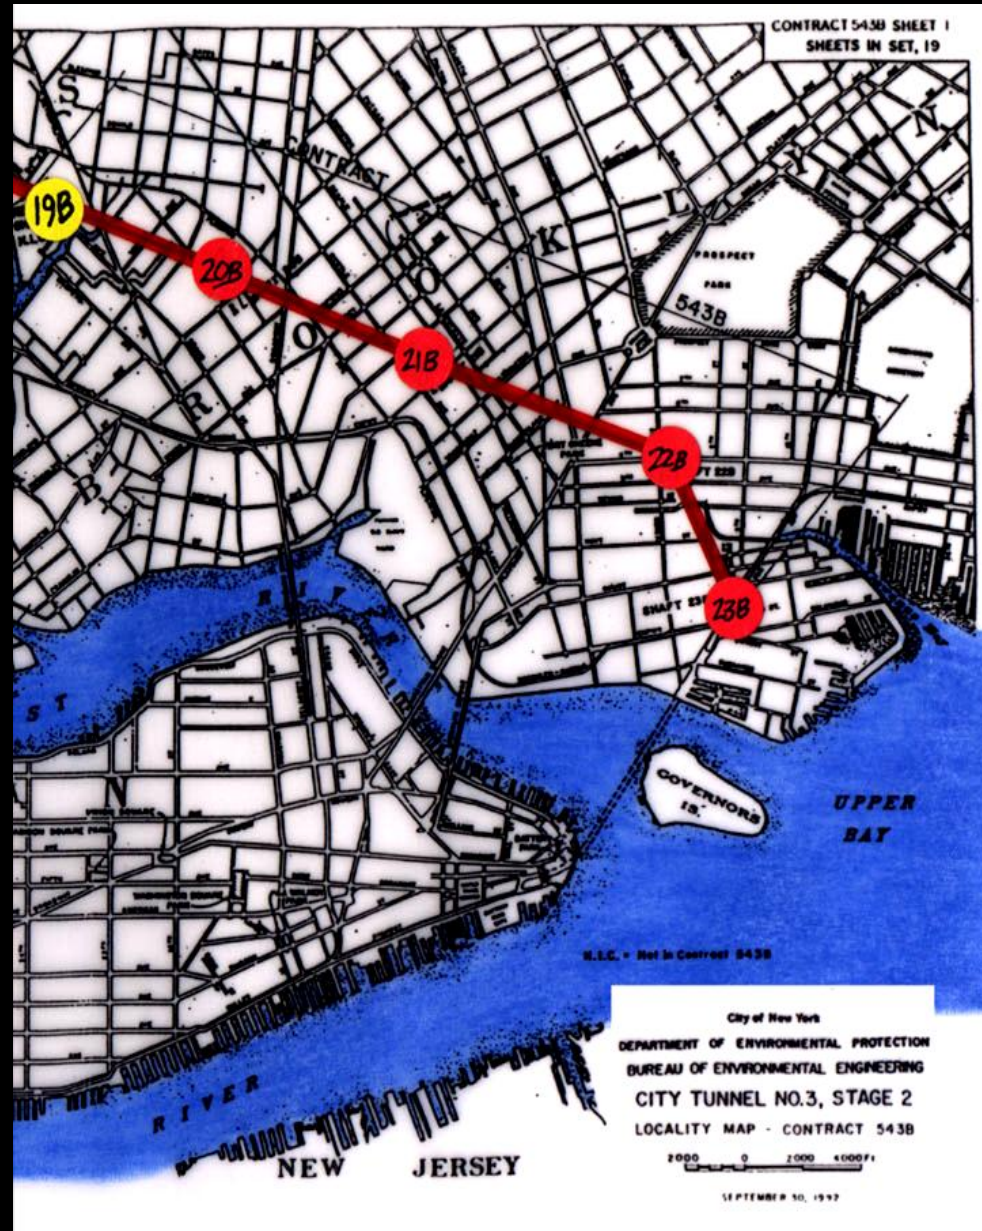
Brooklyn Water Tunnel

- Open Beam TBM from 63rd Street Tunnel Job
- July 1994 – Jan 1997
- 19' Diameter; 5.5 Mi
- Variable Penetration Through Zones A, B, C
- Fordham Gneiss and Walloomsac Schist
- Penetration = ~10'/Hour

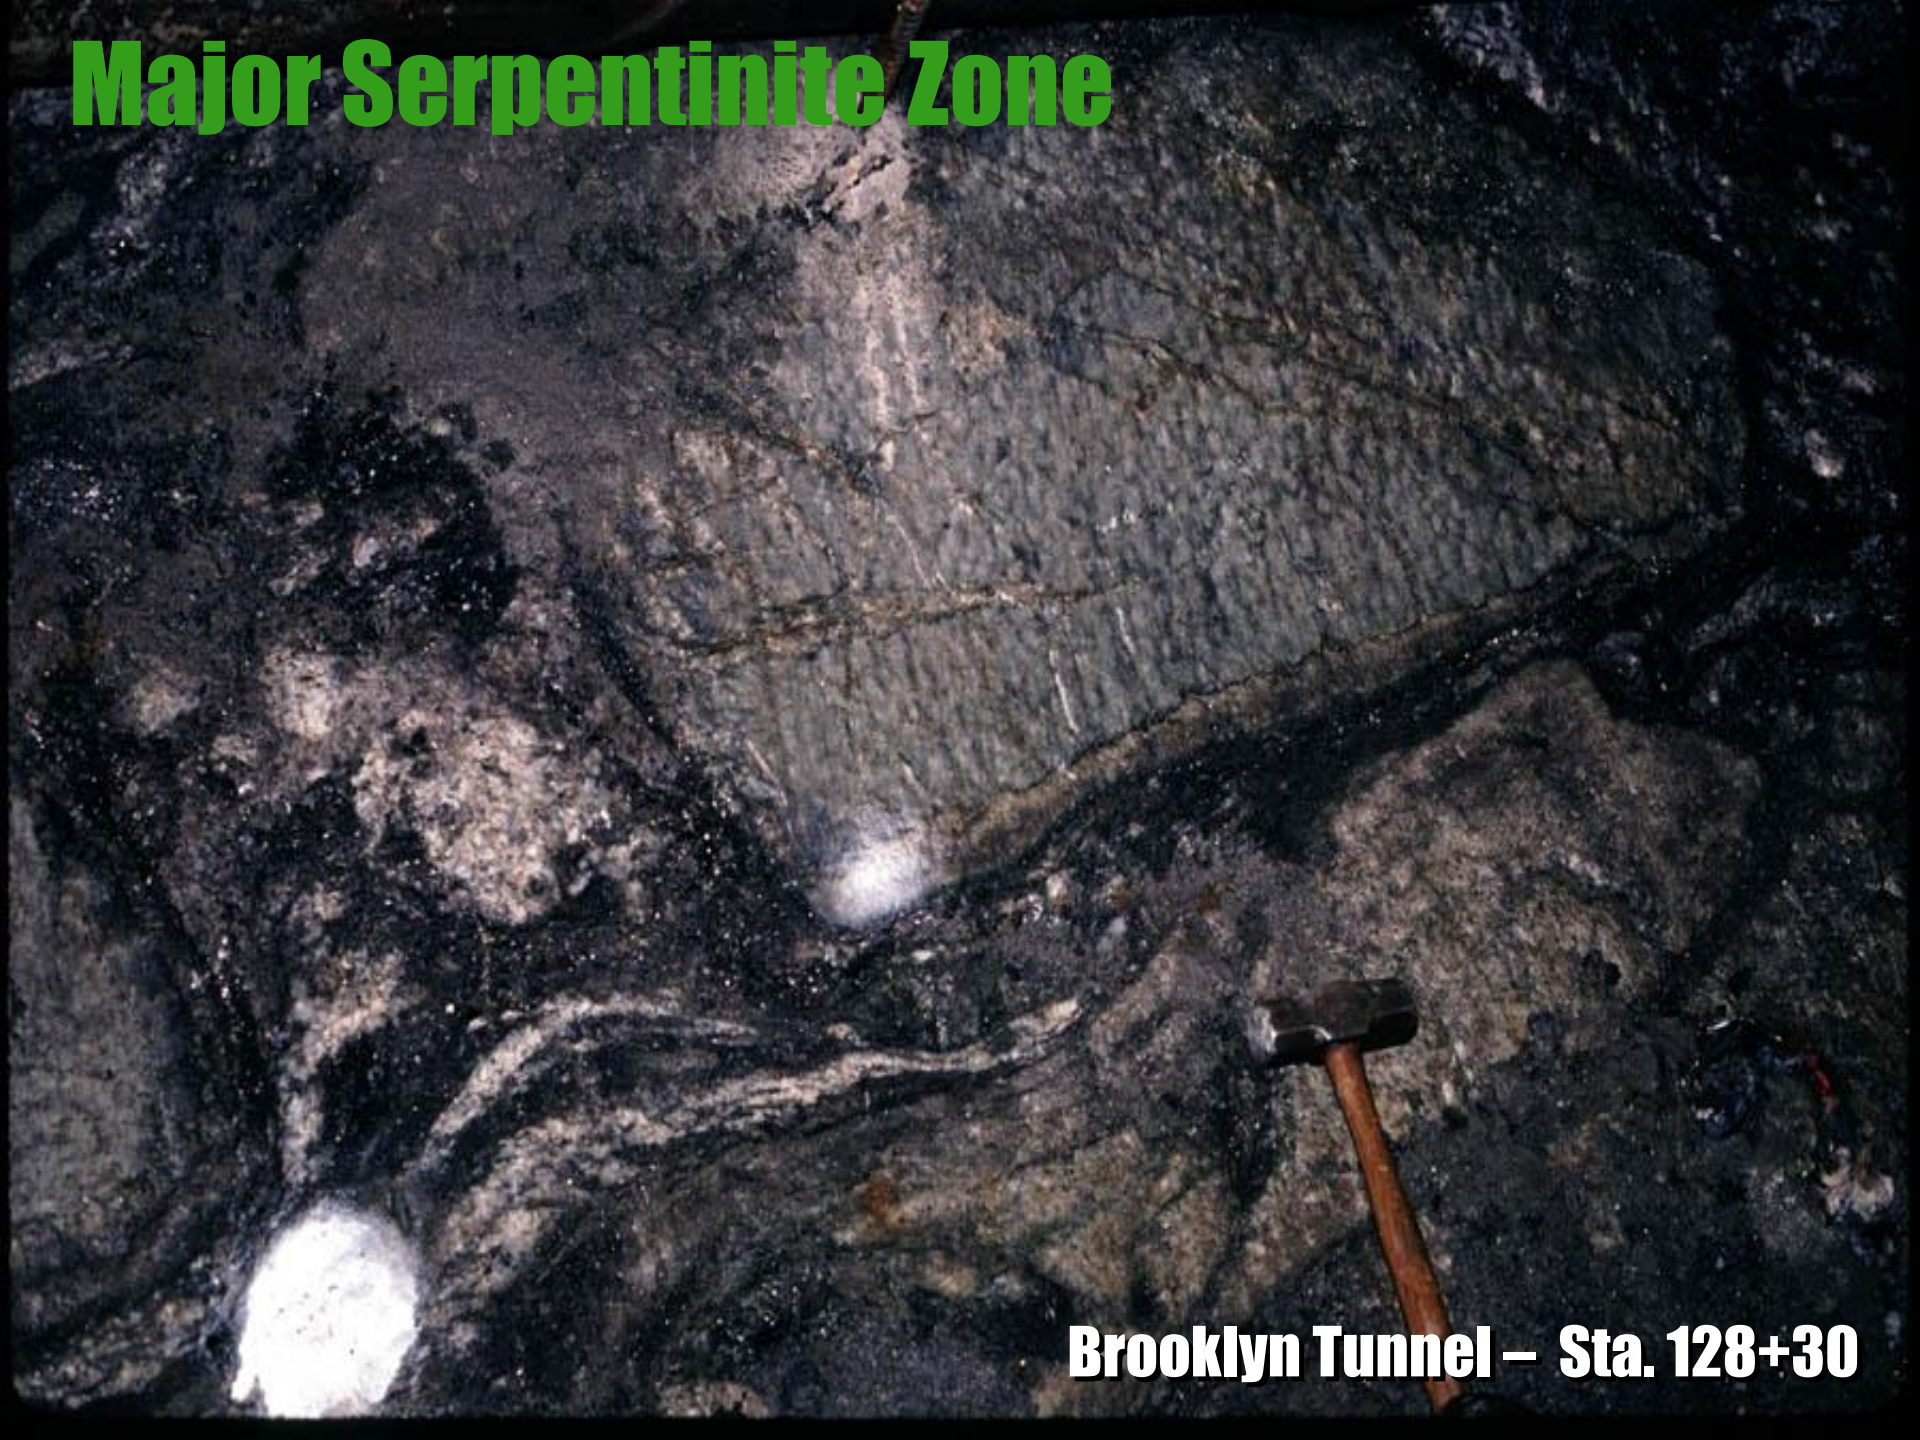
Brooklyn Tunnel – Sta. 128+30

Schistose Rock

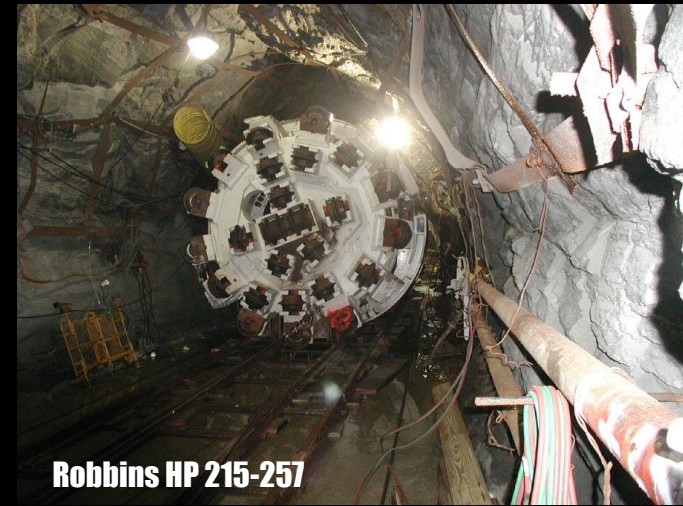
Robbins HP 215-257

- 12.5' Open Beam HP 215-257 TBM
- 17" Cutters; Length 0.76 Mi
- Oct 2002 - Feb 2003
- Hartland Formation
- Penetration = ~9'/Hr

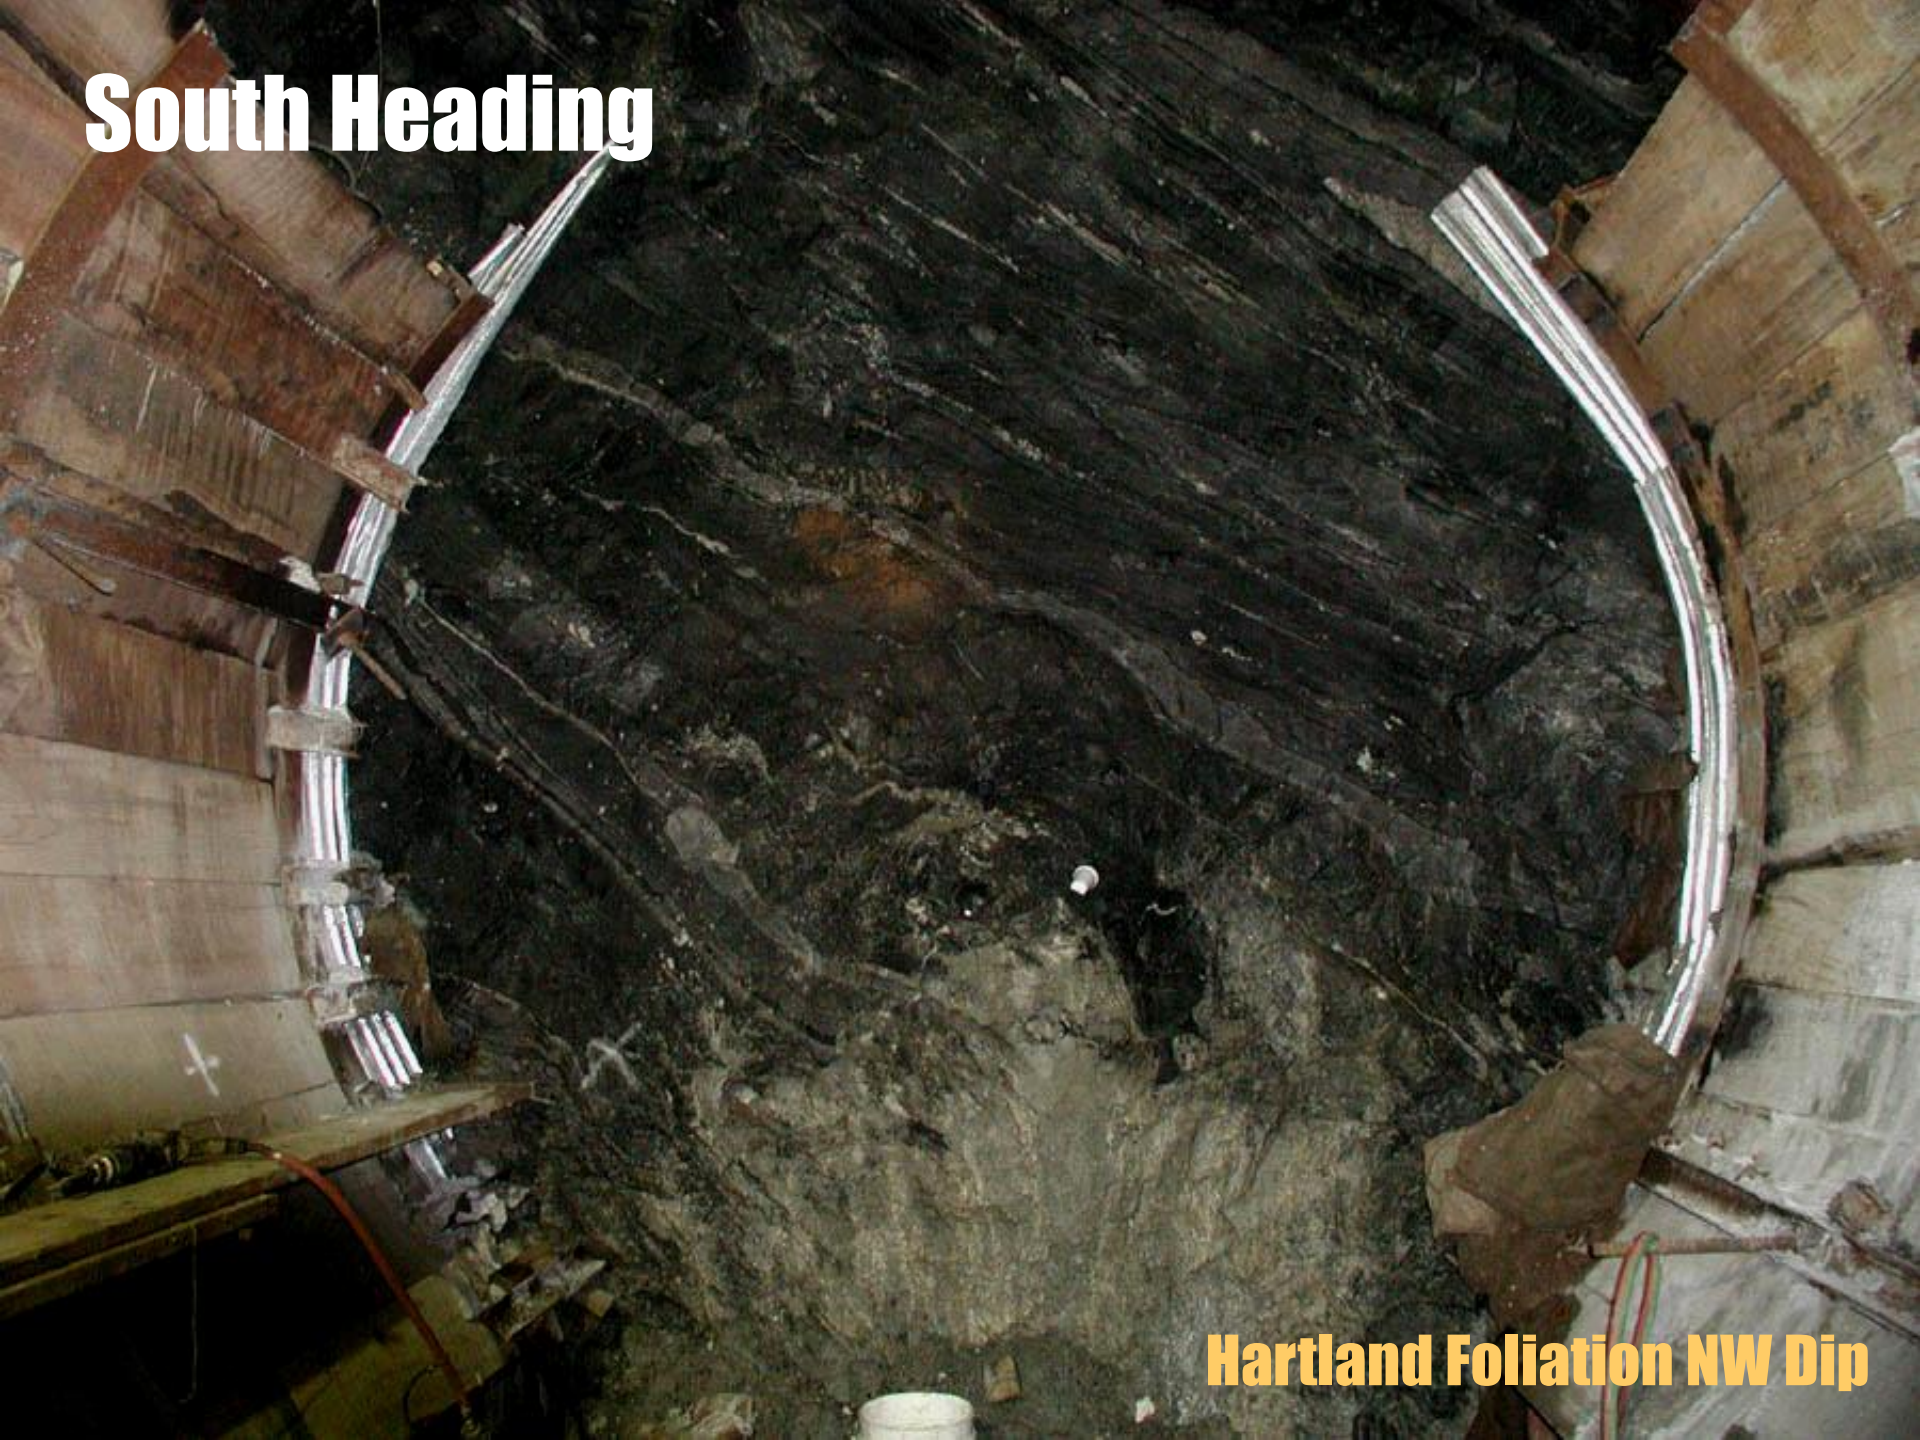
Hartland Foliation NW Dip

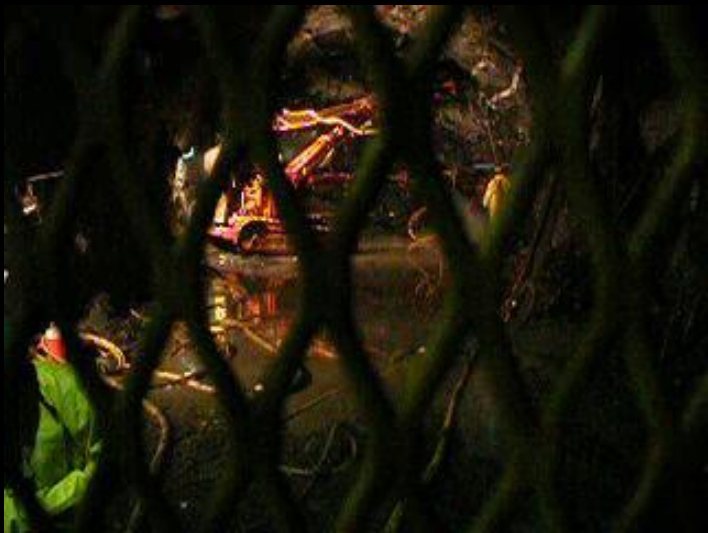
- Retrofitted Con Ed Steam TBM
- Separate Drives (N, S, E-W)
- Length 9.04 Mi
- Diam 12.5'; 17" Cutters
- Hartland Formation
- **Penetration = 13.6'/Hr**

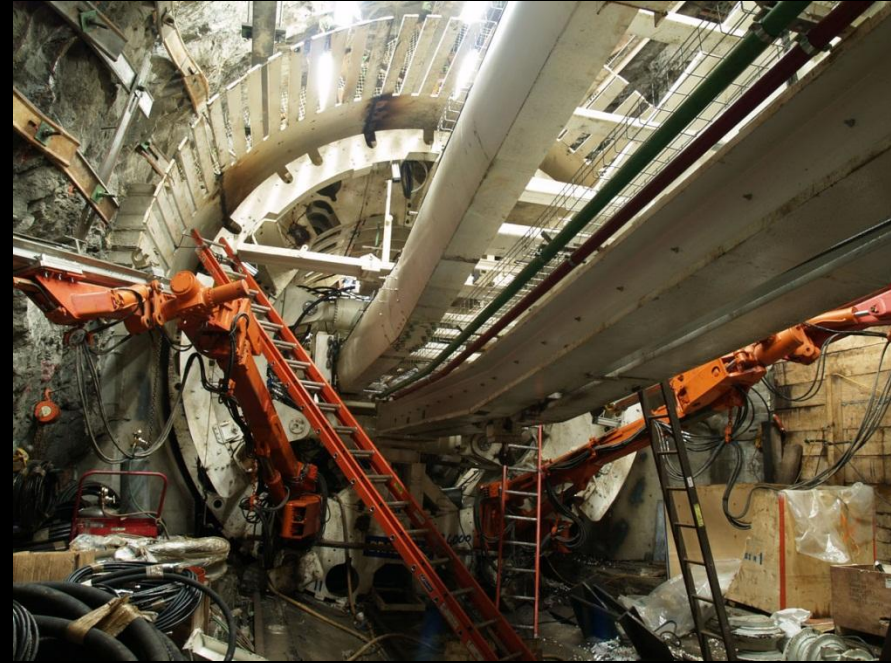
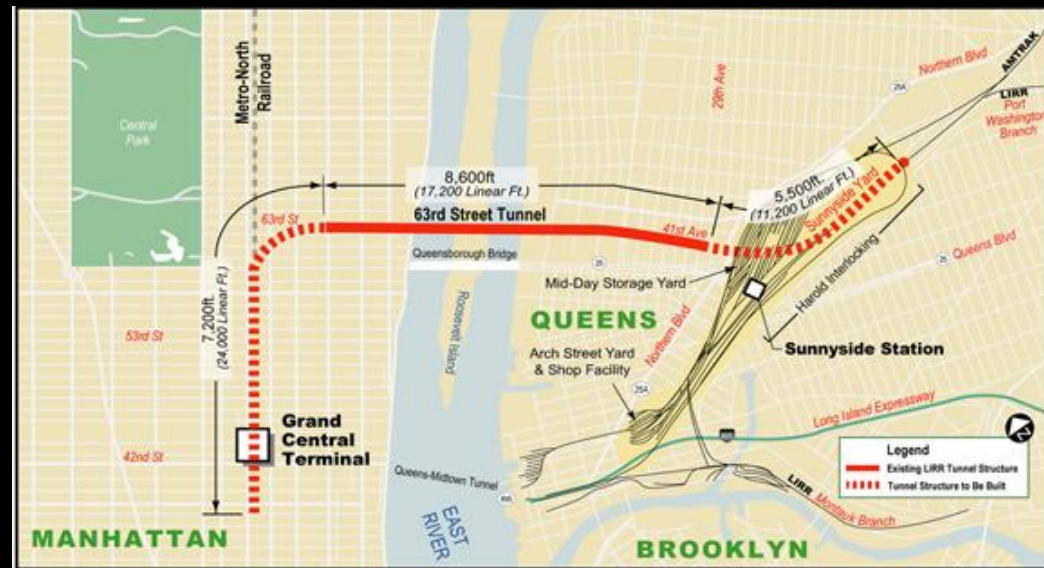
- Diam = 22'; 7.7 Mi; 19" Cutters
- Gently Inclined Hartland
- Seli Double Shield (7'/Hr)
Robbins Open Beam (10'/Hr)
- Penetration Max = 15'/Hr

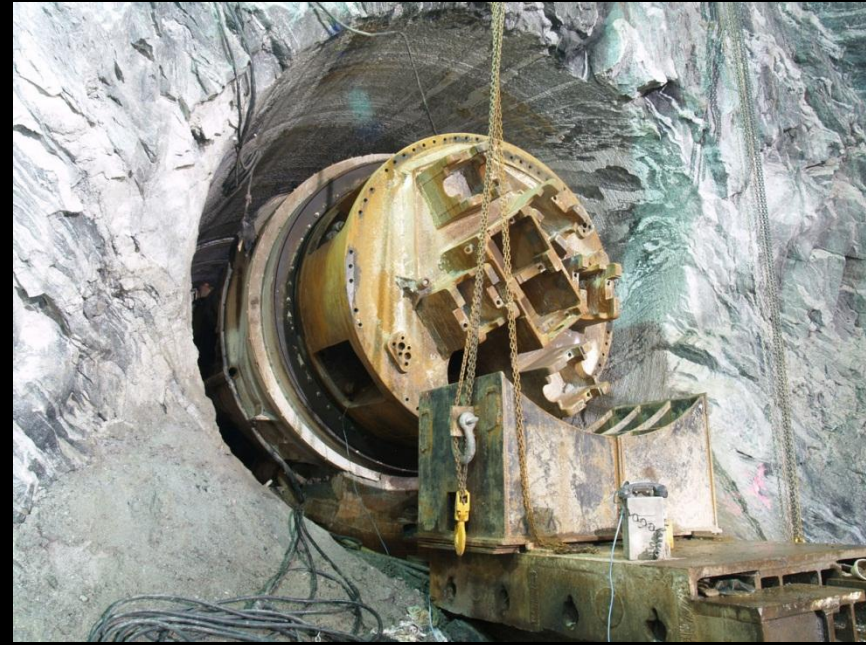
- Retro-fit Manhattan TBM
- 17" Cutters (27 Total)
- Low 3,650'; Hi 3,150'; Raw 865'
- Diam = 13.5'; Length 1.29 Mi
- Bid as D&B; ~250 Mining Days Saved w/ TBM
- Fordham, Yonkers Gneiss
- Penetration = ~10'/Hr

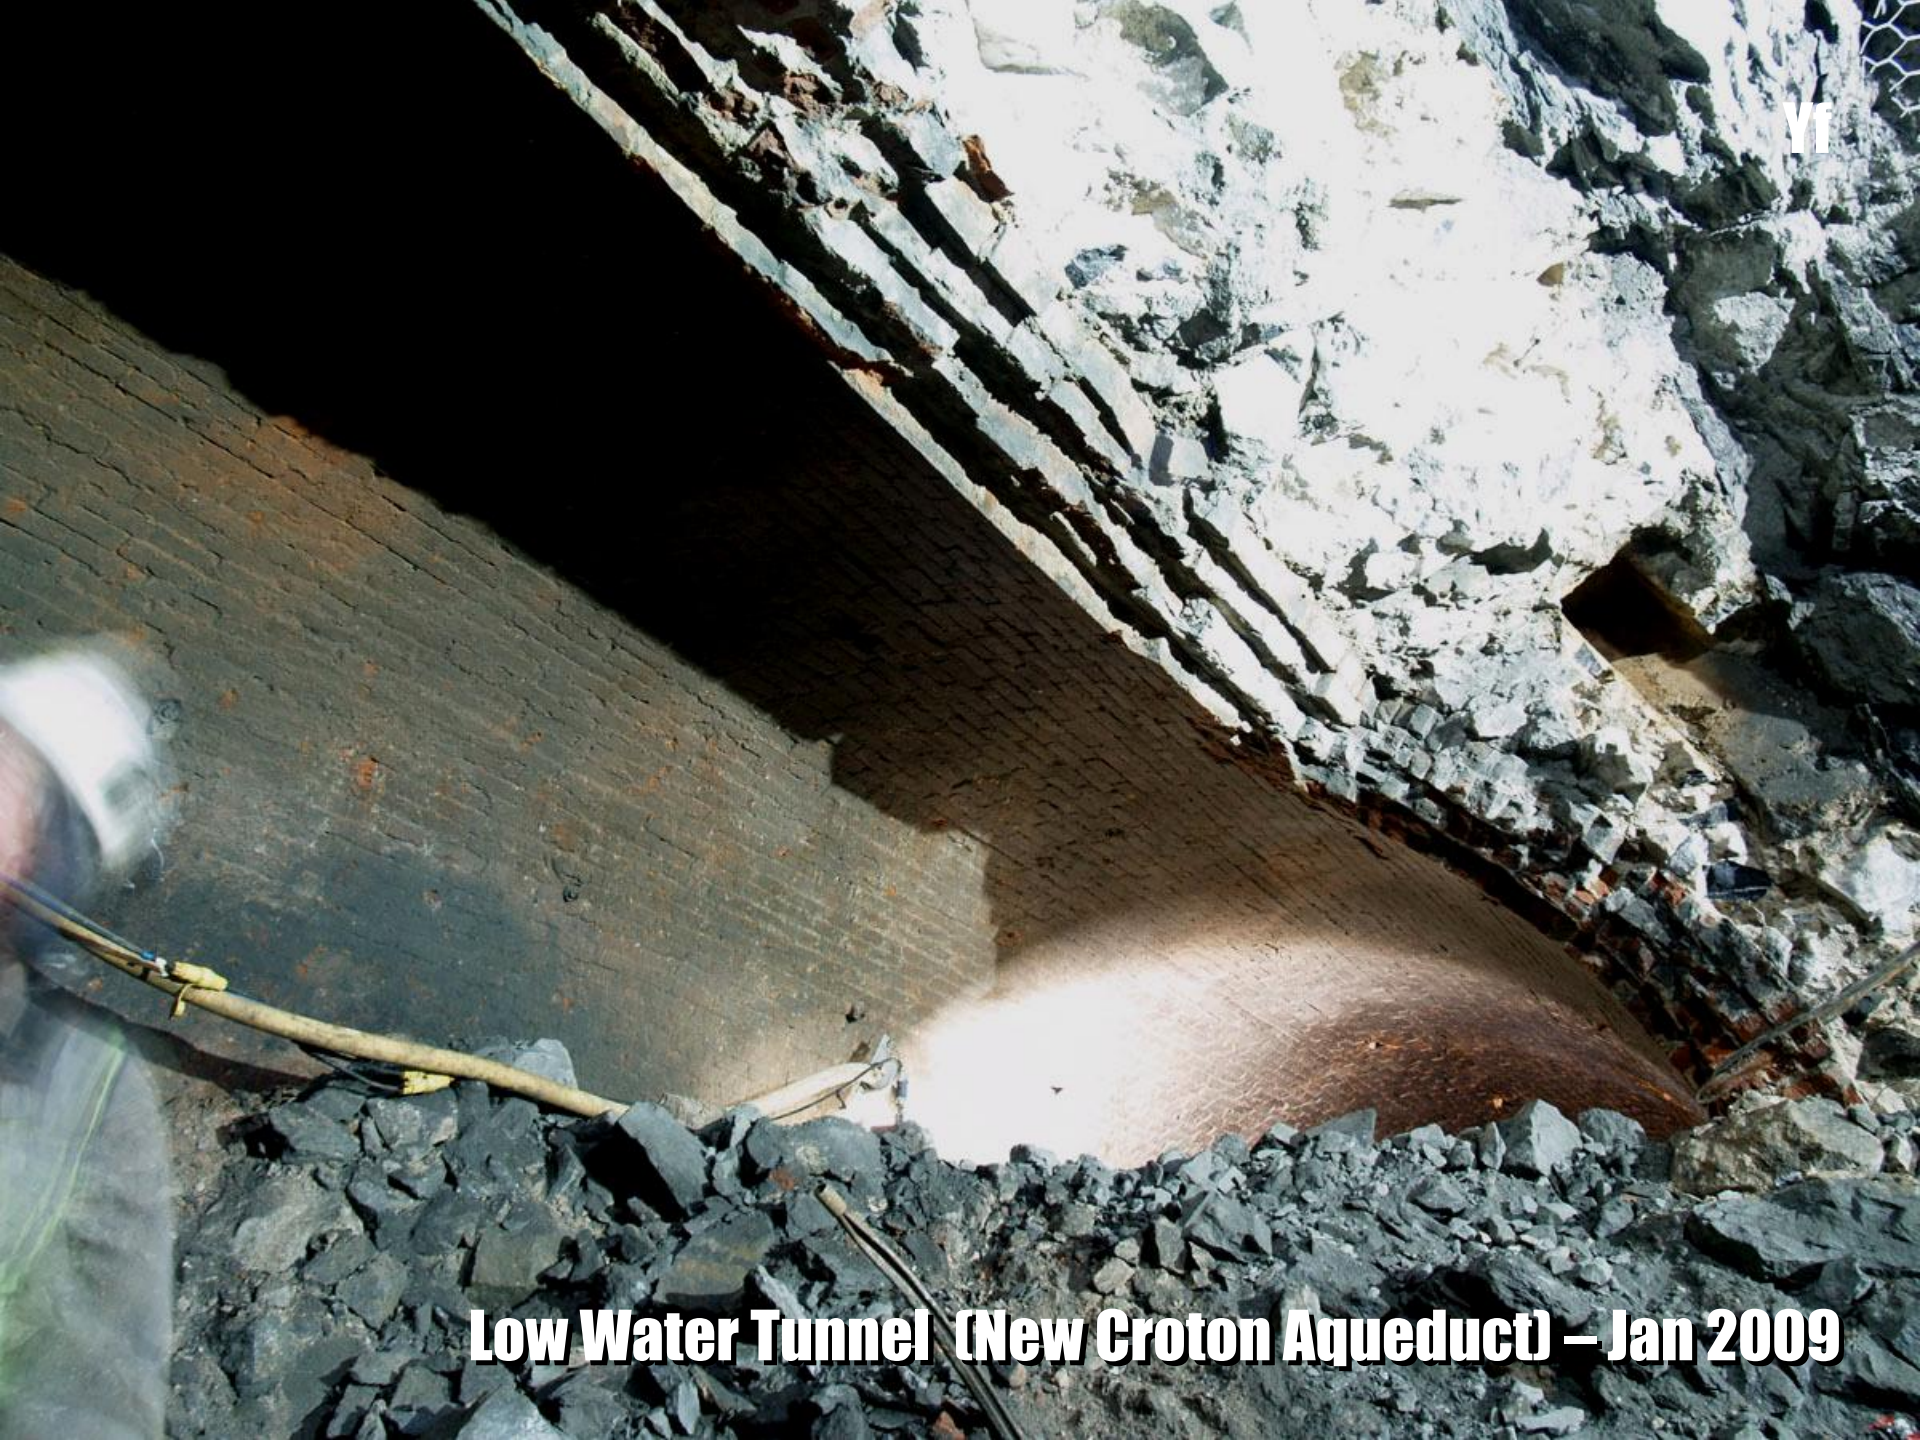
Low Water Tunnel (New Croton Aqueduct) – Jan 2009

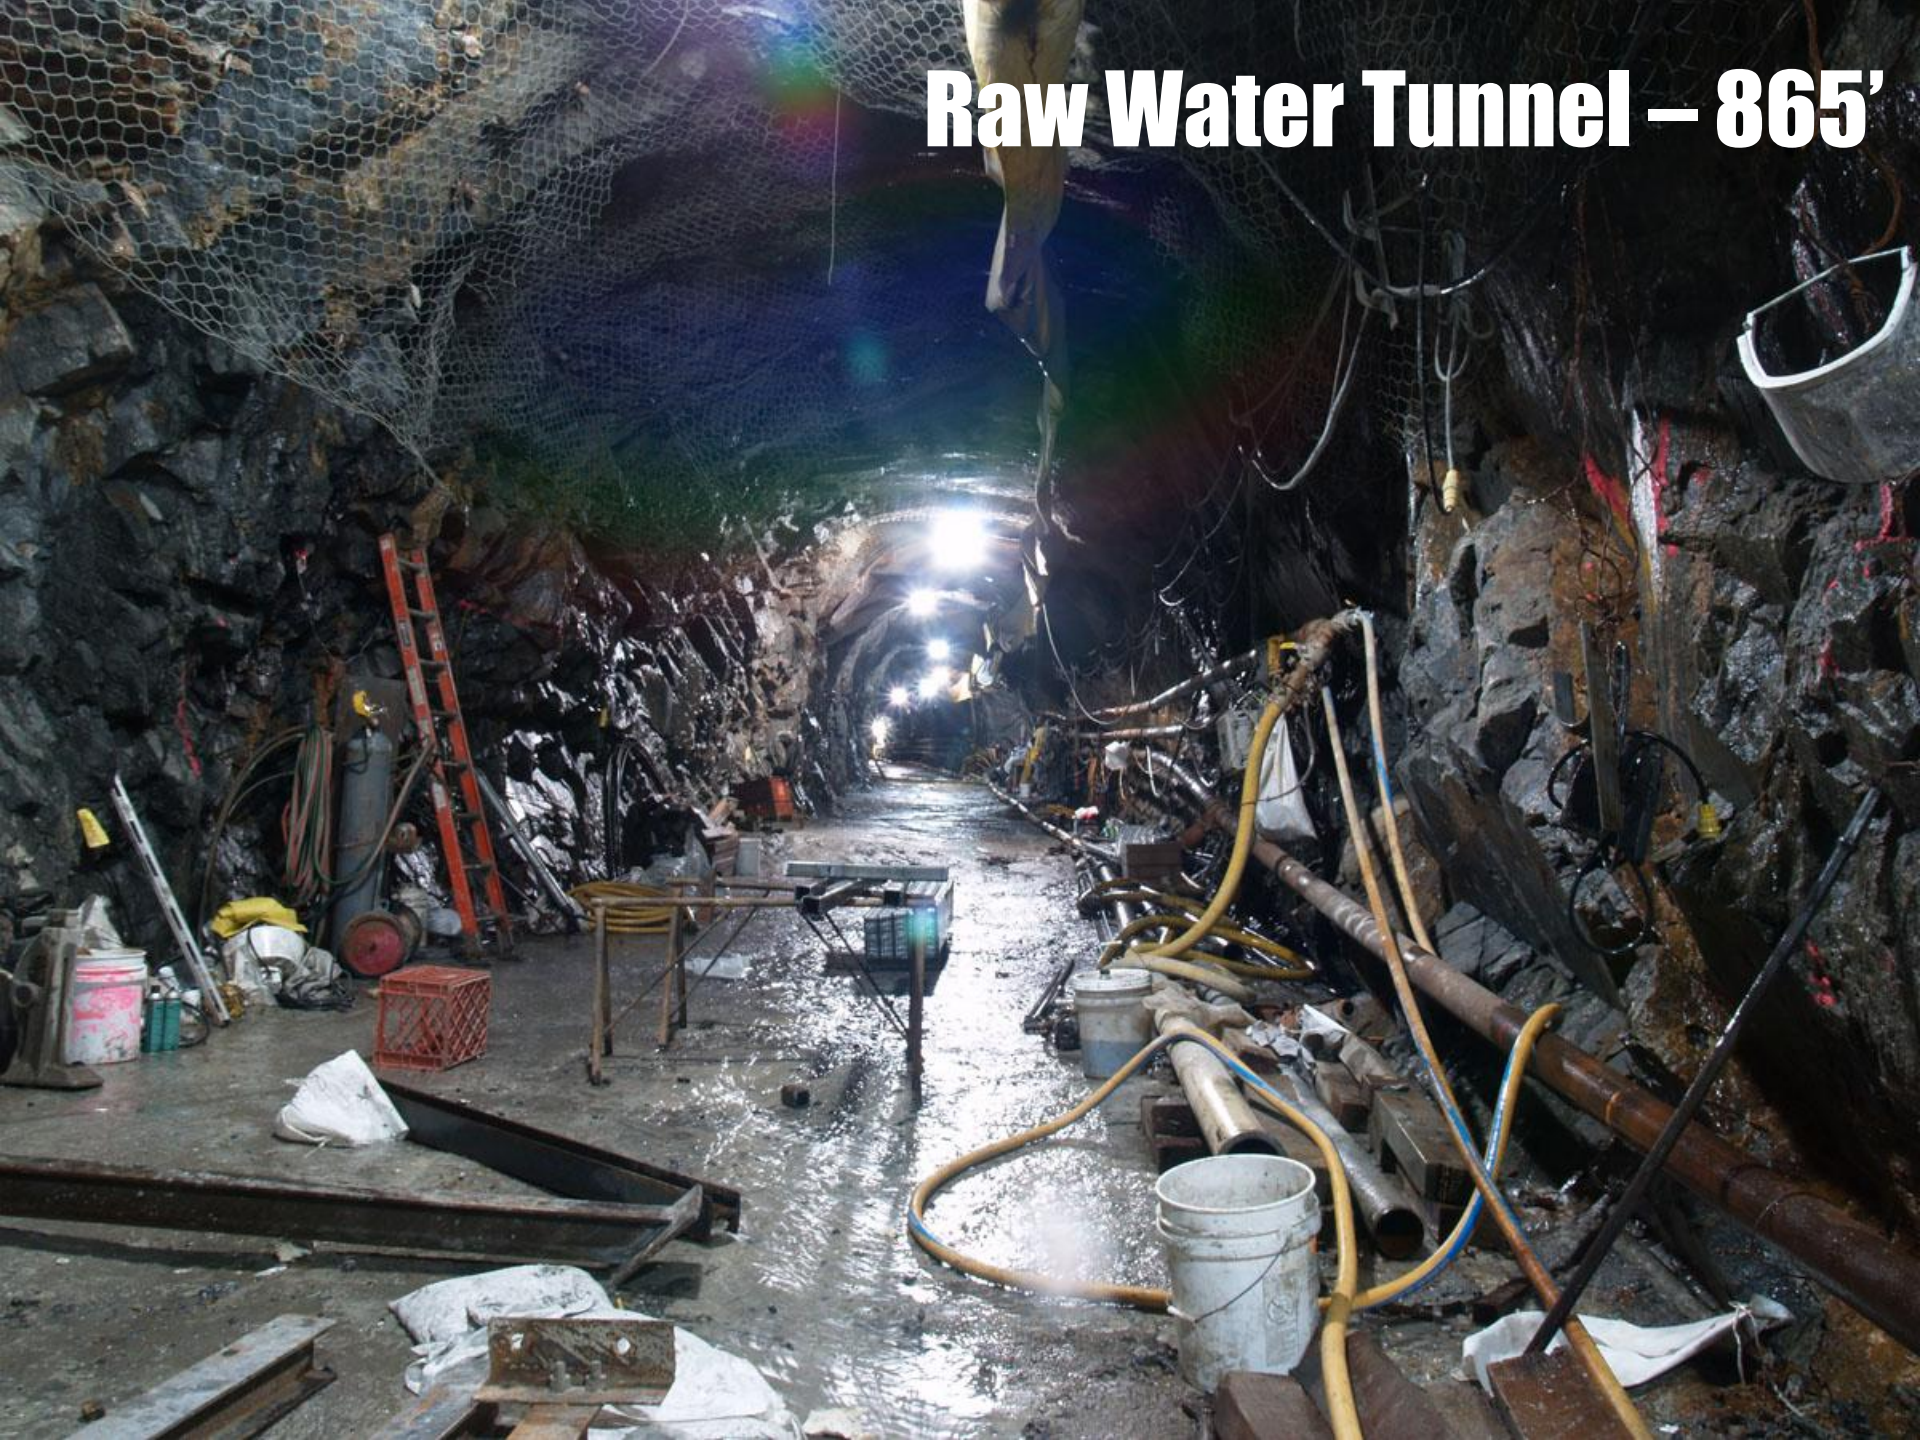
Croton Water Treatment Plant, Bronx New York - North Wall Raw Water Tunnel, Stations 4+50 to 6+65
