Geological Controls on Megaconstruction Projects, NYC

Charles Merguerian

25 April 2013

Penetration Destiny TBM Tunnelling in NYC

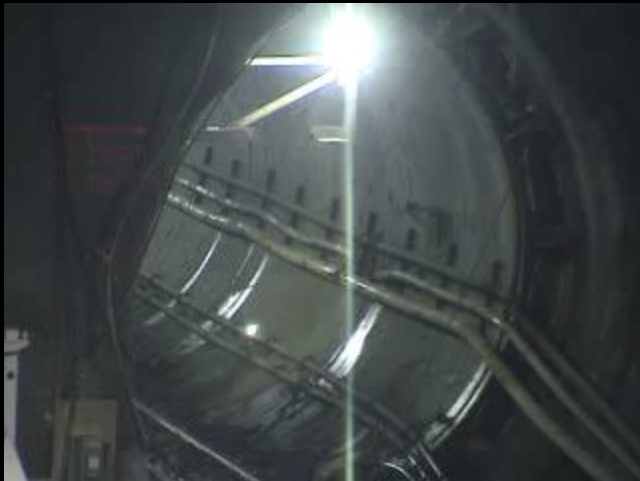
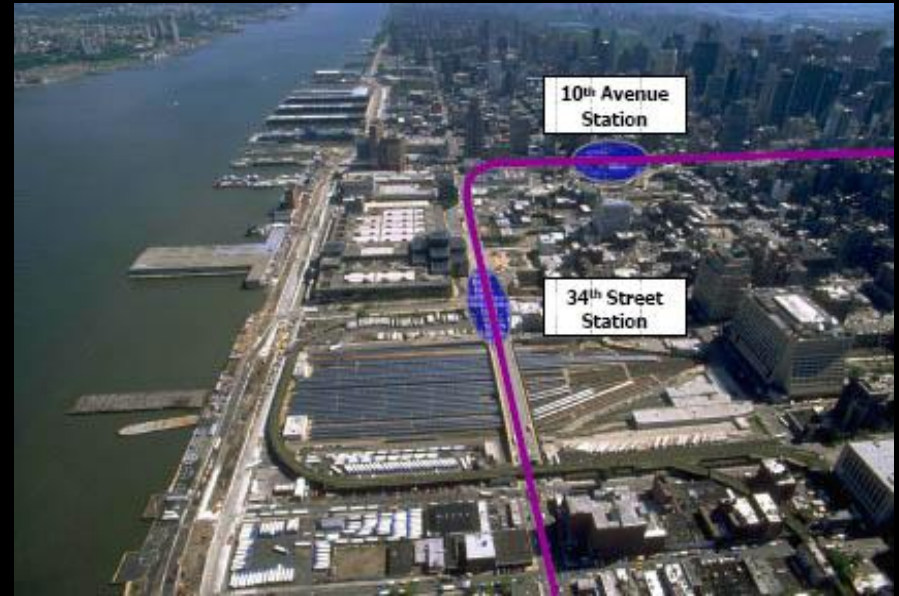
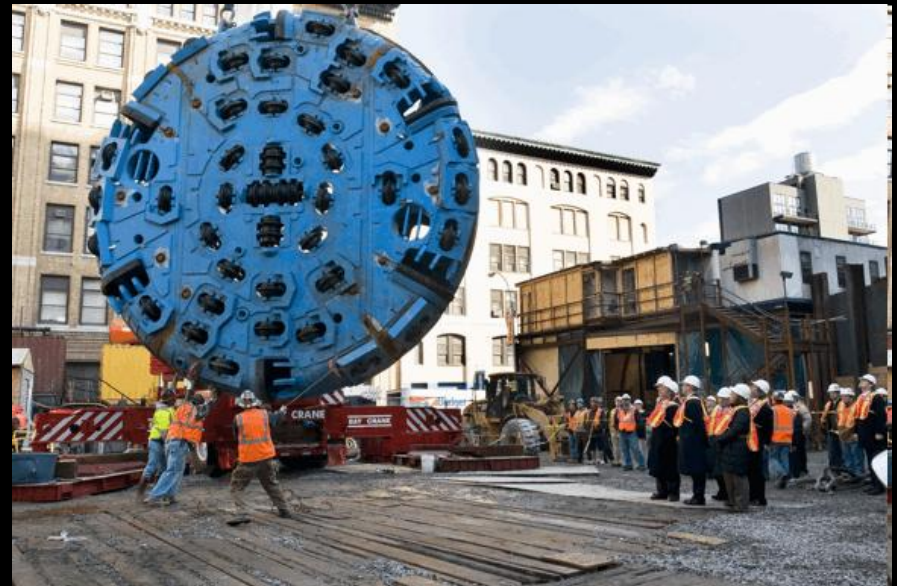
- Double Shielded TBMs
- 34th Street Cavern - D&B
- Diam = 22.5'; Length 1.78 Mi
- Hartland Formation
- 4,700' One Year (~16'/Day) with Installed Segments
