# Stratigraphy, Structure and Rock Mass Properties of the Hartland Formation, Second Avenue Subway, NYC, NY

*Charles Merguerian  
Hofstra Geology  
J. Mickey Merguerian  
Univ. Texas @ El Paso  
24 Mar 2014*

# NYC TBM Projects

## Second Avenue Subway

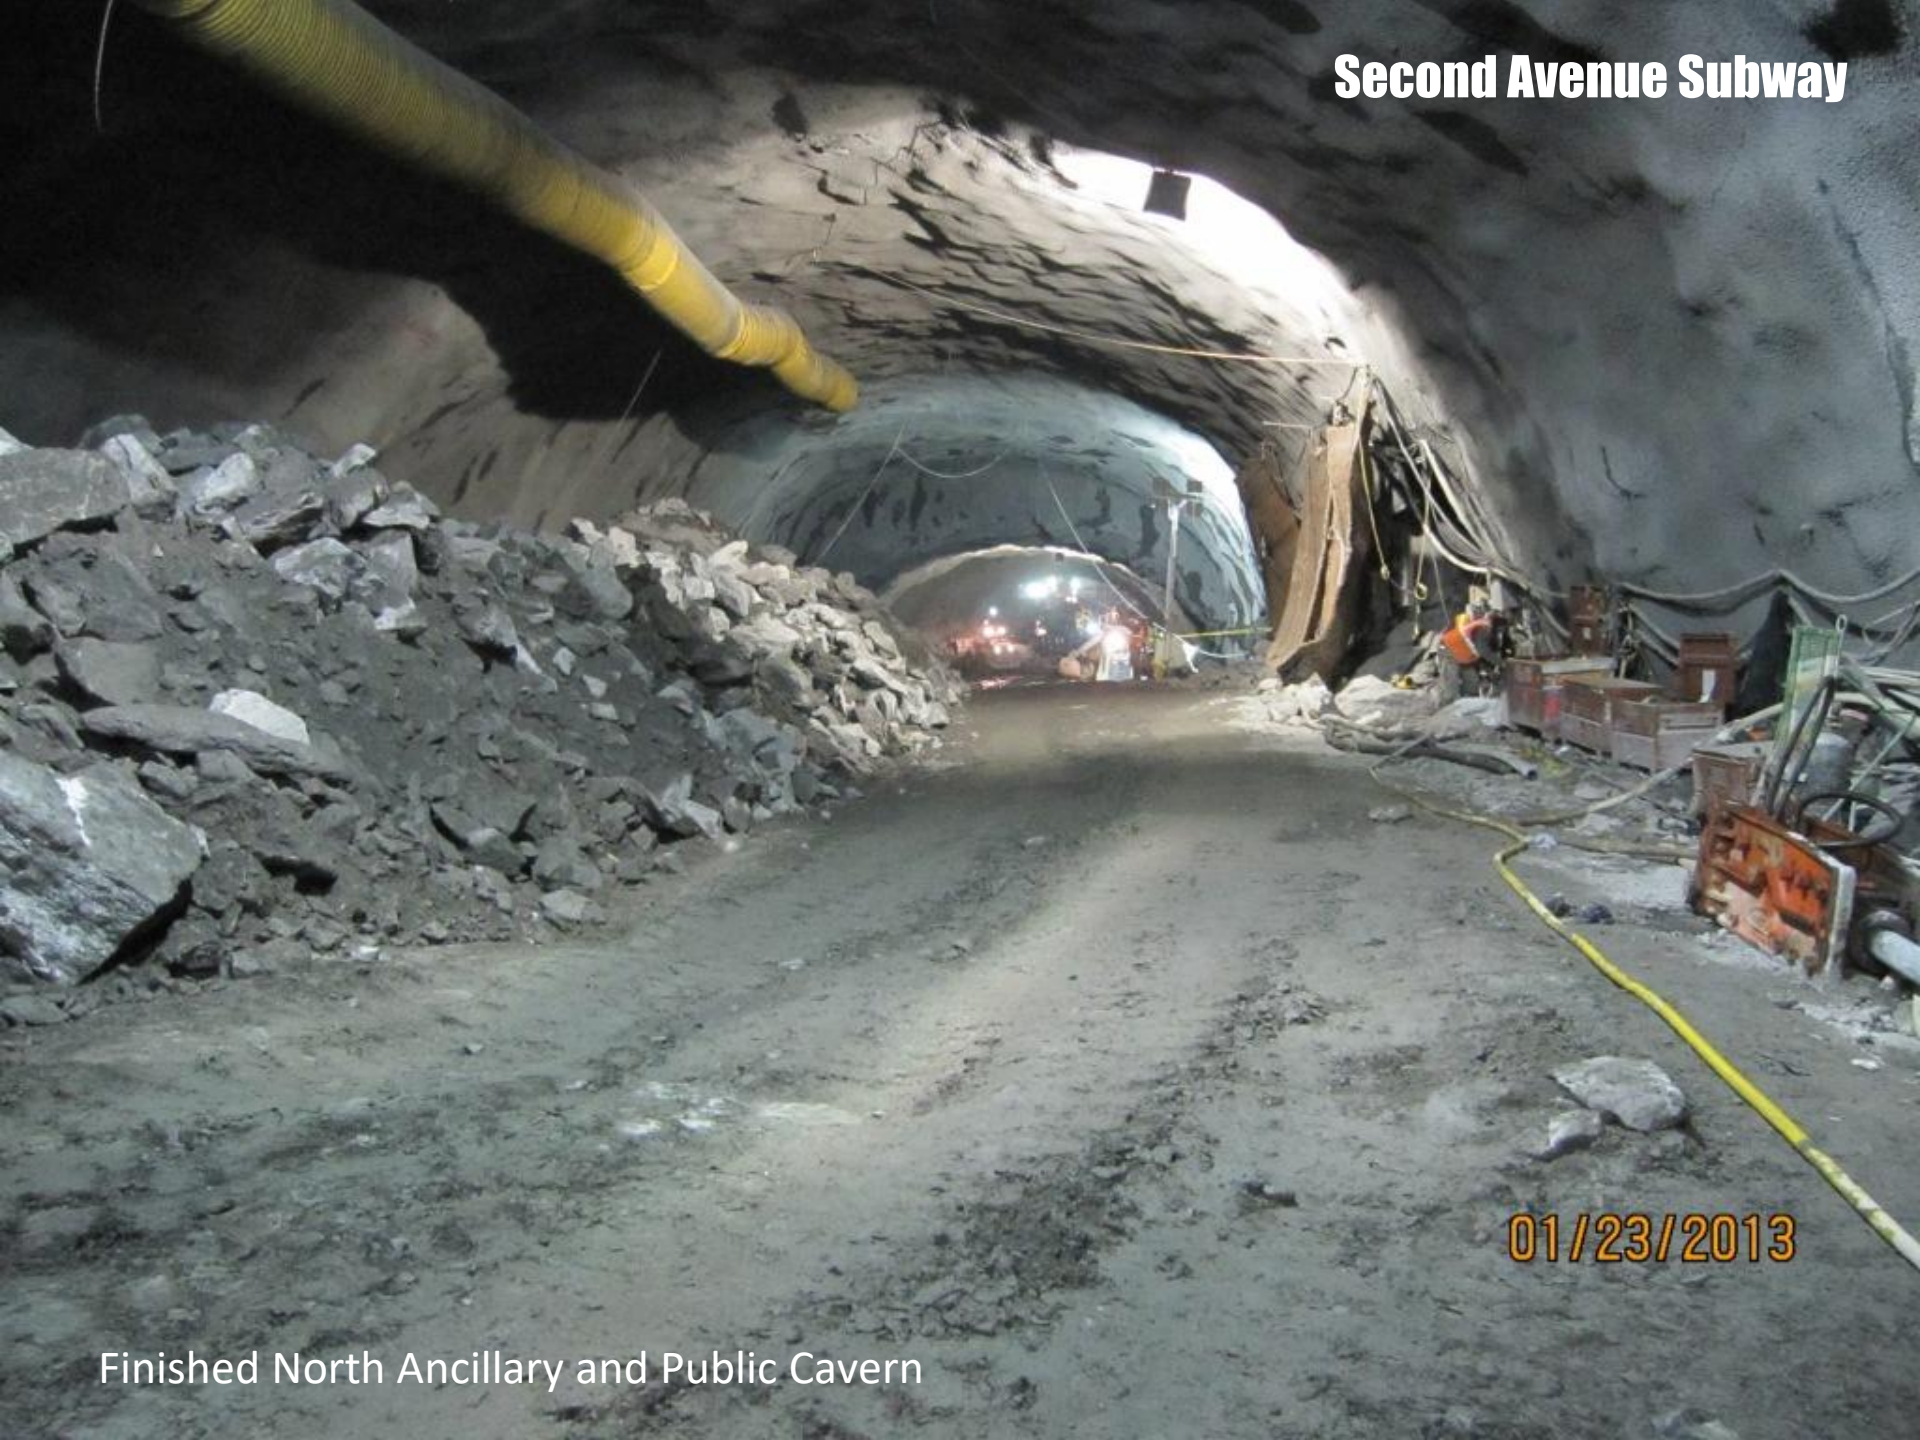
Finished North Ancillary and Public Cavern

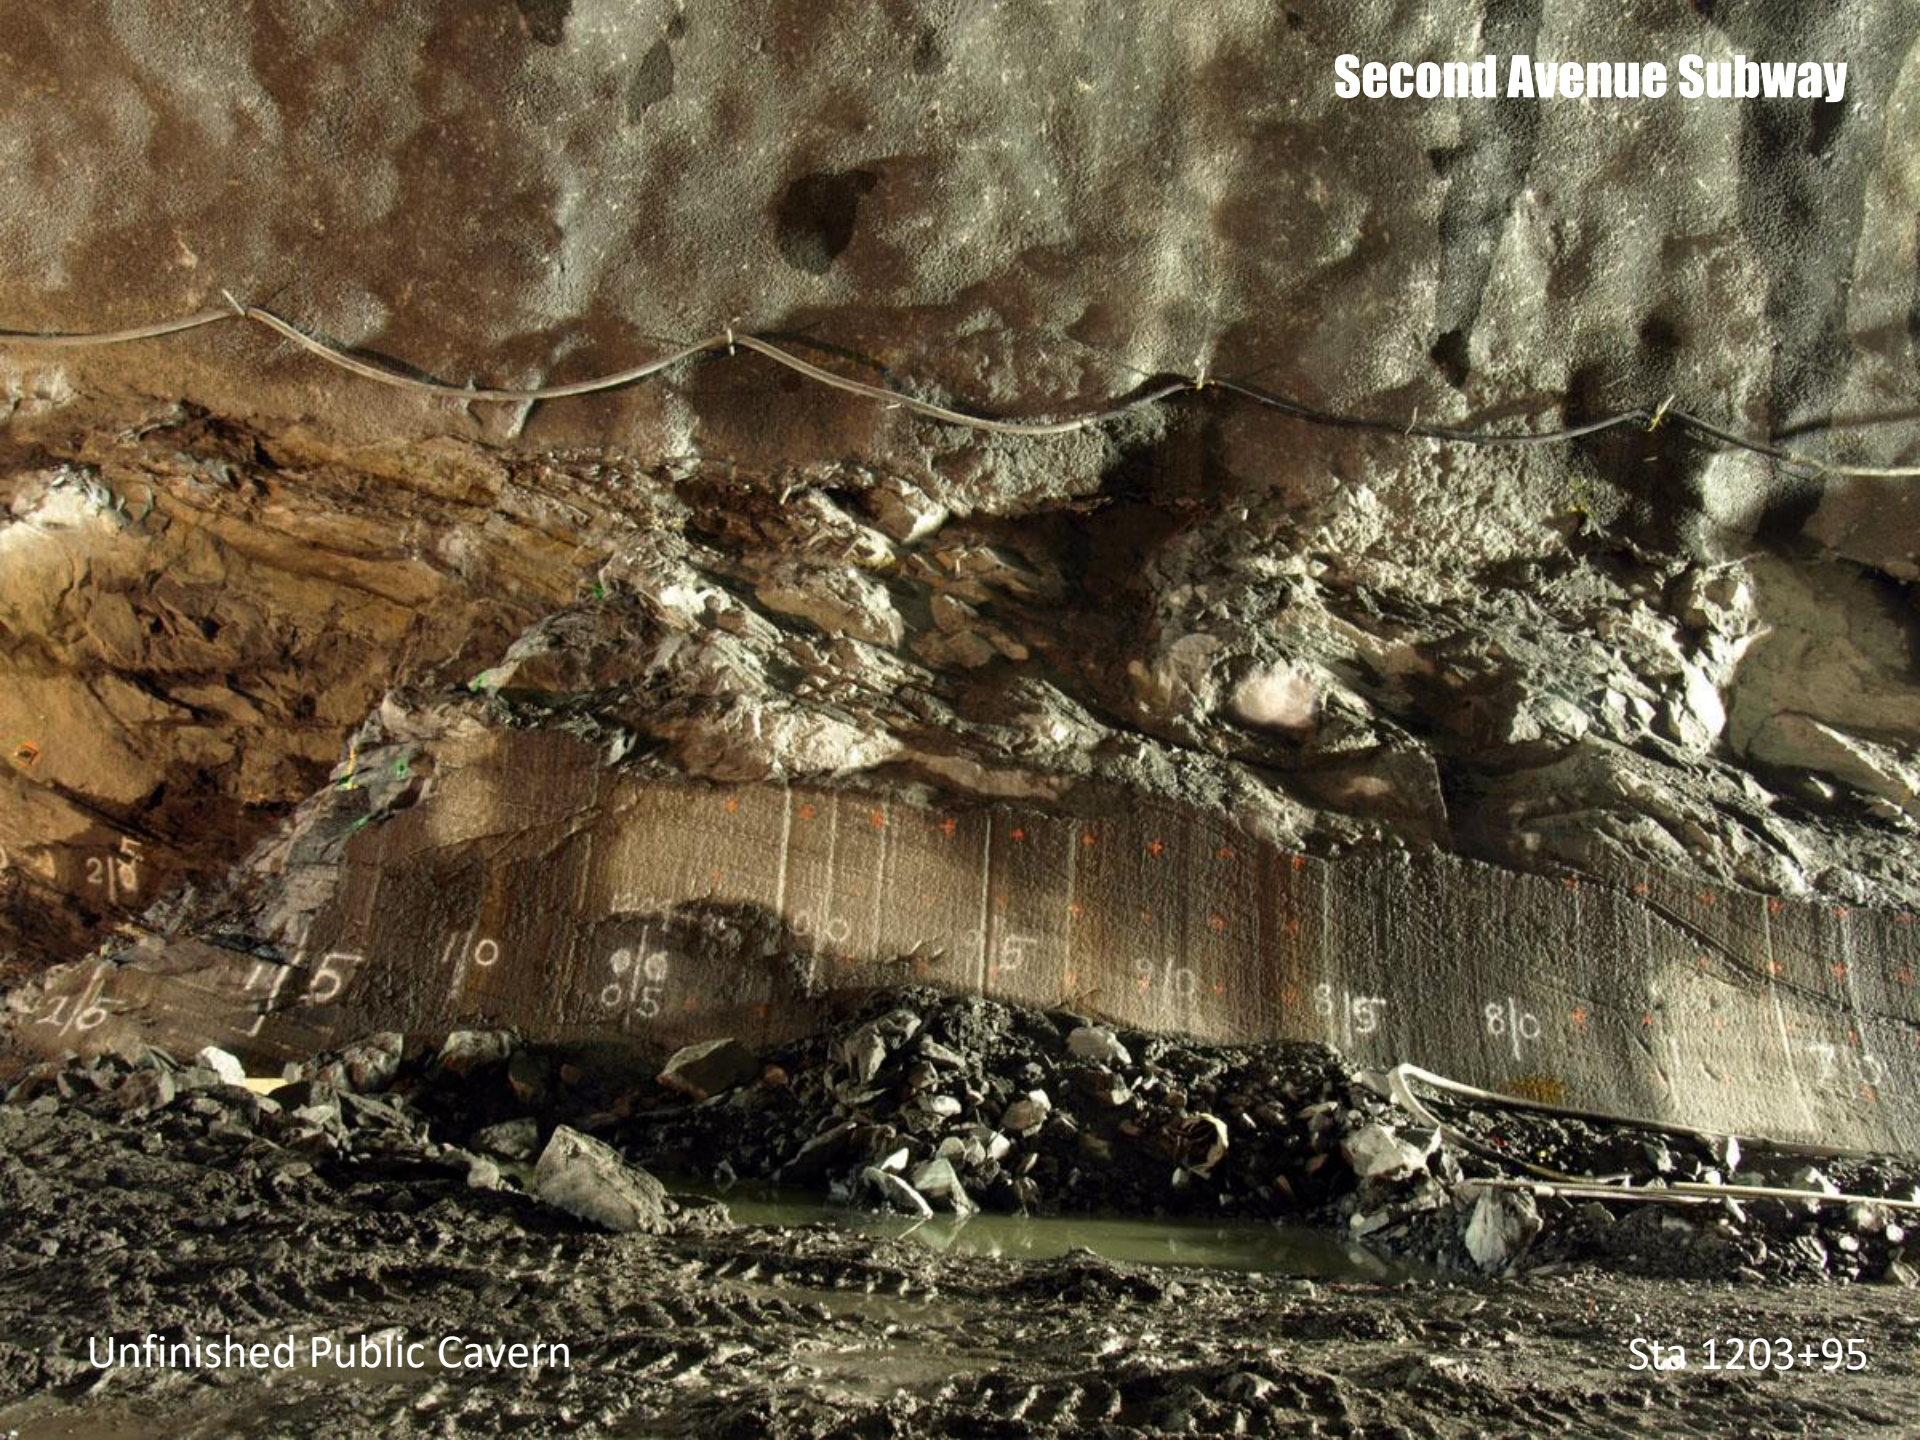
Sta 1203+95

Unfinished Public Cavern

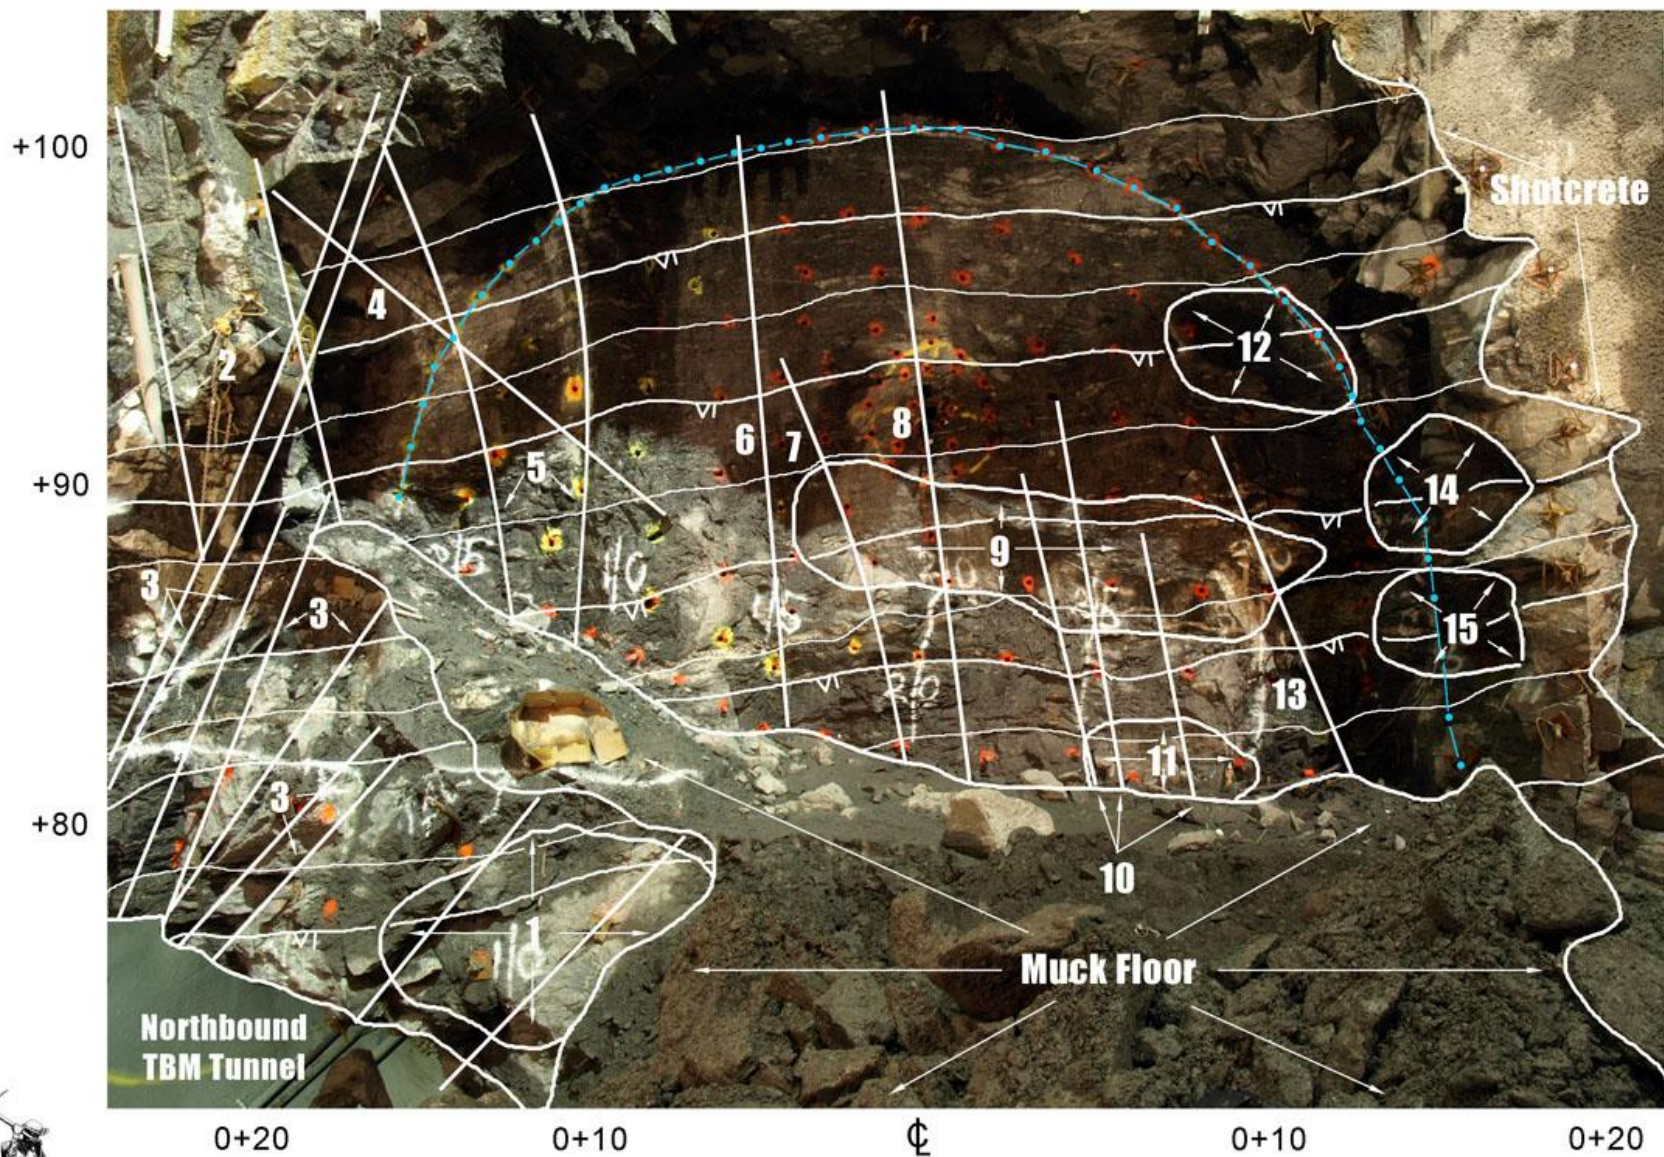
Sta 1198+75 – CIR Room

← Stationing in Feet East and West of Second Avenue Centerline →

— = Perimeter Drill Holes of CIR room

Mapped 28 February 2013

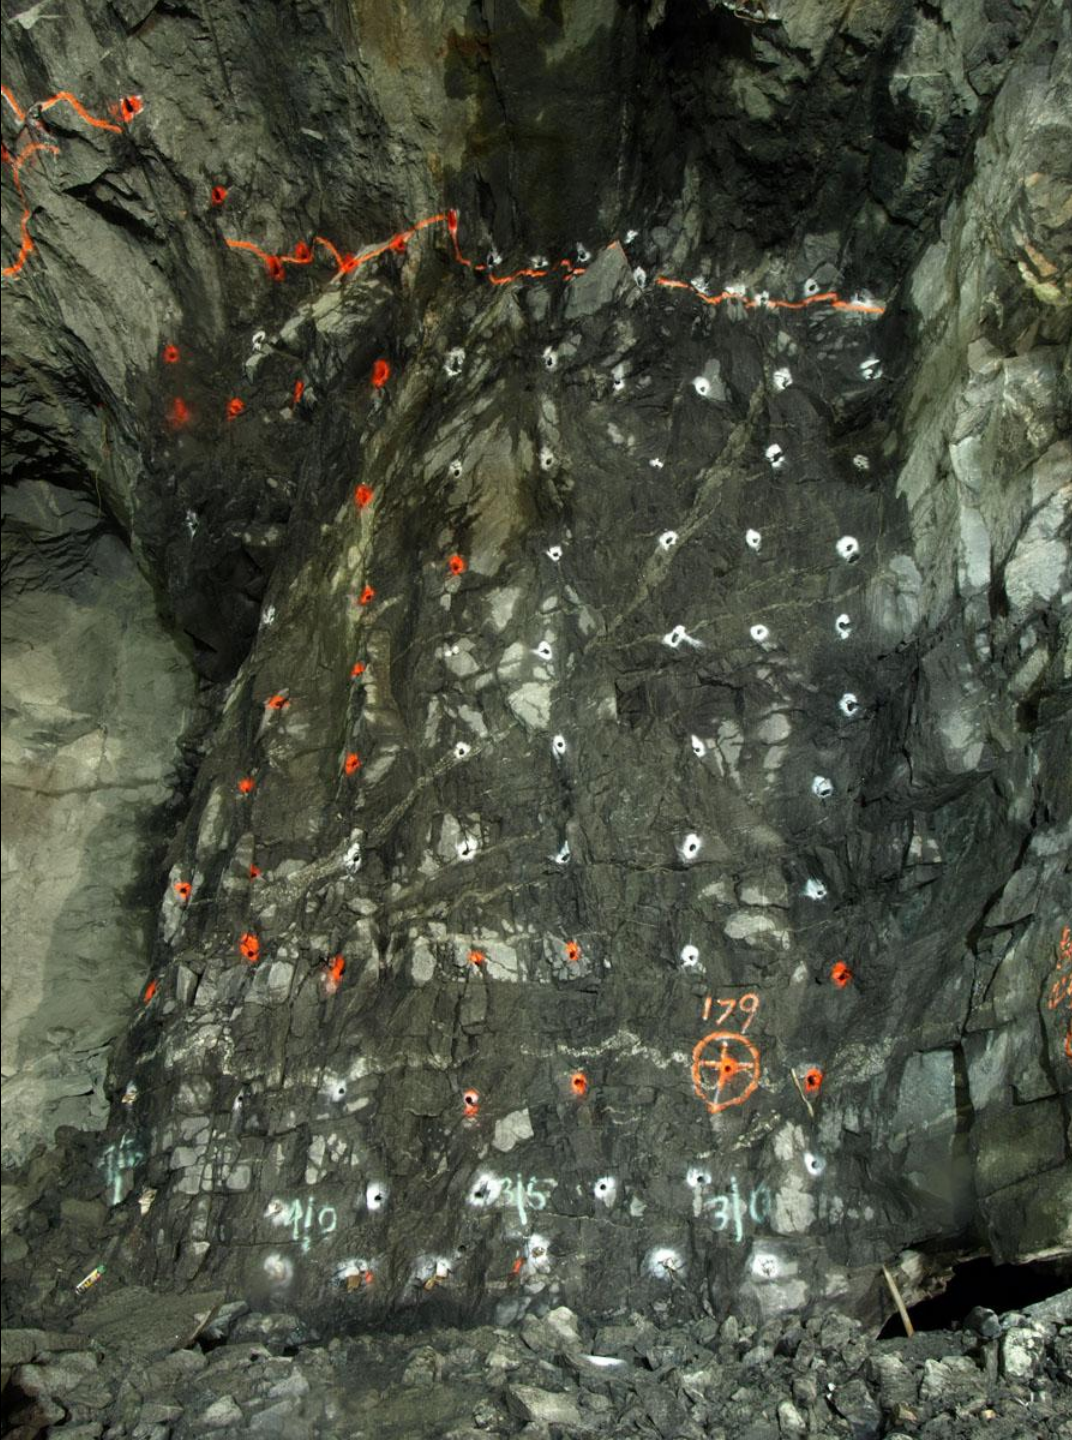
Sta 1204+90  
North Cavern Center Slash

**Second Avenue Subway - North Cavern Center Slash**  
**Working Face at Sta. 1204+90; Elev. +75' to +108'**

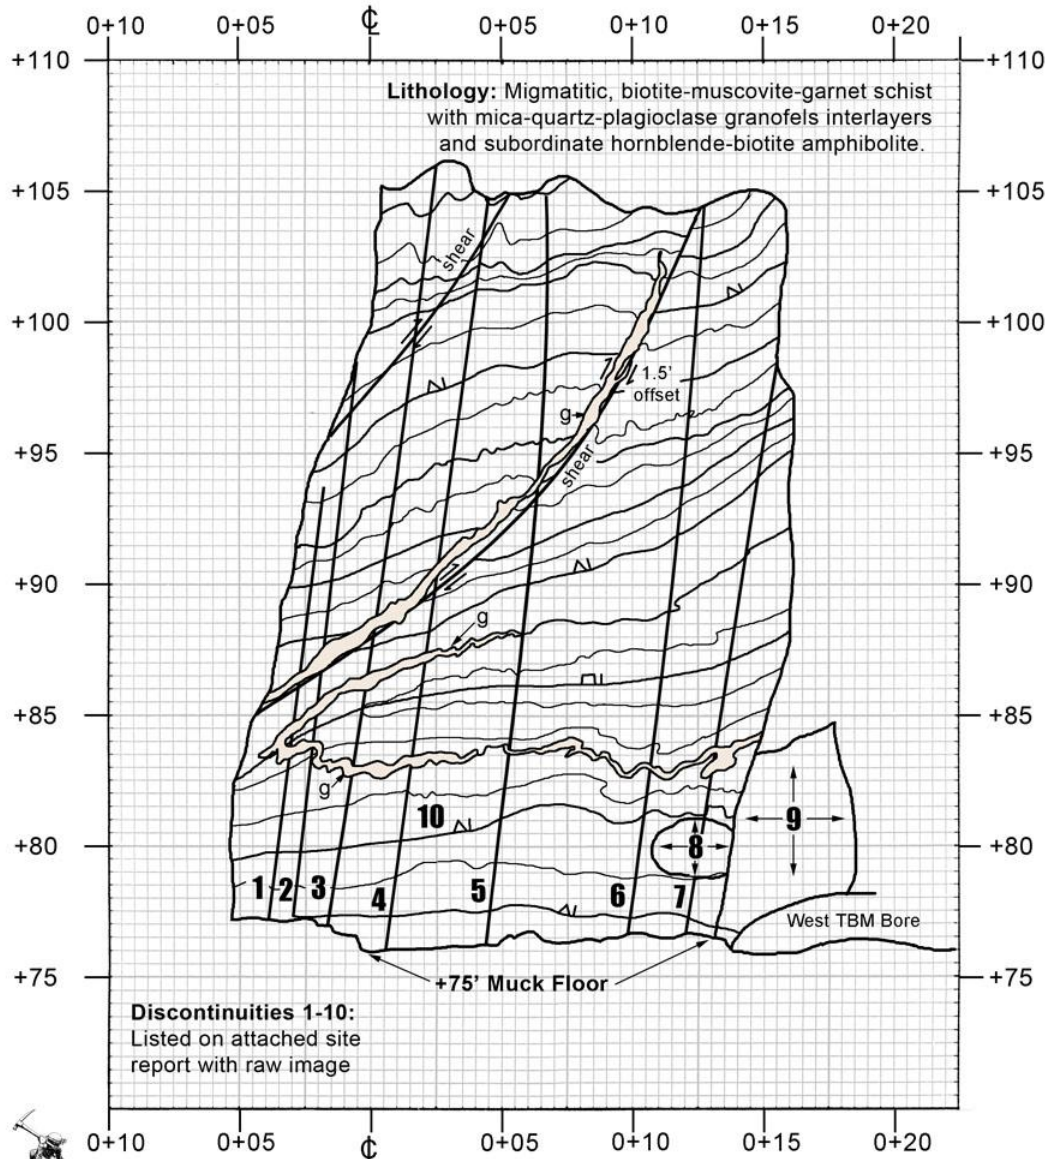
**Sta 1204+90**  
**North Cavern Center Slash**

Mapped 19 December 2012

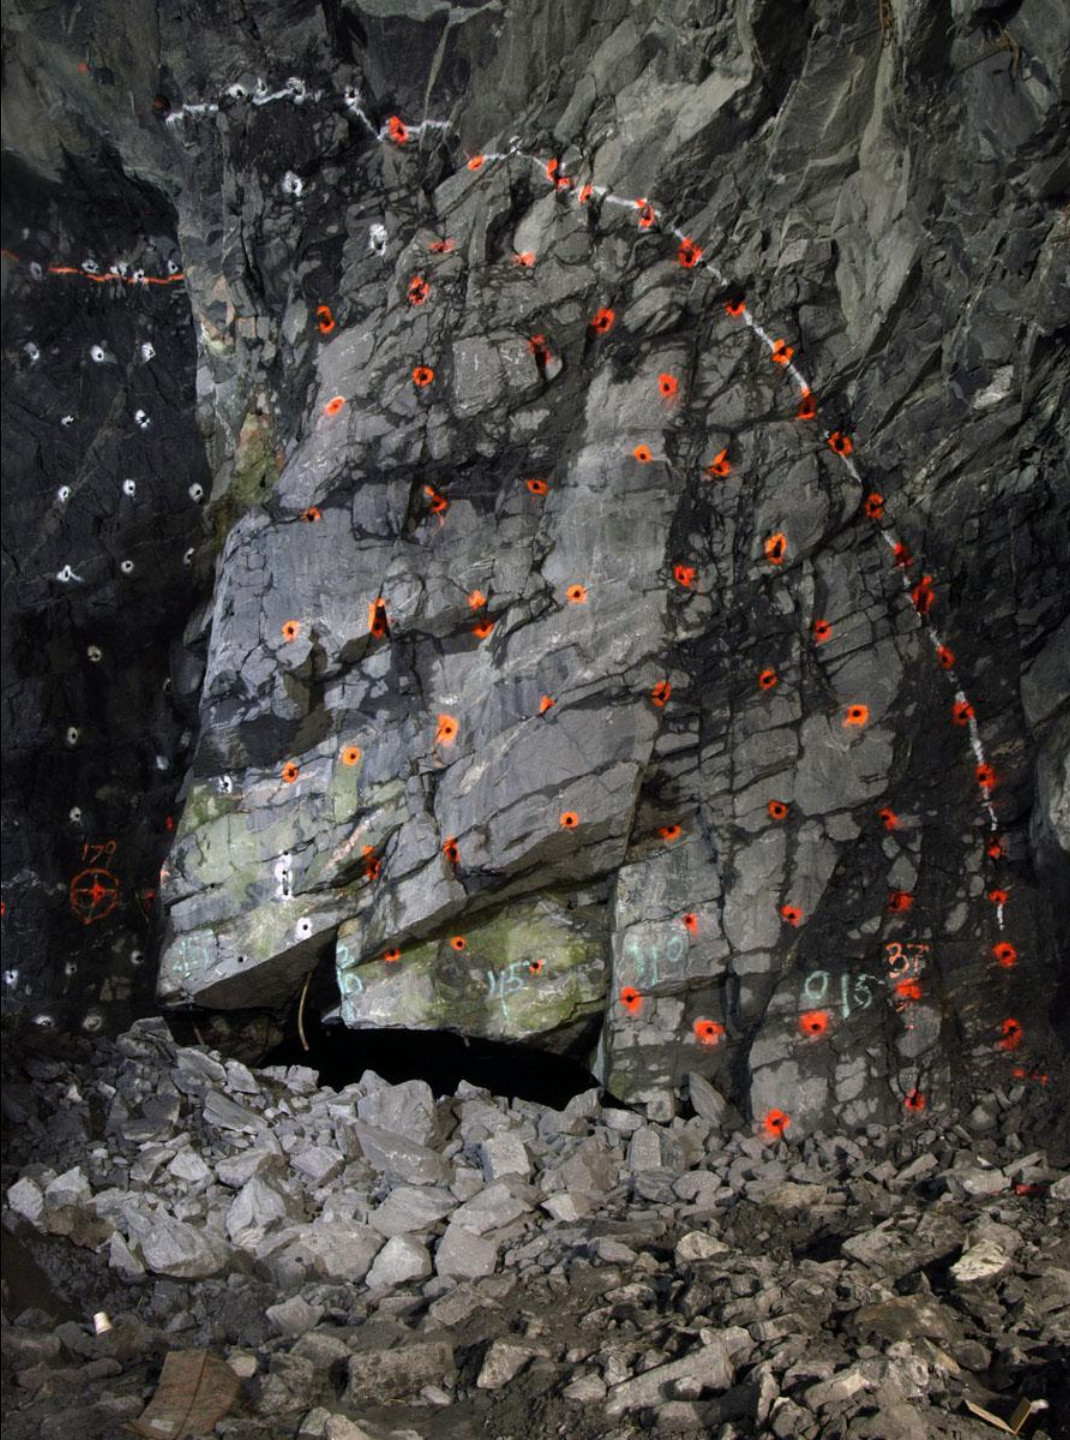
Sta 1205+10 – North Cavern

**Second Avenue Subway - North Cavern West Slash  
Working Face at Sta. 1205+10; Elev. +75' to +105'**

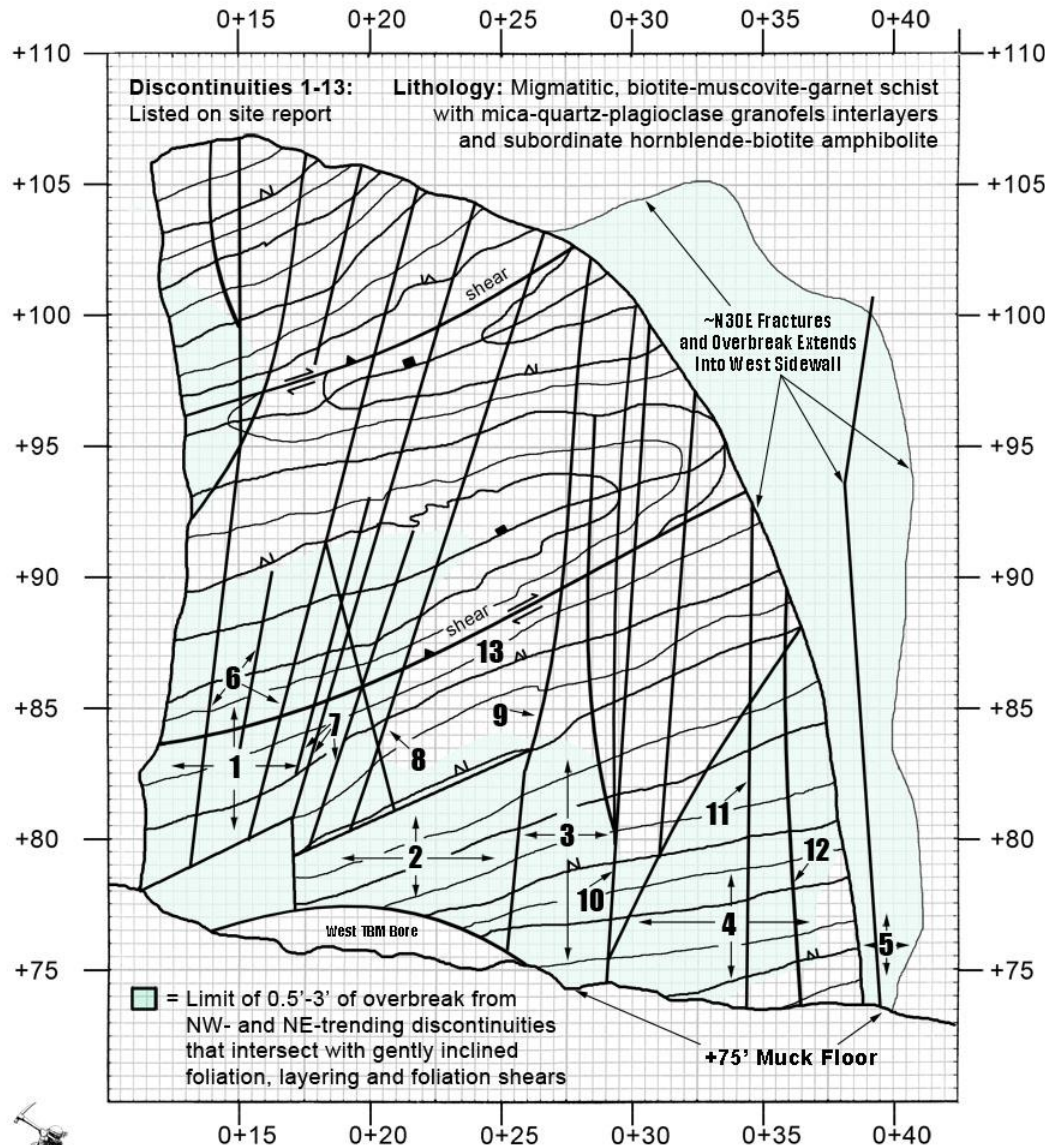
**Sta 1205+10 – North Cavern**

**Stationing in Feet West of Second Avenue Centerline** →

Mapped 19 December 2012
