Review of New York City Bedrock with a Focus on Brittle Structures

Charles Merguerian

GANJ 2015

16 October 2015

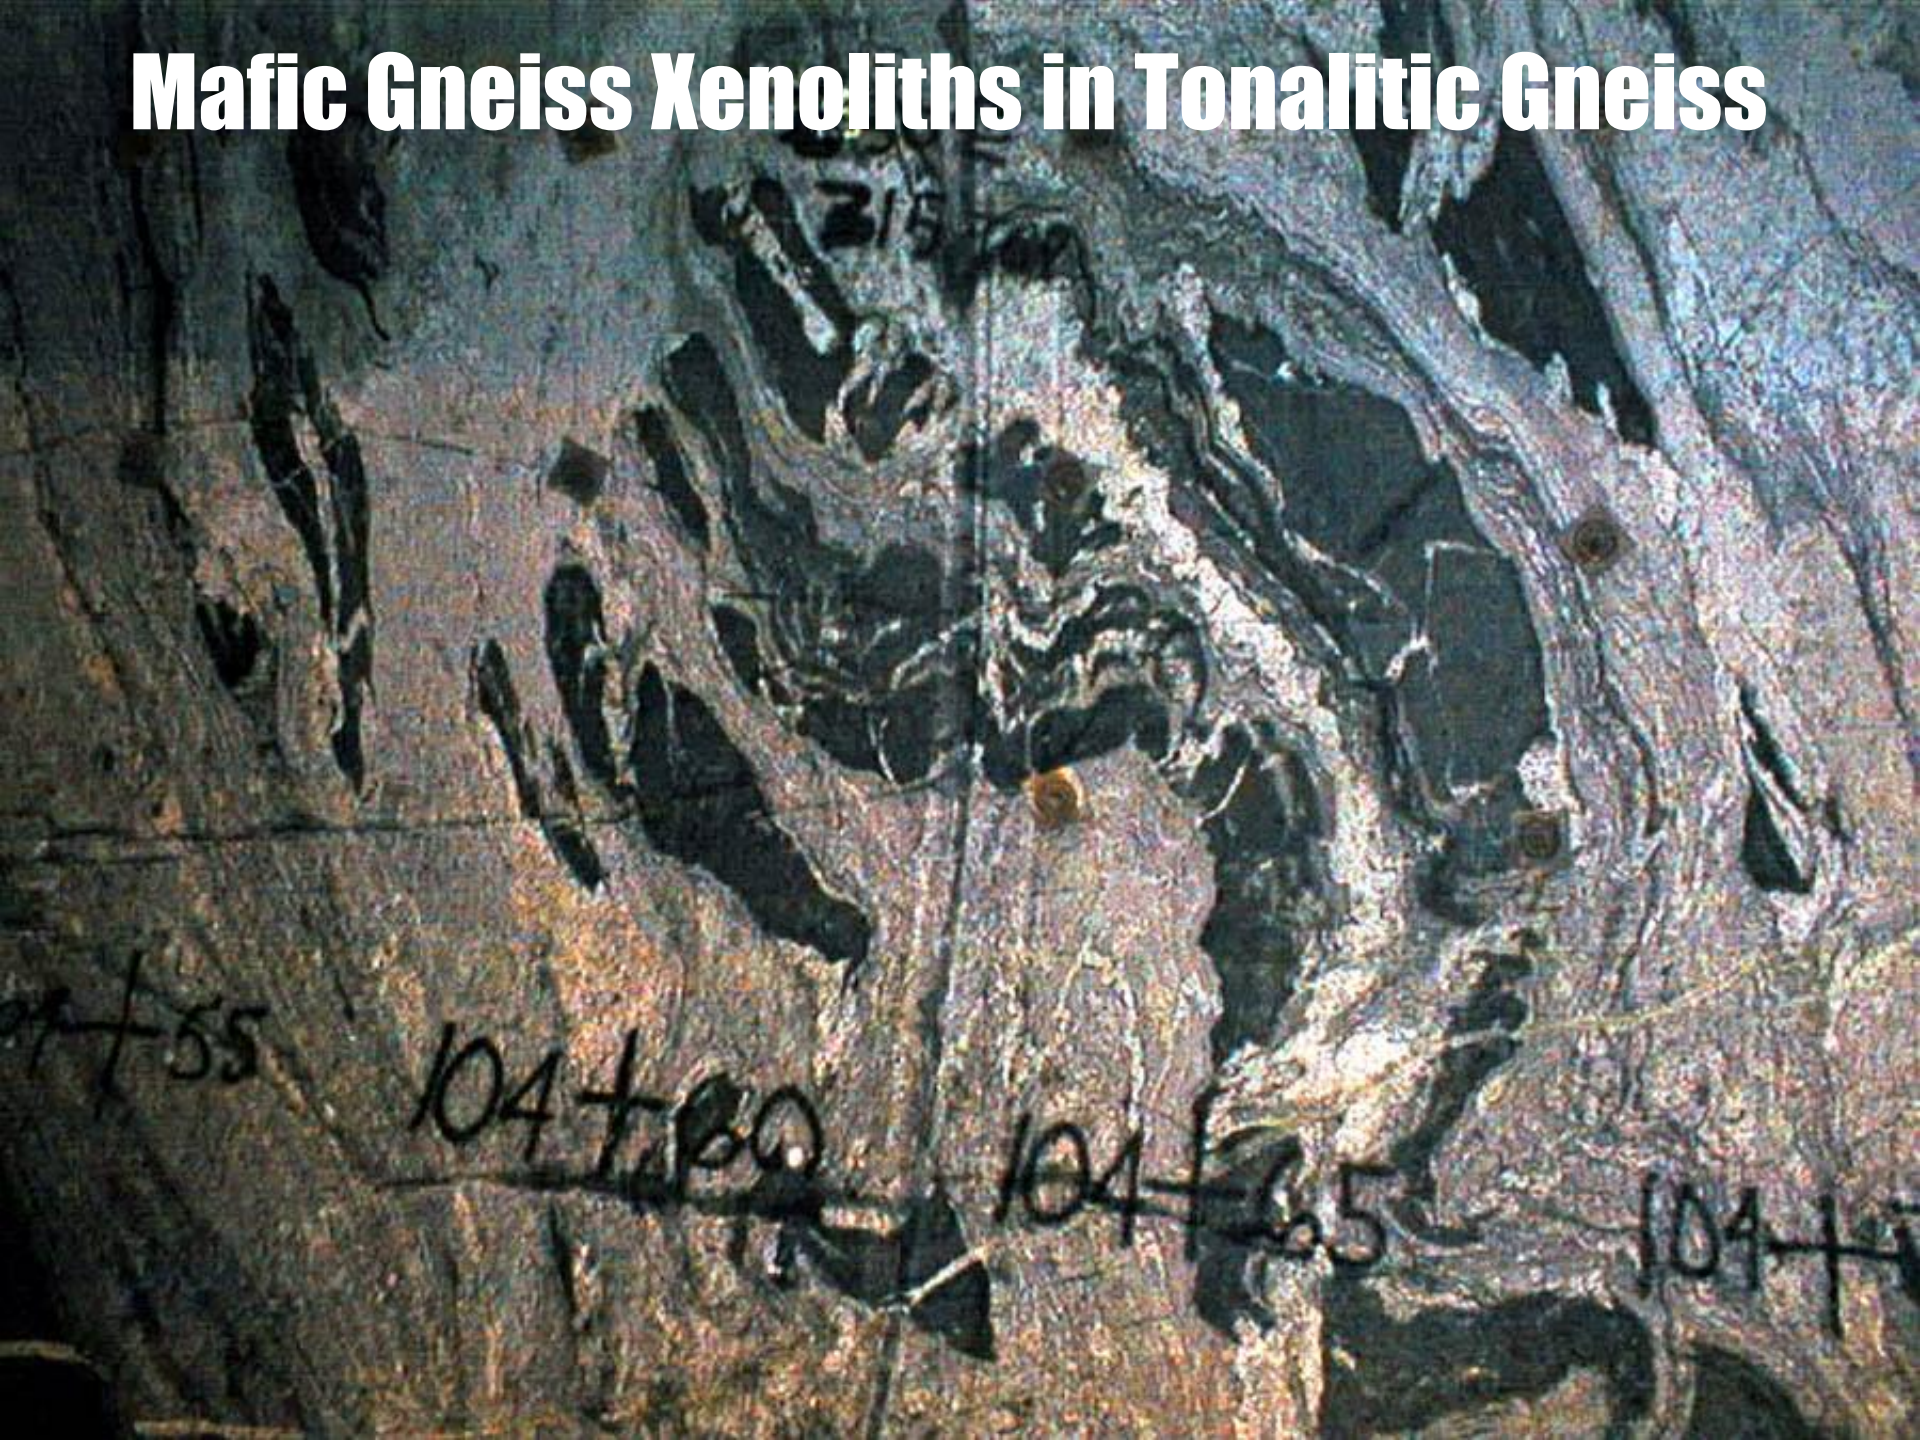
Mafic Gneiss Xenoliths in Tonalitic Gneiss

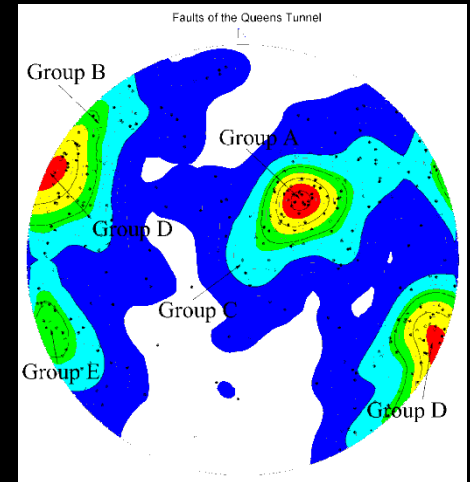
Hundreds of faults mapped in five groups
From oldest to youngest:

Group A = NW strike and gentle SW dipping faults

Group B = ENE-trending steeply dipping faults

Group C = Subhorizontal fractures and faults

Group D = NNE-trending steeply dipping fault system

Group E = NNW-trending "Manhattanville" fault system

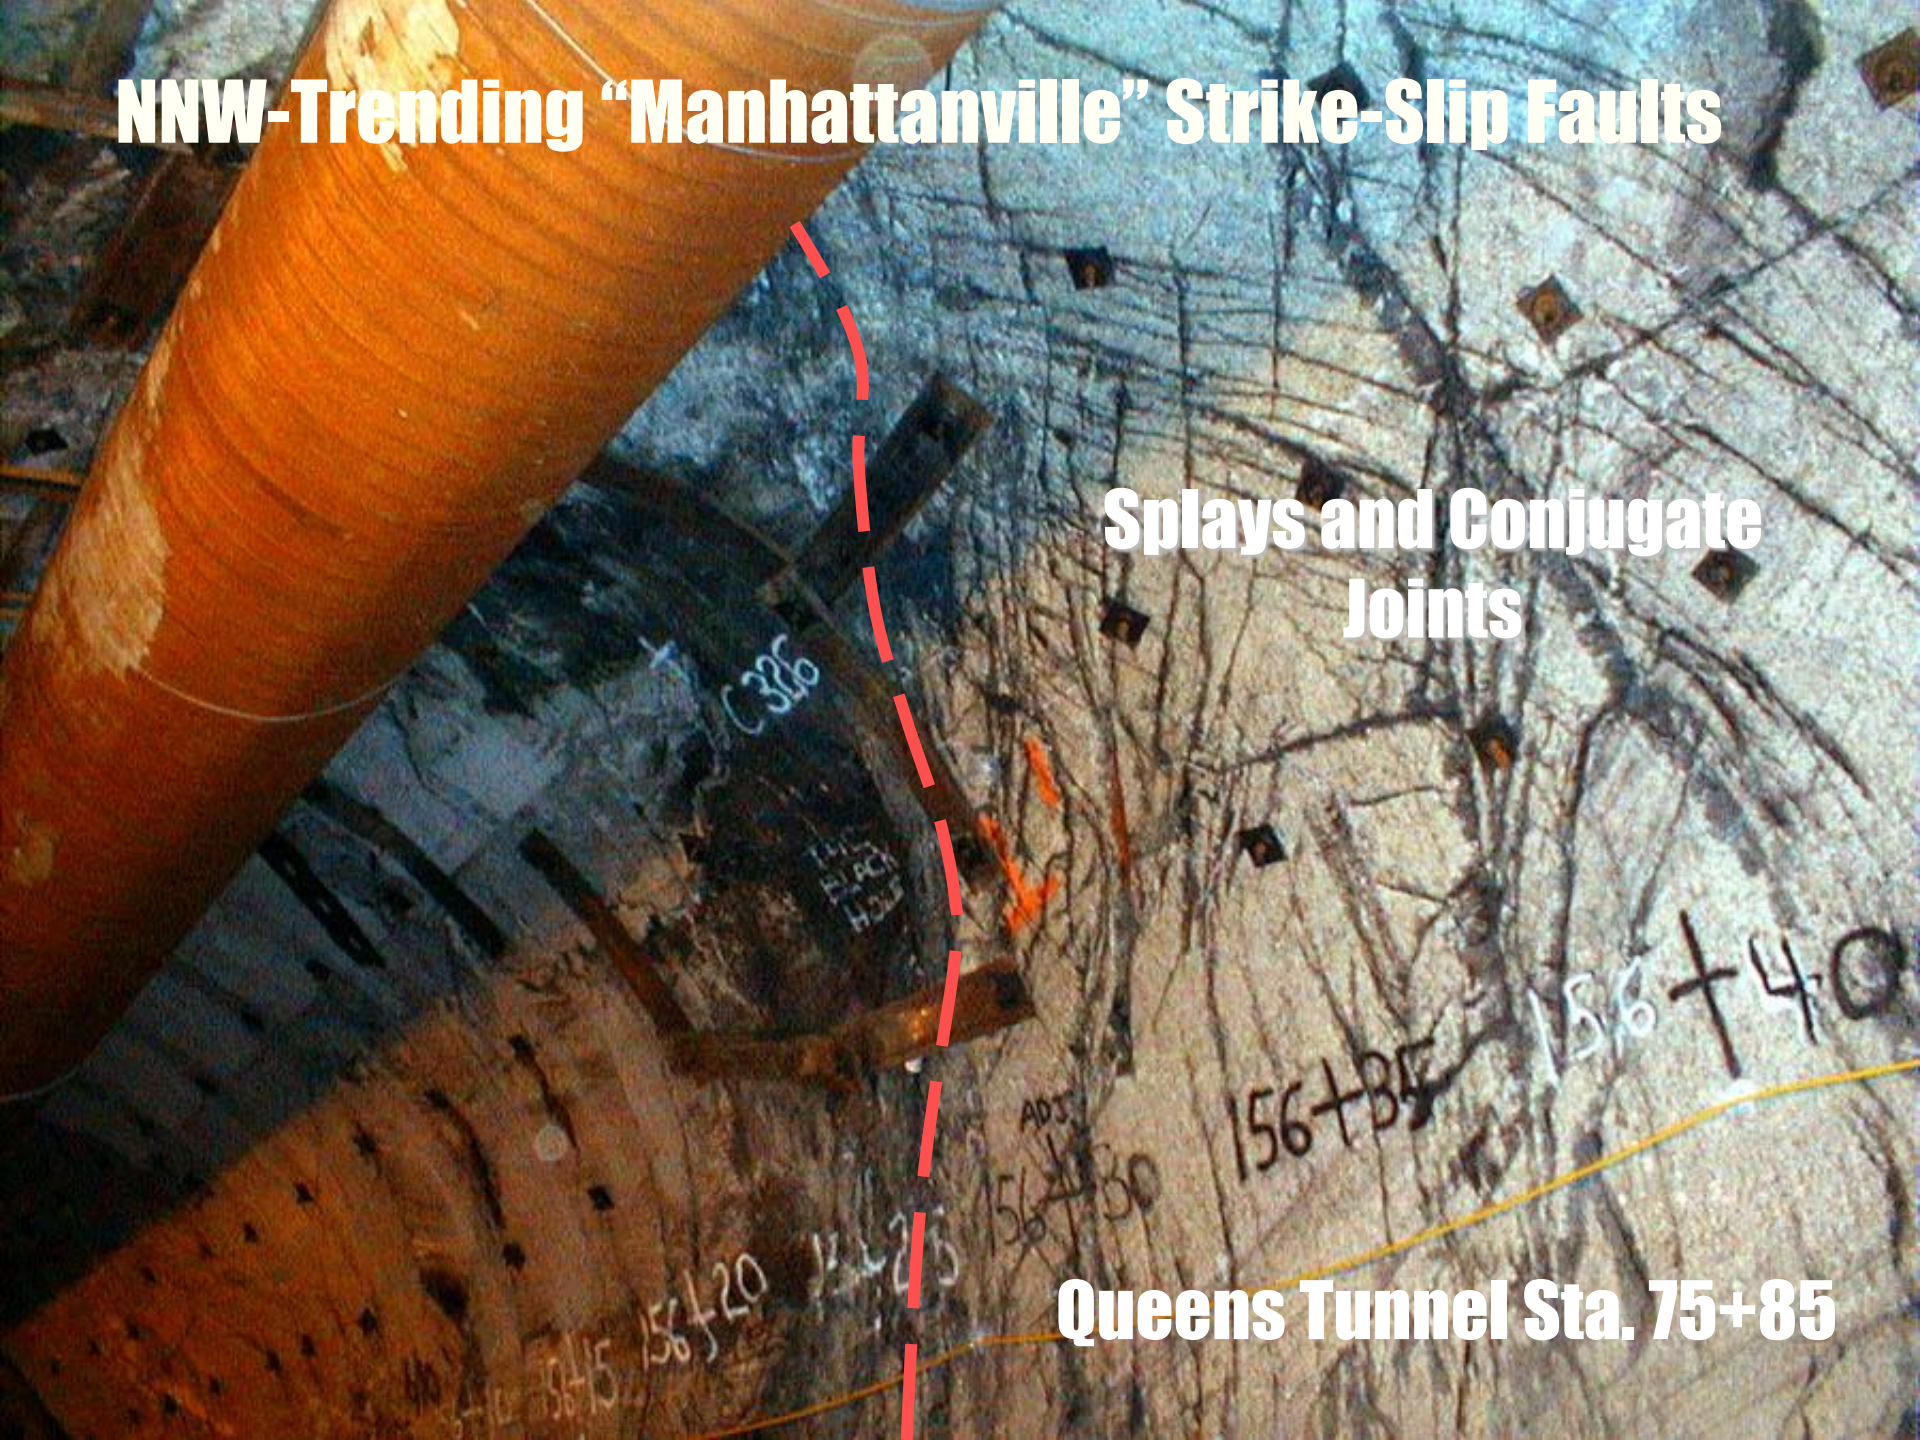
Queens Tunnel Sta. 75+85

NNW-Trending “Manhattanville” Strike-Slip Faults

Splays and Conjugate Joints
