Geology and Mineralogy of the Second Avenue Subway, NYC, NY

*Charles Merguerian
Duke Geological Lab
Stone Ridge, NY
14 October 2015*

Second Avenue Subway

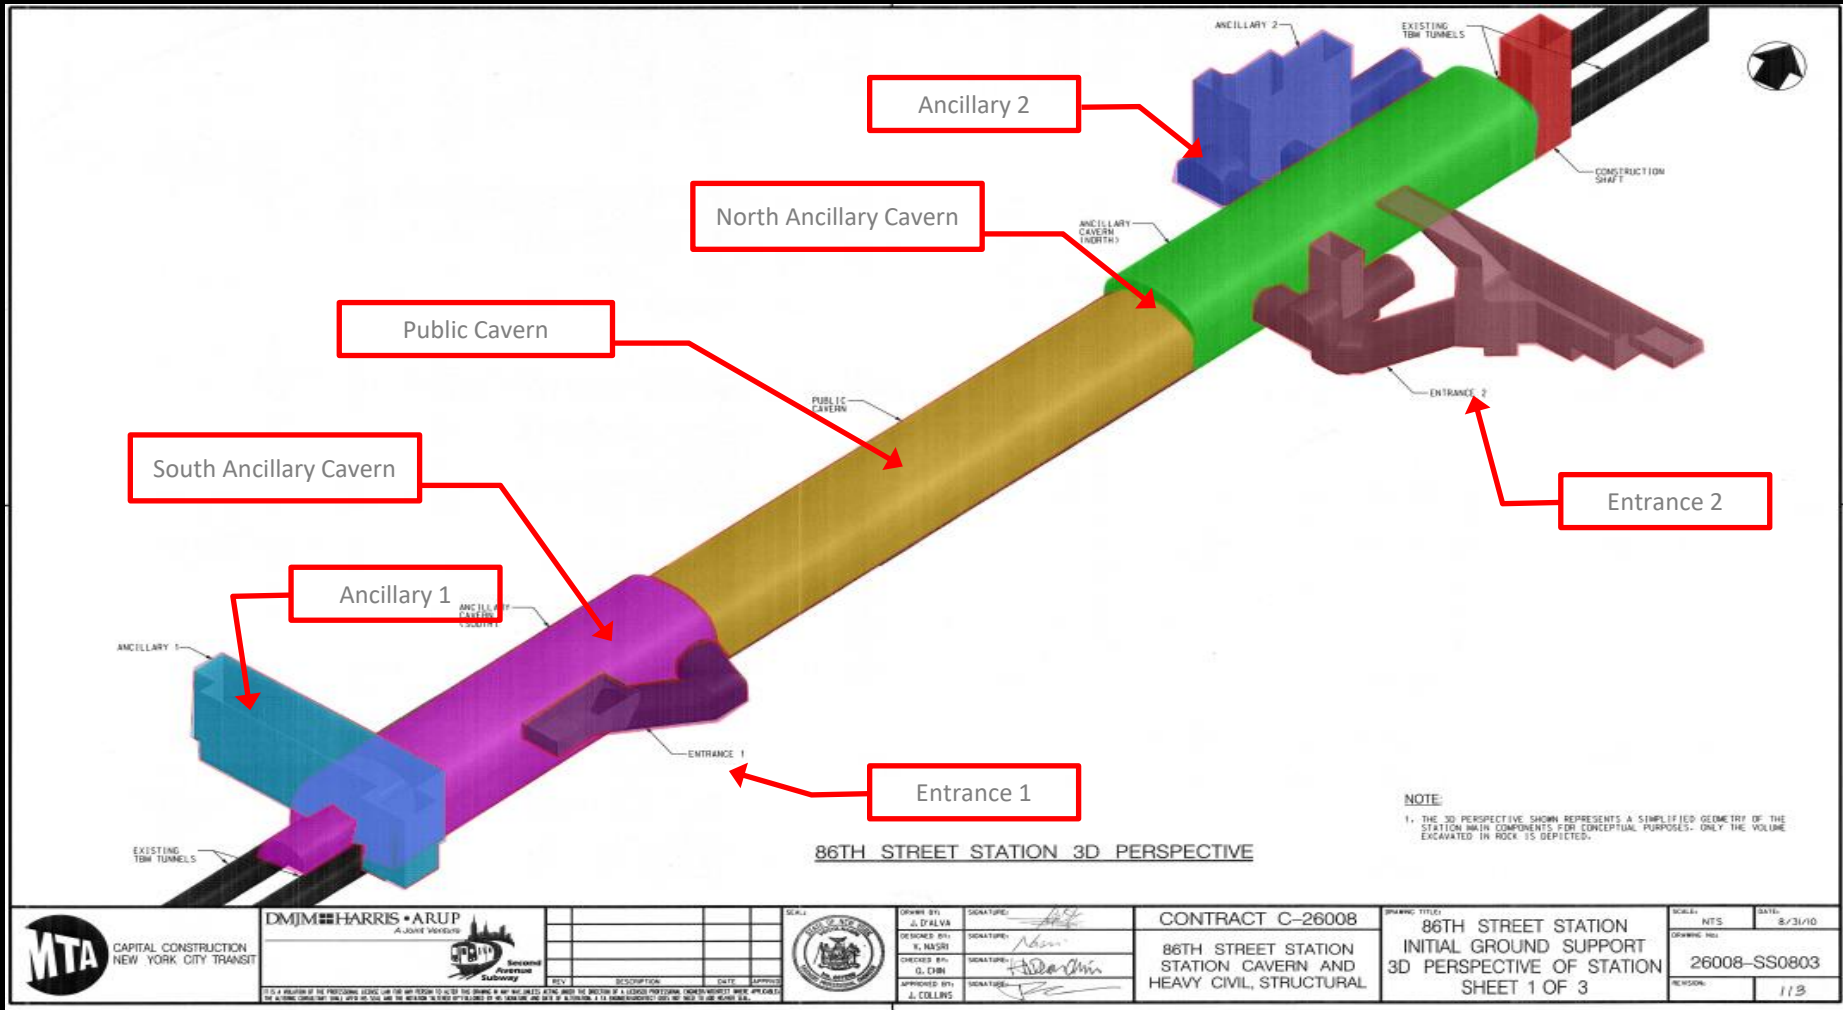
86th Street Station Cavern Excavation

Stations 1198+00 to 1209+00 = ~1,100'

Excavation Methods

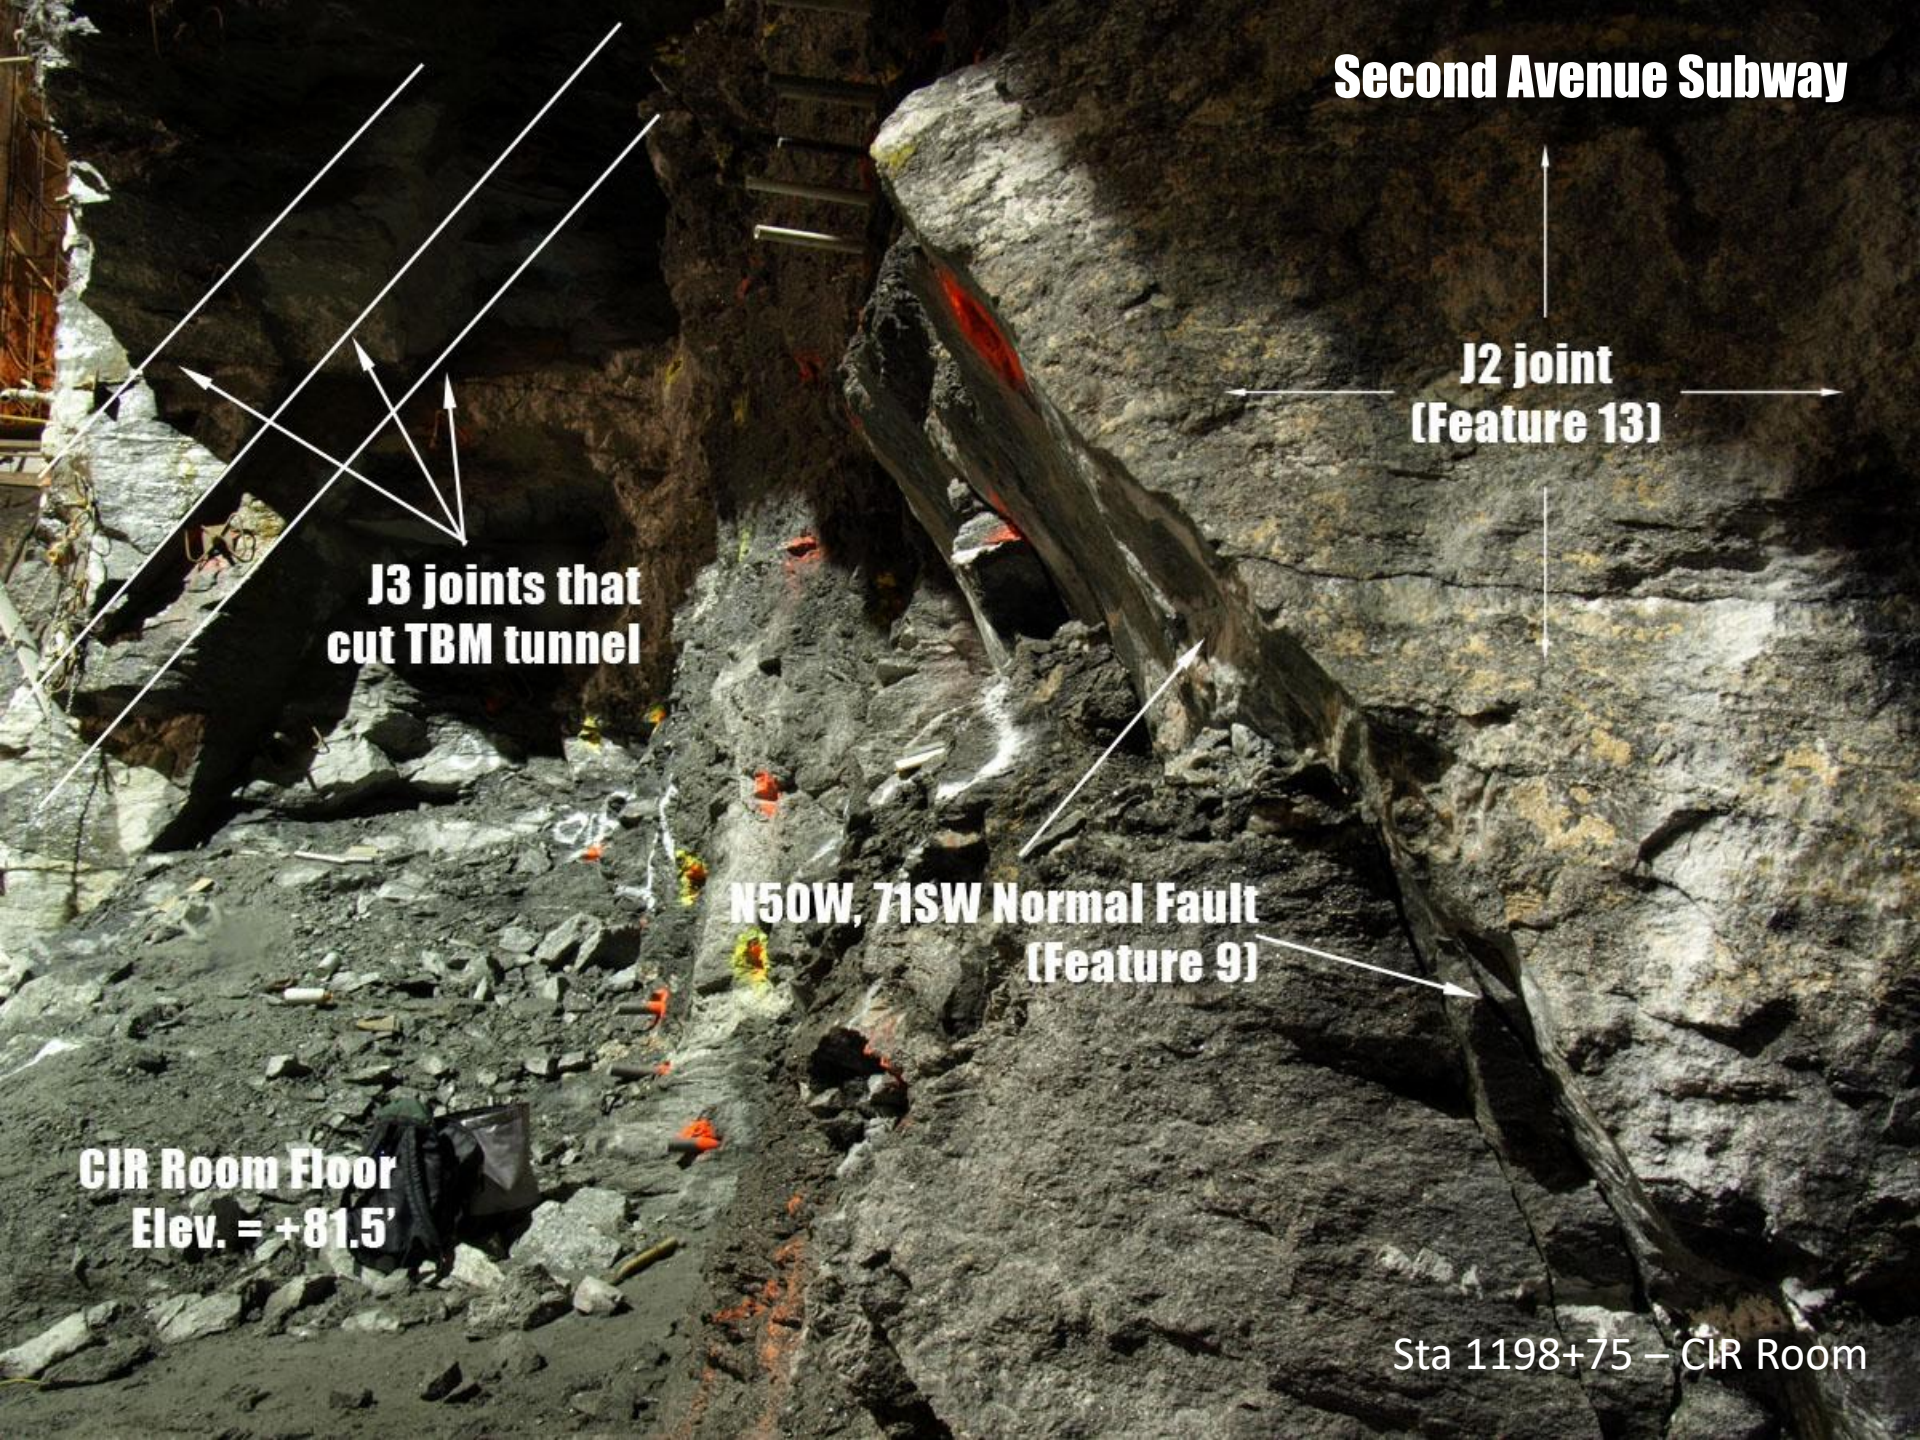
Sta 1198+75 – CIR Room

**J2 joint
[Feature 13]**

**J3 joints that
cut TBM tunnel**

**N50W, 71SW Normal Fault
[Feature 9]**

**CIR Room Floor
Elev. = +81.5'**

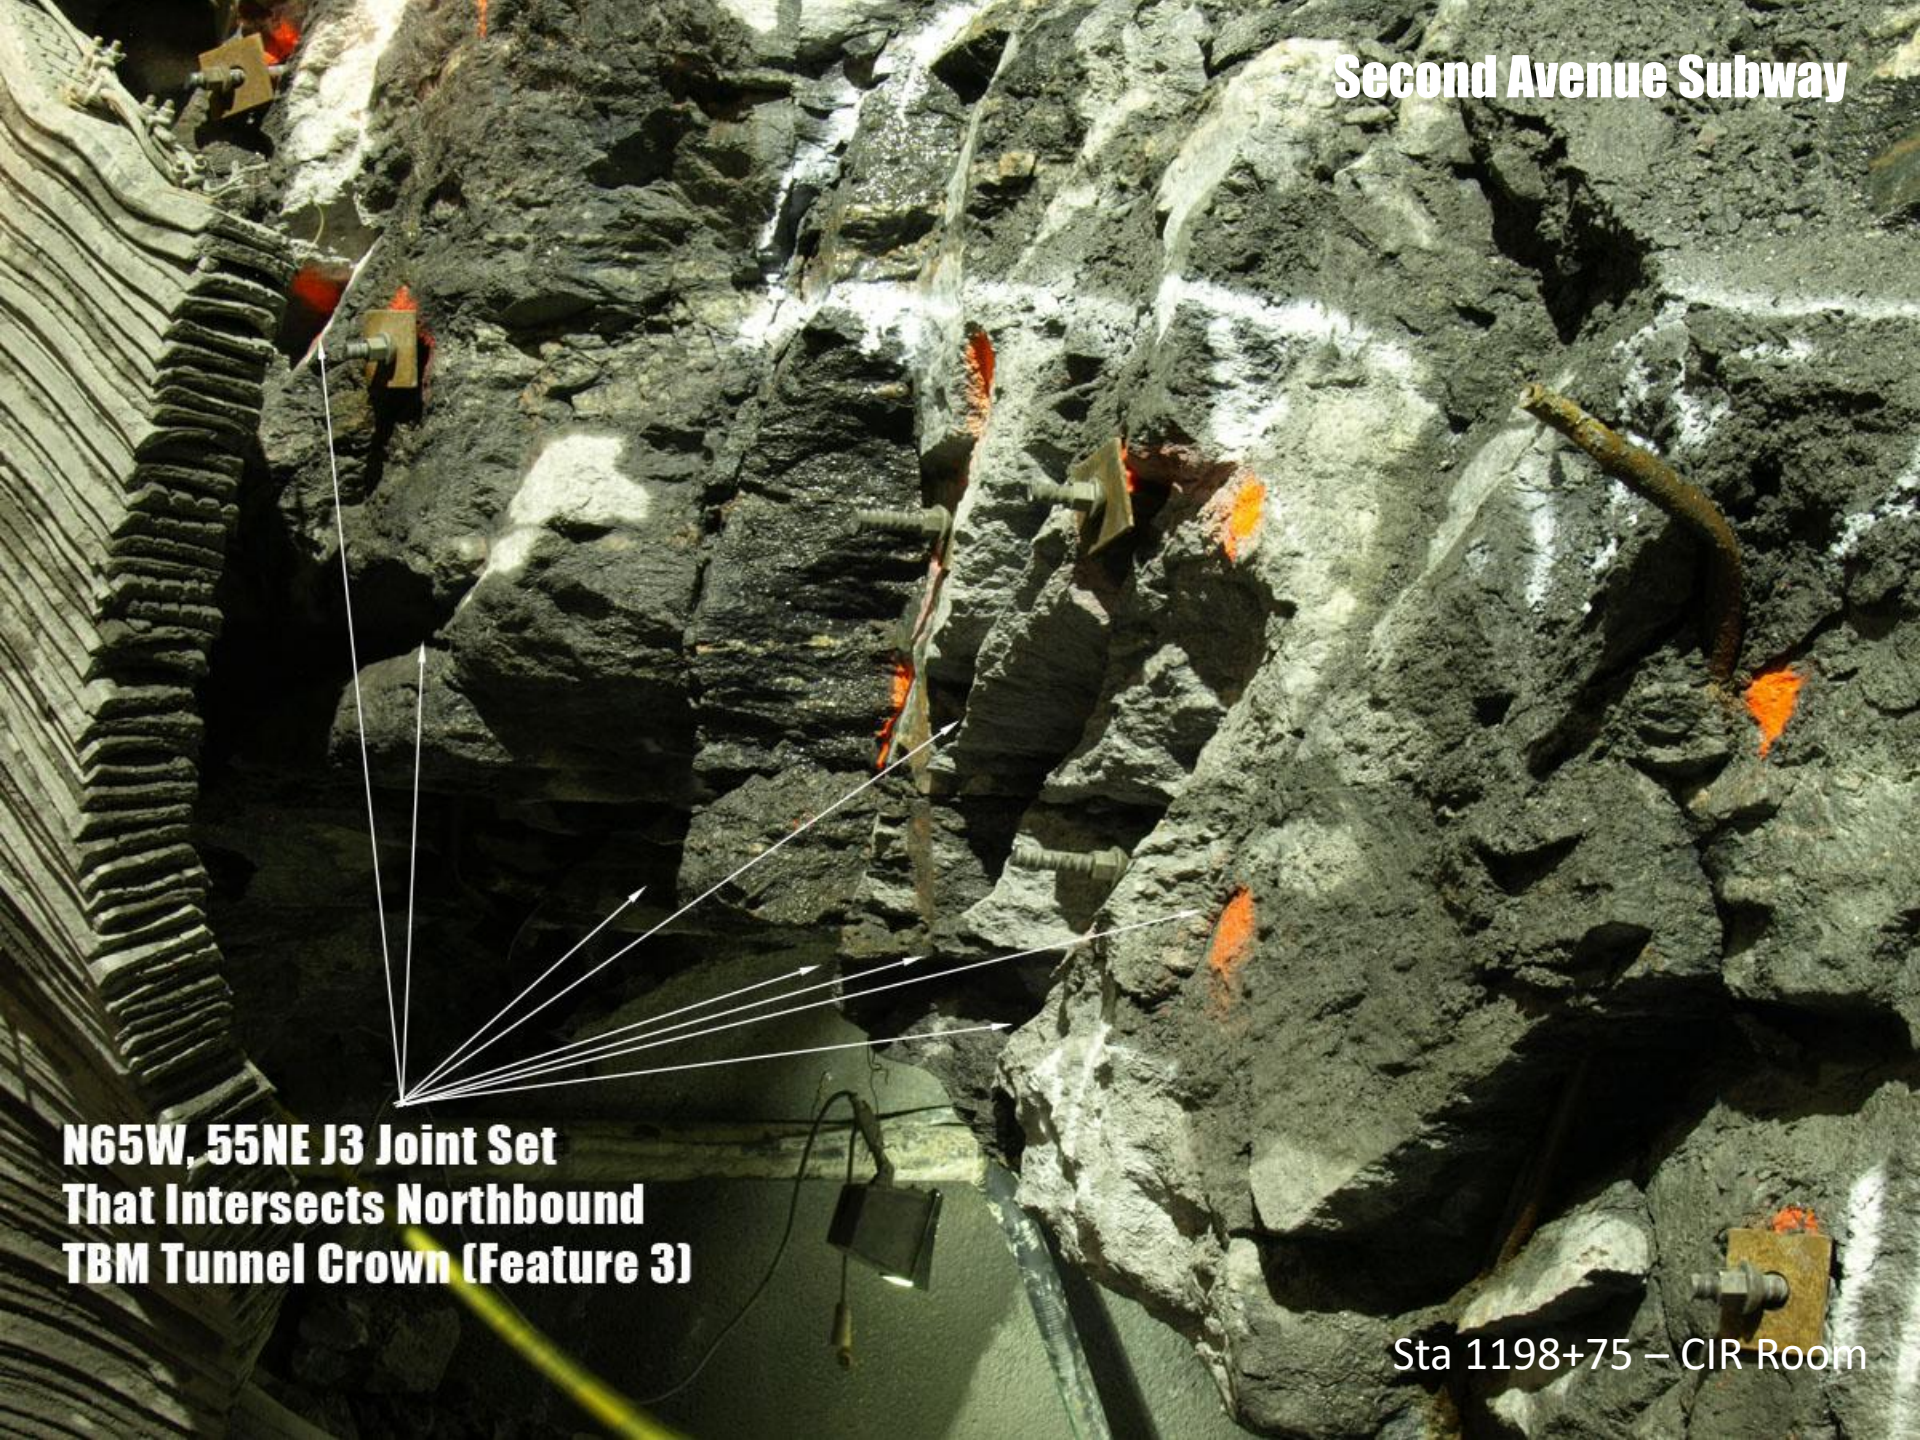
Sta 1198+75 – CIR Room

**N65W, 55NE J3 Joint Set
That Intersects Northbound
TBM Tunnel Crown (Feature 3)**

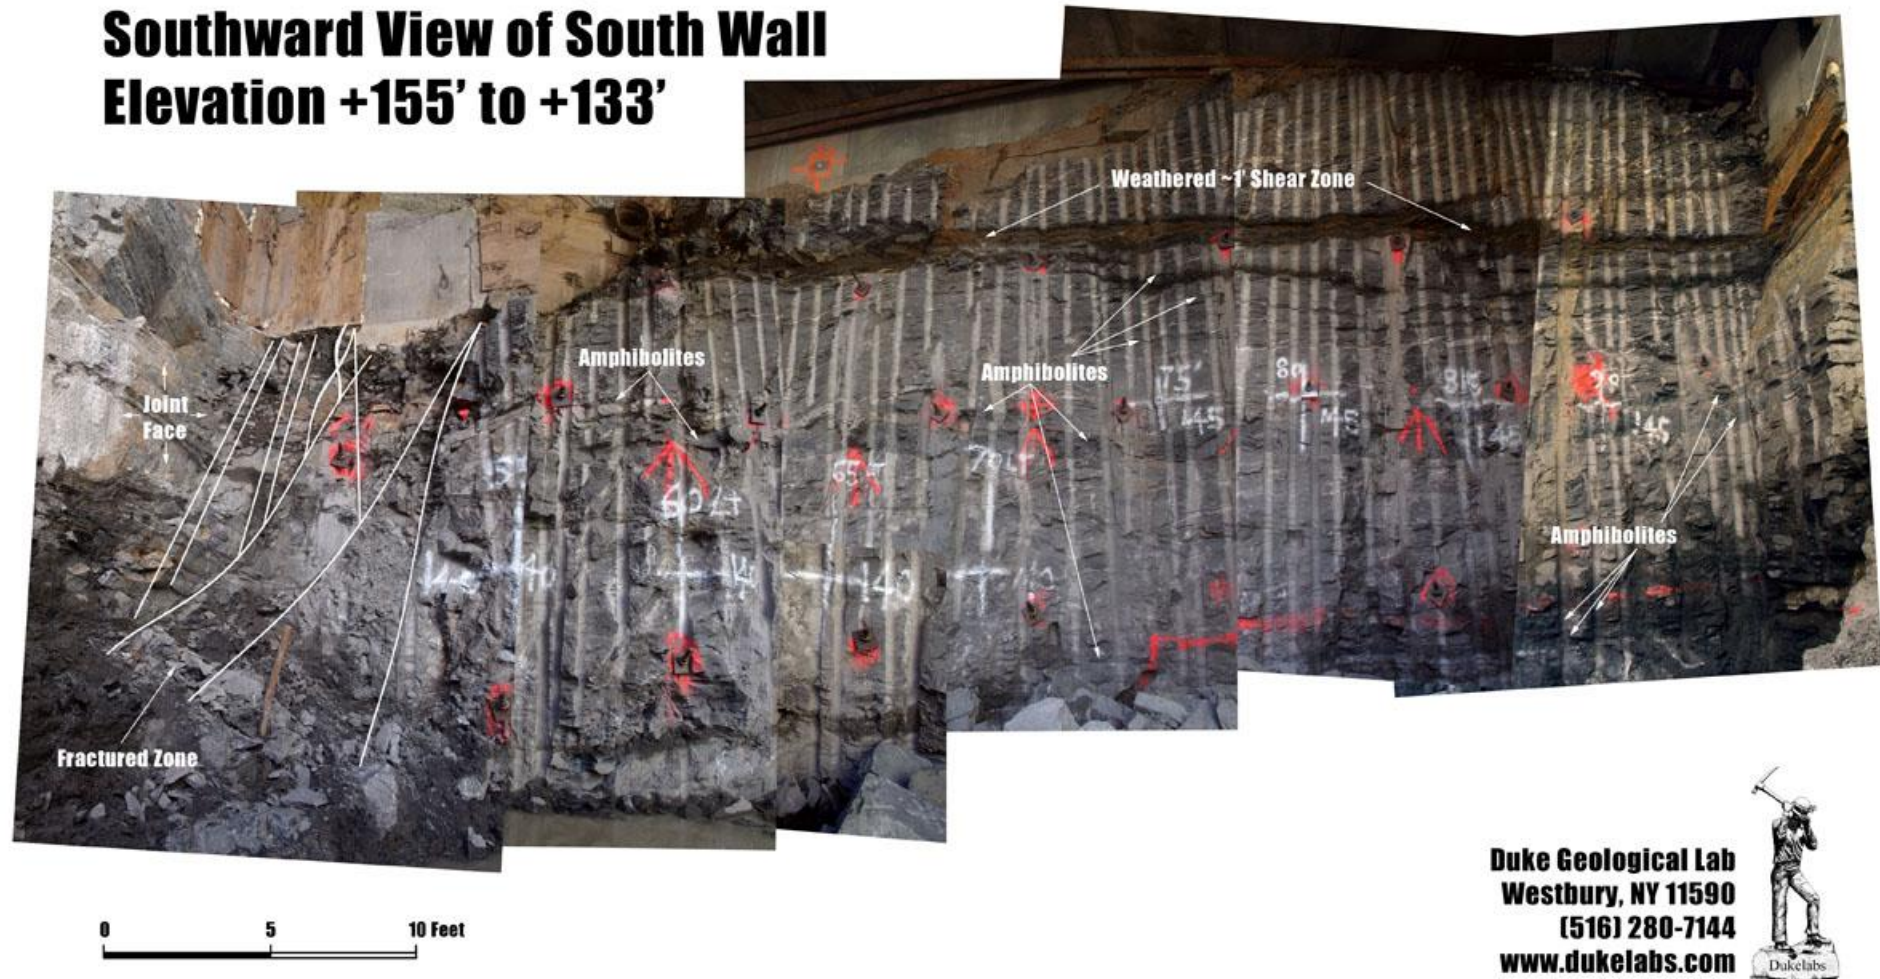
Plate 2

**Second Avenue Subway
86th Street Ancillary #2
Southward View of South Wall
Elevation +155' to +133'**
