## **Geological Solutions for Providing a Scientific Basis for Differing Site Condition Claims**

### **Abstract**

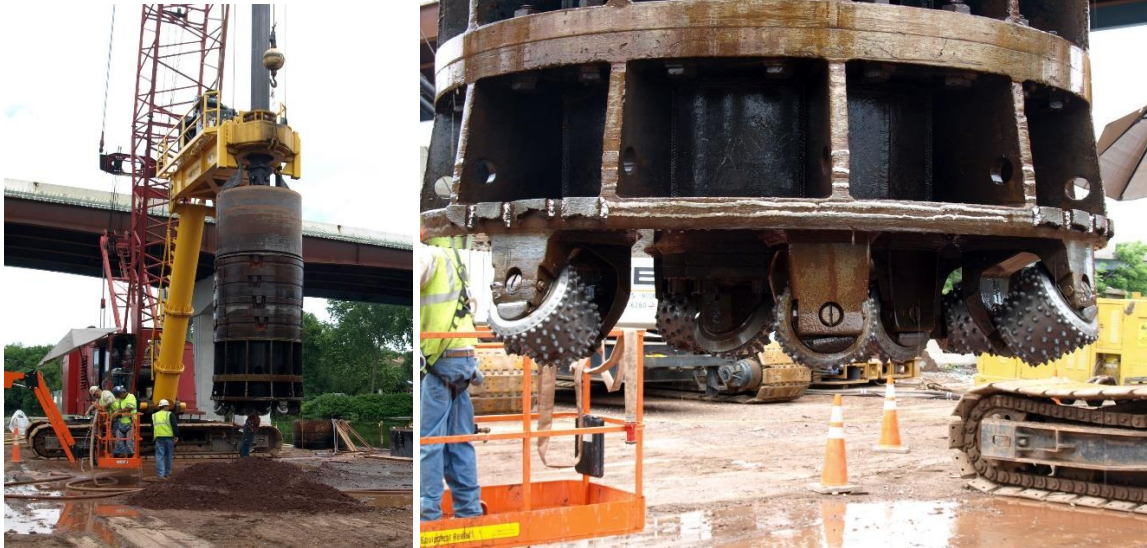
During construction of the bridge, 45 shafts of 96” diameter were drilled for bridge piers using identical means and methods and finished with 90” rock sockets. Difficulties in construction were encountered in drilling eight of the river shafts. In these instances, shaft construction was hindered by voids, high-water inflows and in-falling blocks of red-colored siltstone and sandstone. The ground conditions required remediation including grouting, additional drilling, reseating of casings and deepening of shafts. A view of the equipment used for subaqueous drilling is shown below (Figure 2).

**Figure 2** – Westward view of Shaft #23 construction rig near Pier 3 of job site in New Jersey (L) and close-up view of the cutterhead and cutters (R) designed for sedimentary rocks. (Dukelabs digital images taken 14 June 2013.)

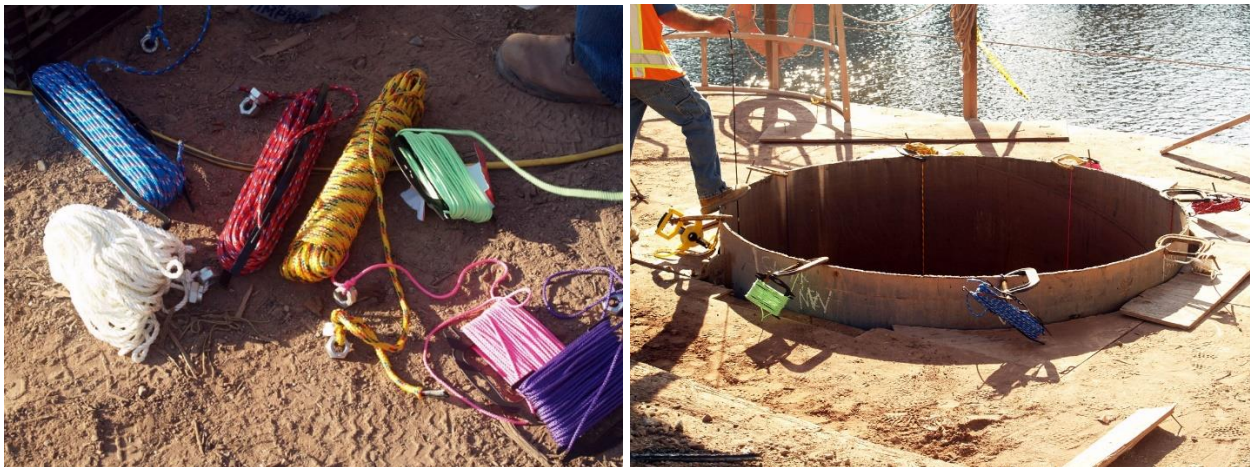
In order to calibrate and map the shaft interior we marked the walls by suspending weighted colored ropes with magnetic N, E, S, and W and intervening magnetic compass directions NE, SE, SW, NW so that calibration, recording and calculating the orientation of geological features could be accomplished (Figure 5).

**Figure 5** – Various ropes used with weights and C-clamps to hold ropes taught and vertical down the sides of the shaft in order to video each compass rose direction with depth calibration. Analysis of the color-coded videos allowed us to generate an accurate flat 2-D map of the interior of the rock socket.

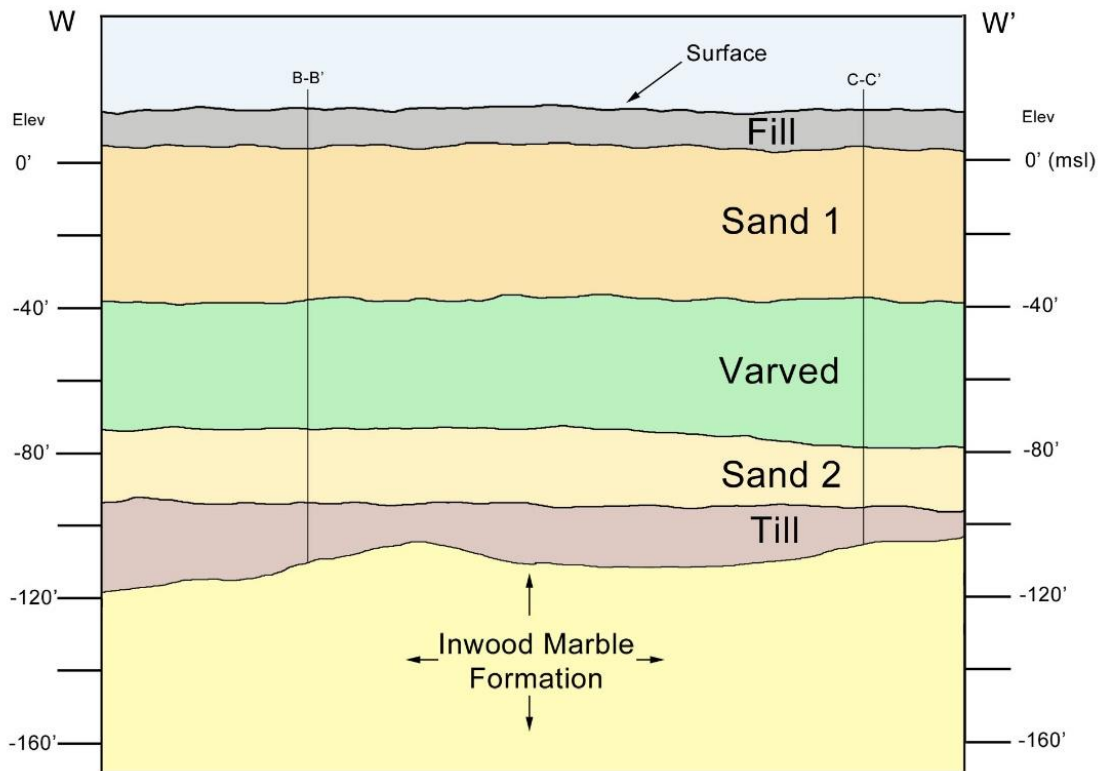
The stratigraphy of roughly 100' of overburden from the top down included Holocene fill, Pleistocene sand units, intervening varved strata and basal till below which penetrations into the Inwood Marble bedrock were met with persistent excessive water and material inflows (Figure 10).

**Figure 10** – Across site roughly W-E geological profile section drawn from data supplied in the geotechnical report showing overburden strata and the buried Inwood Marble bedrock layer. This view of the site was the anticipation and design criteria for the contractor’s approved means and methods.

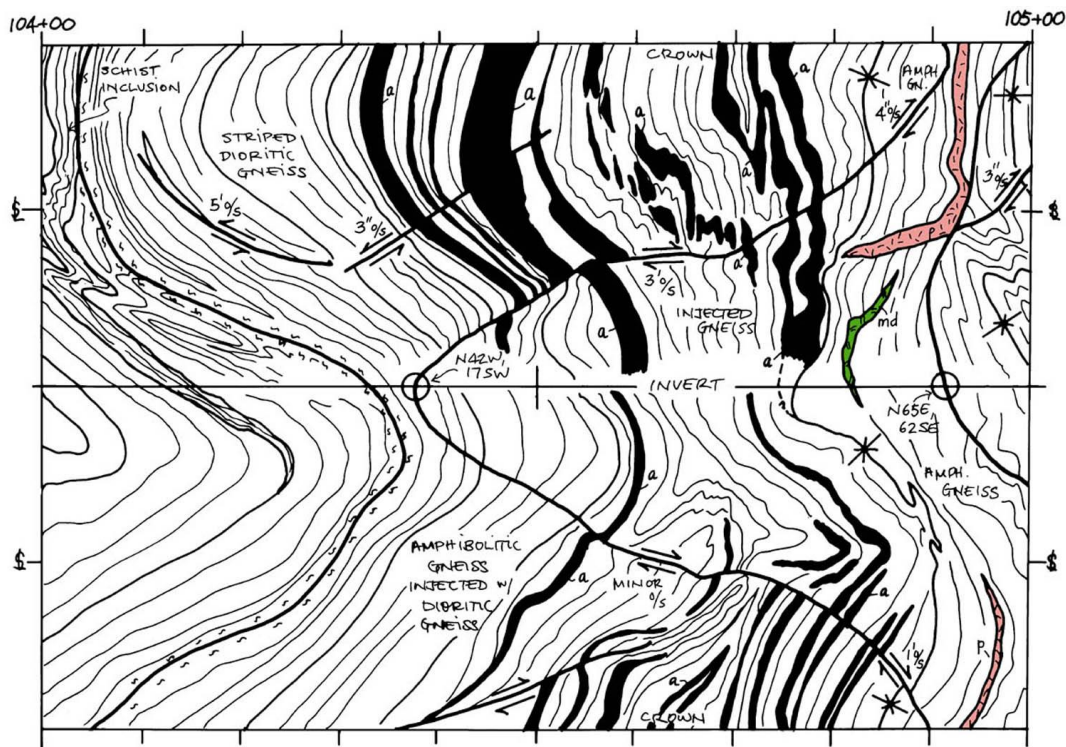
**Figure 19** – Geological map of Tunnel #1 shows granulite-facies amphibolite gneiss and younger dioritic orthogneiss cut by pegmatite (p) and a mafic dike (md). The amphibolitic gneiss is locally sheared but clearly occurs as inclusions in the dioritic gneiss. The tunnel invert is shown along the center of the map and the tunnel walls curl upward into a cylinder to join at the crown. The position of the tunnel springline is shown at the map edge. This map, one of 250 in the unpublished Tunnel #1 Map Portfolio, records 100' of the tunnel. A low-angle reverse fault oriented N42°W, 17°SW cuts the invert at Station 104+38 (tunnel invert bearing is N22°E). A younger N65°E, 62°NE brittle fault cuts the invert at Station 104+91. Original map scale 1" = 10'; tunnel diameter 23' 2".
