Geological Solutions: Pre-Bid Risk Assessment and As-Built Claims in the NY Metropolitan Region

Charles Merguerian¹, Ph.D., P.G. and J. Mickey Merguerian², M. Sci.

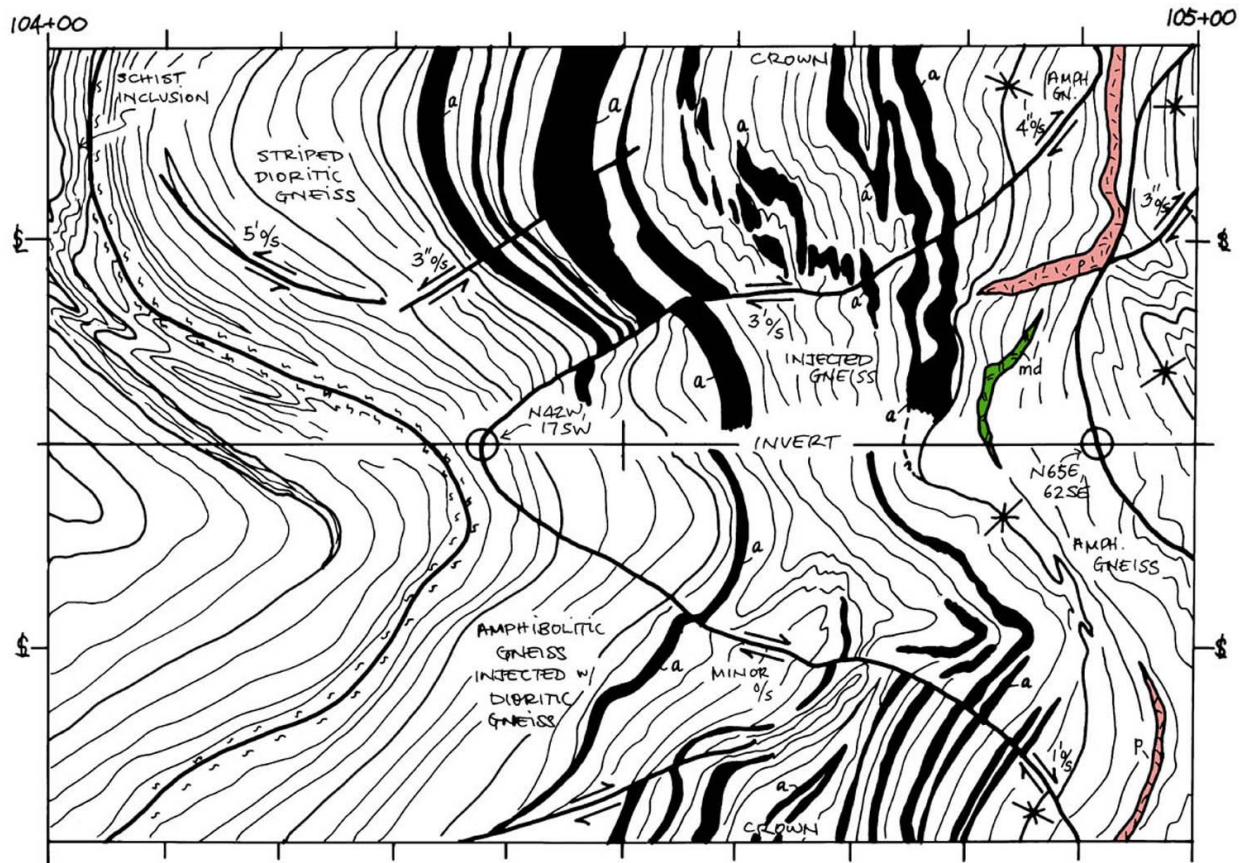
Figure 3 – Geological map of Tunnel #1 shows granulite-facies amphibolite gneiss and younger dioritic orthogneiss cut by pegmatite (p) and a mafic dike (md). The amphibolitic gneiss is locally sheared but clearly occurs as inclusions in the dioritic gneiss. The tunnel invert is shown along the center of the map and the tunnel walls curl upward into a cylinder to join at the crown. The position of the tunnel springline is shown at the map edge. This map, one of 250 in the unpublished Tunnel #1 Map Portfolio, records 100' of the tunnel. Here, a low-angle reverse fault oriented N42°W, 17°SW cuts the invert at Station 104+38 (tunnel invert bearing is N22°E). A younger N65°E, 62°NE brittle fault cuts the invert at Station 104+91. Original map scale 1" = 10'; tunnel diameter 23' 2".

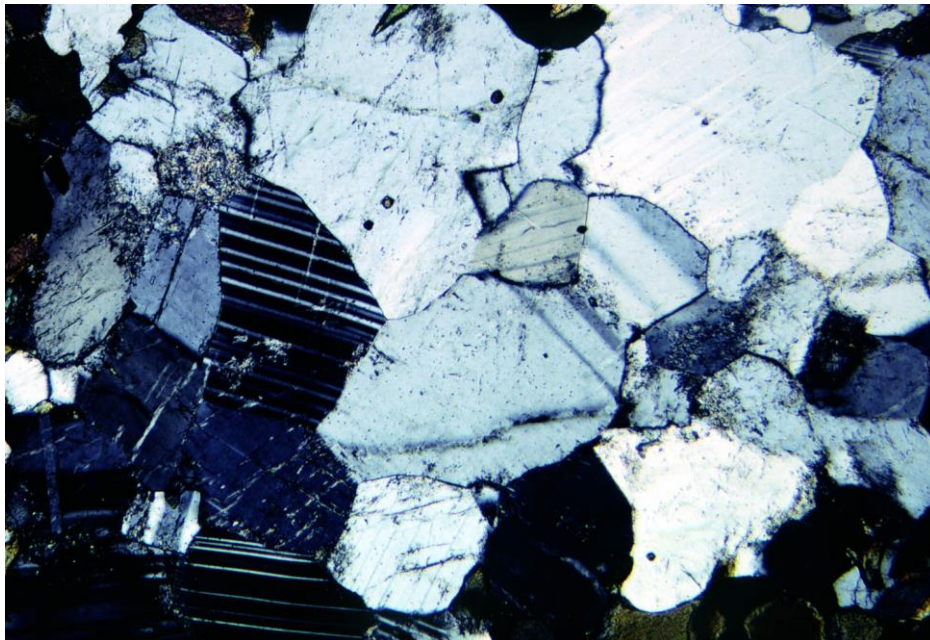
Figure 5B – Photomicrograph in crossed nicols of Tunnel #1 leucocratic gneiss (Sample Q085; Station 159+80) showing granoblastic intergrowth of plagioclase and minor quartz. Note the granular texture, the stable 120° crystal boundaries of the interlocking plagioclase and interstitial quartz and the lack of any penetrative foliation. Both photomicrographs are 2 mm across.

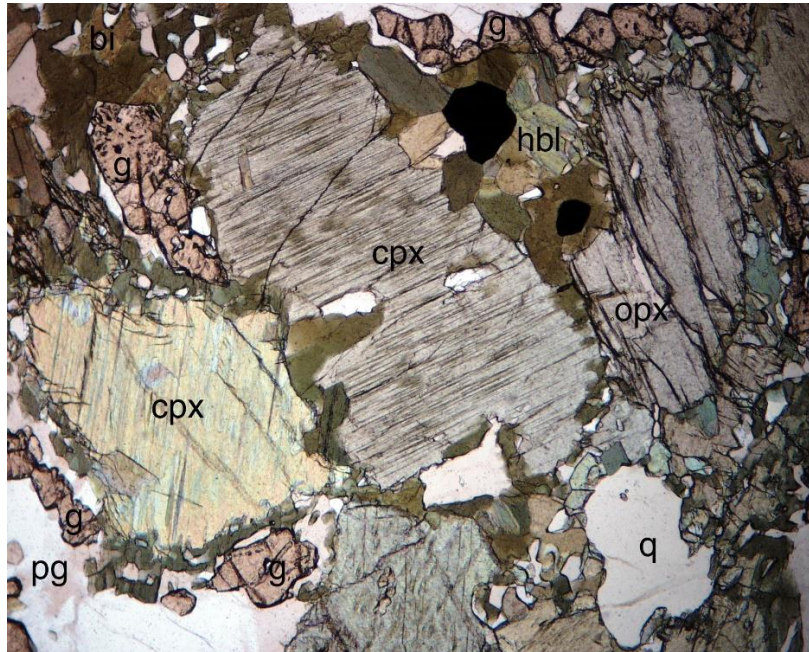
Figure 8 – Photomicrograph in plane-polarized light of Tunnel #1 mafic gneiss showing coarse-textured granulite facies texture in the form of partly recrystallized orthopyroxene (opx), clinopyroxene (cpx), and primary garnet (g). Quartz = q. Note the secondary thin overgrowths of green hornblende (hbl), granular garnet (g) and biotite (bi), the result of late retrograde metamorphic recrystallization. (Sample Q114; Station 15+90; 2 mm field of view.)

During TBM mining the importance of garnet hinges on the extreme hardness and high density of the mineral (Hardness 6.5 to 7.5 on Mohs' scale; Density 3.1 to 4.3 g/cm³). Along with quartz at hardness 7 on Mohs' scale, in concert they produce unusually hard, abrasive rocks when found in high concentration. (See Figures 9A, B and Table 1.) The garnet is commonly found along with quartz (another abrasive mineral) and can occur as finely disseminated garnet, garnetiferous layers a few feet thick, as lenticular lenses, and in highly laminated areas forming broad zones up to 263' long in the tunnel. Garnet is also found in high concentrations within amphibole-pyroxene bearing rocks as garnet+plagioclase segregations. In thin section, thin zones of garnet rim areas of relict orthopyroxene+clinopyroxene the product of secondary metamorphism. (See Figure 8.) Petrographic analysis of Tunnel #1 gneisses demonstrated that high-pressure granulite facies metamorphism promoted the growth of garnet and other dense mineral phases including orthopyroxene and clinopyroxene (Brock, Brock and Merguerian 2001; Spear 1993). Note that high-pressure granulite facies metamorphism is simply not recognized in Hartland Formation rocks in this area of NYC.

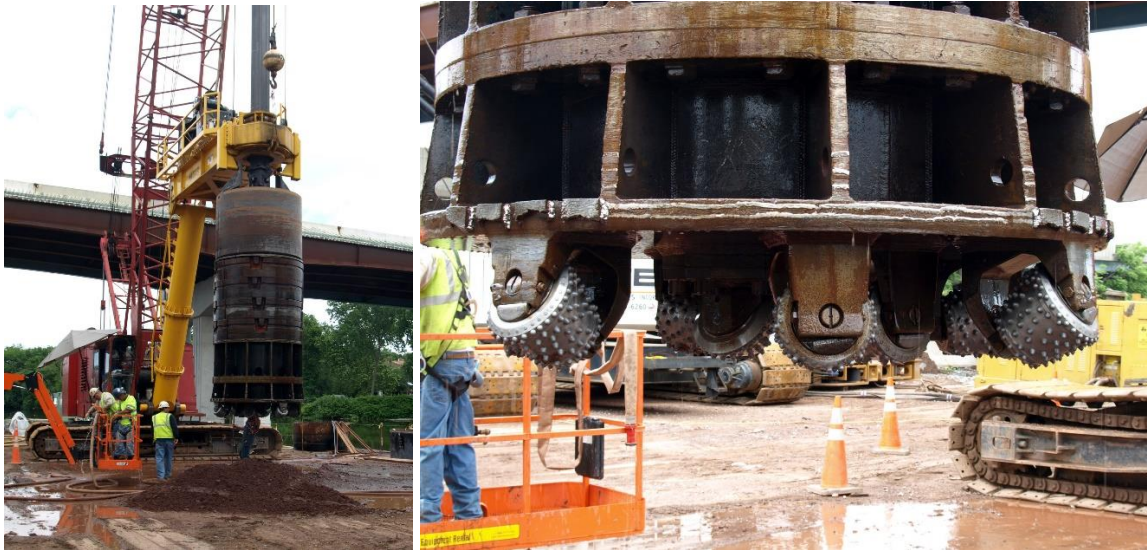
During construction of the bridge, 46 shafts of 96” diameter were drilled using identical means and methods for bridge piers and finished with 90” rock sockets but difficulties in construction were encountered at eight of the shafts on the west side of the river. In these instances, shaft construction was hindered by sink holes, blow-ins, high-water inflows and in-falling blocks of red-colored siltstone and sandstone. The ground conditions required remediation including grouting, additional drilling, reseating of casings and deepening of shafts. A view of the equipment used for subaqueous drilling is shown below (Figure 11).

Figure 11 – Westward view of Shaft #23 construction rig near Pier 3 of the job site in New Jersey (L) and close-up view of the cutterhead and cutters (R). (Dukelabs digital images taken 14 June 2013.)

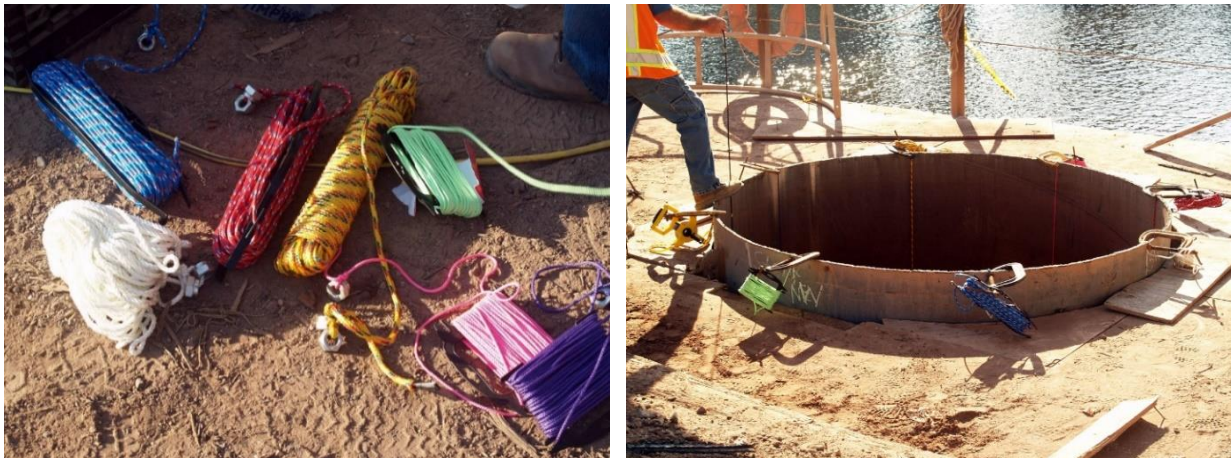
In order to decipher the as-built contractor experience, we devised and supervised video recordings of a water-filled 96" problem shaft and a developed a down-hole method of mapping the interior of the 90" (7.5') diameter rock socket extending below top of rock in order to generate an associated 2-D map and construct an analog 3-D view of the as-built subsurface geological structure. To calibrate and map the shaft interior we marked the walls by suspending weighted colored ropes with magnetic N, E, S, and W and intervening magnetic compass directions NE, SE, SW, NW clearly visible so that calibration, recording and calculating the orientation of the fractures could be facilitated (Figure 14).

Figure 14 – Various ropes used with weights and C-clamps to hold ropes taught and vertical down the sides of the shaft in order to video each compass rose direction. Analysis of the color-coded videos allowed us to generate an accurate flat 2-D map of the interior of the rock socket.

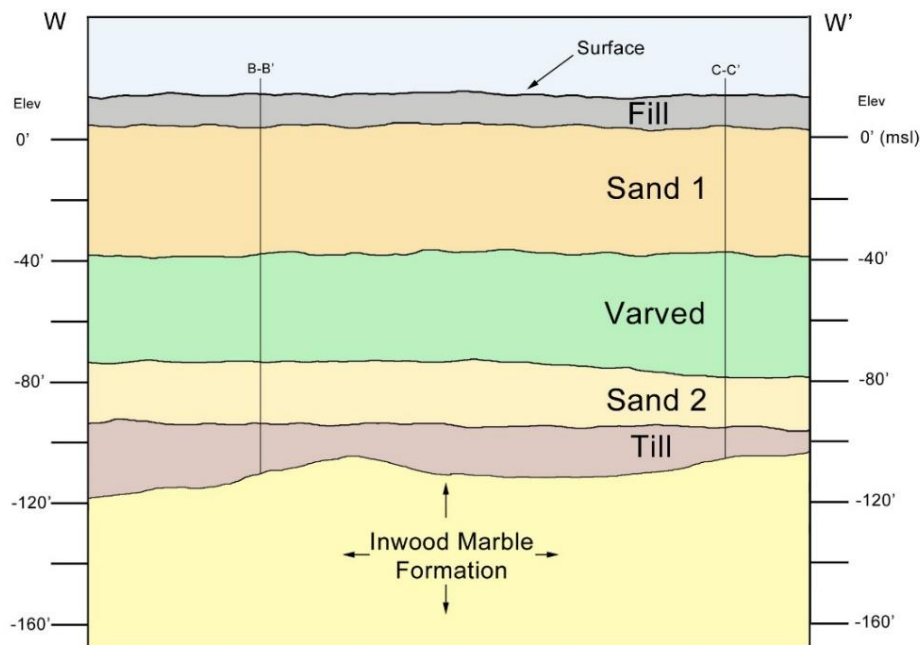
The stratigraphy of roughly 100' of overburden from the top down include Holocene fill, Pleistocene sand units, intervening varved strata and basal till below (Figure 19). Penetration into the Inwood Marble bedrock were met with persistent excessive water and material outflows that in a few cases led to uncontrollable 40'-high geysering consisting of groundwater and sediment at the drill site. (See Figure 18.)

Figure 19 – Across site roughly W-E geological profile section drawn from data supplied in the geotechnical report showing overburden strata and the buried Inwood Marble bedrock layer. This view of the site was the anticipation and design criteria for the contractor’s approved means and methods. (Drawn without vertical exaggeration.)
