# **Rhyodacite Dikes of the Queens Tunnel Complex, NYC Water Tunnel #3**

**Charles Merguerian**

HOFSTRA UNIVERSITY

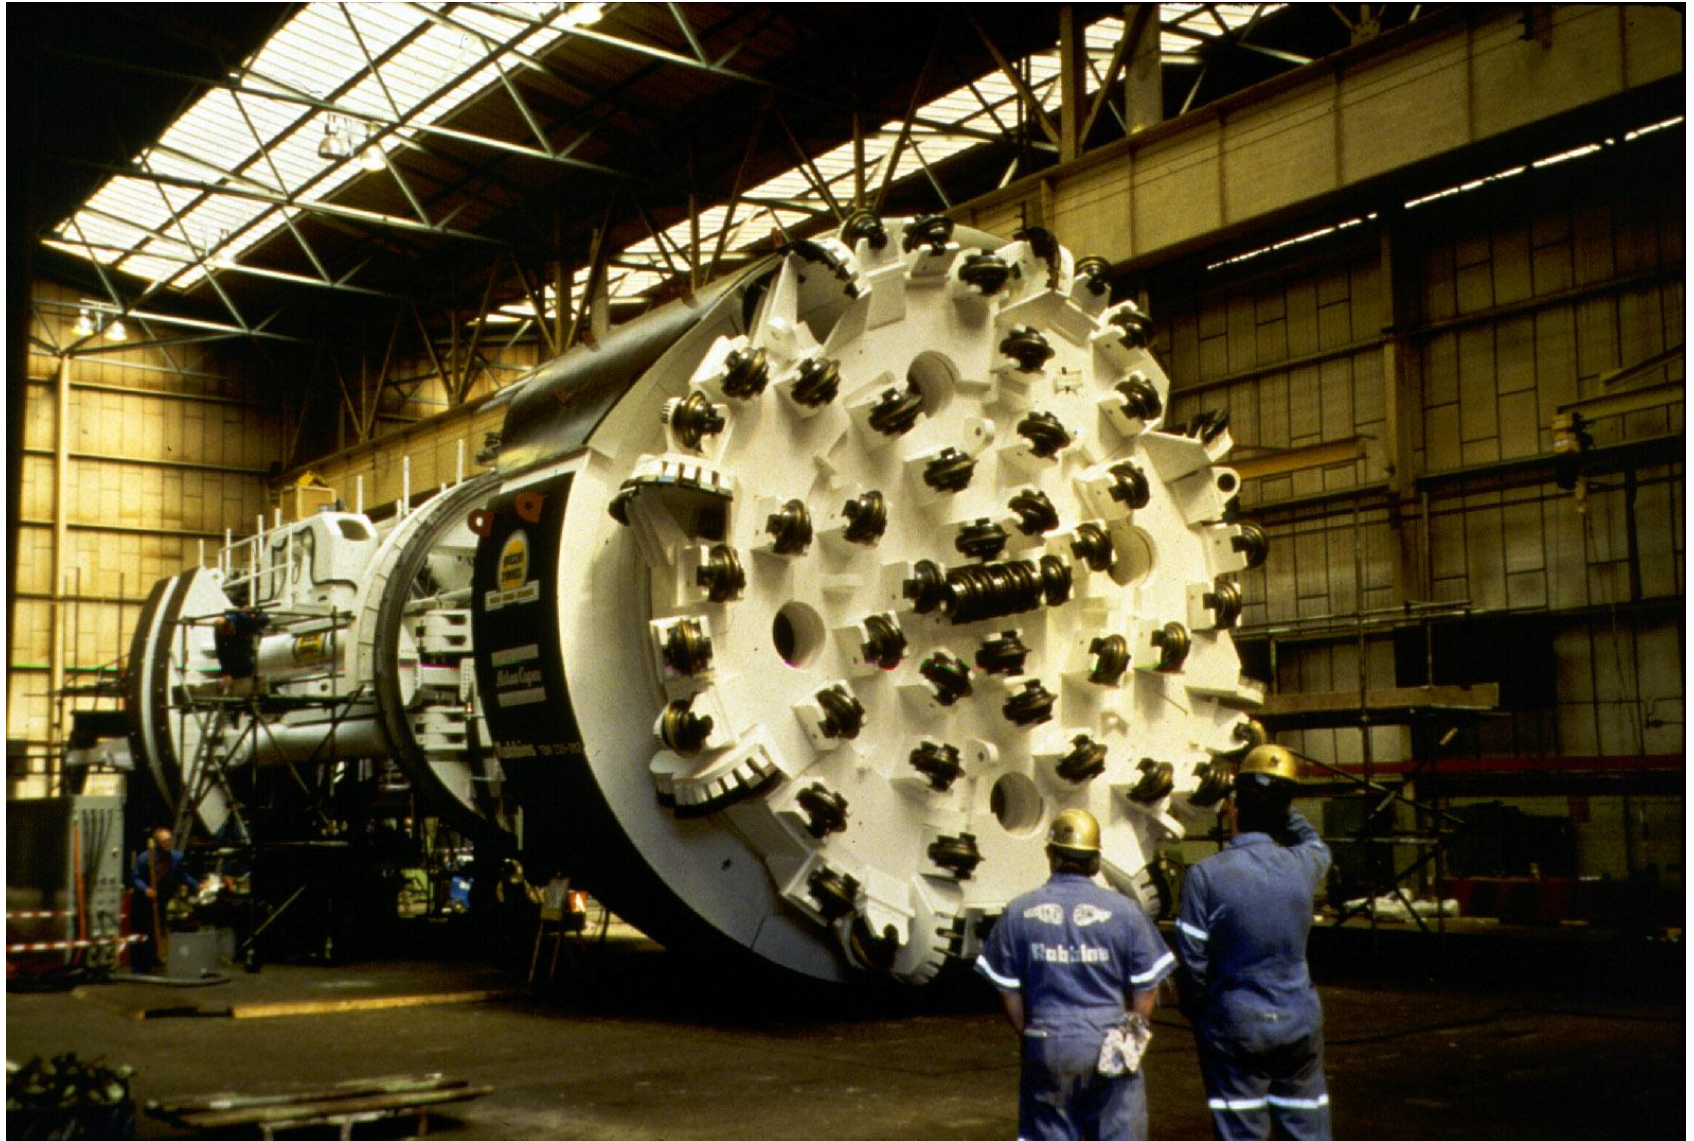
# Robbins 235-282 HP TBM

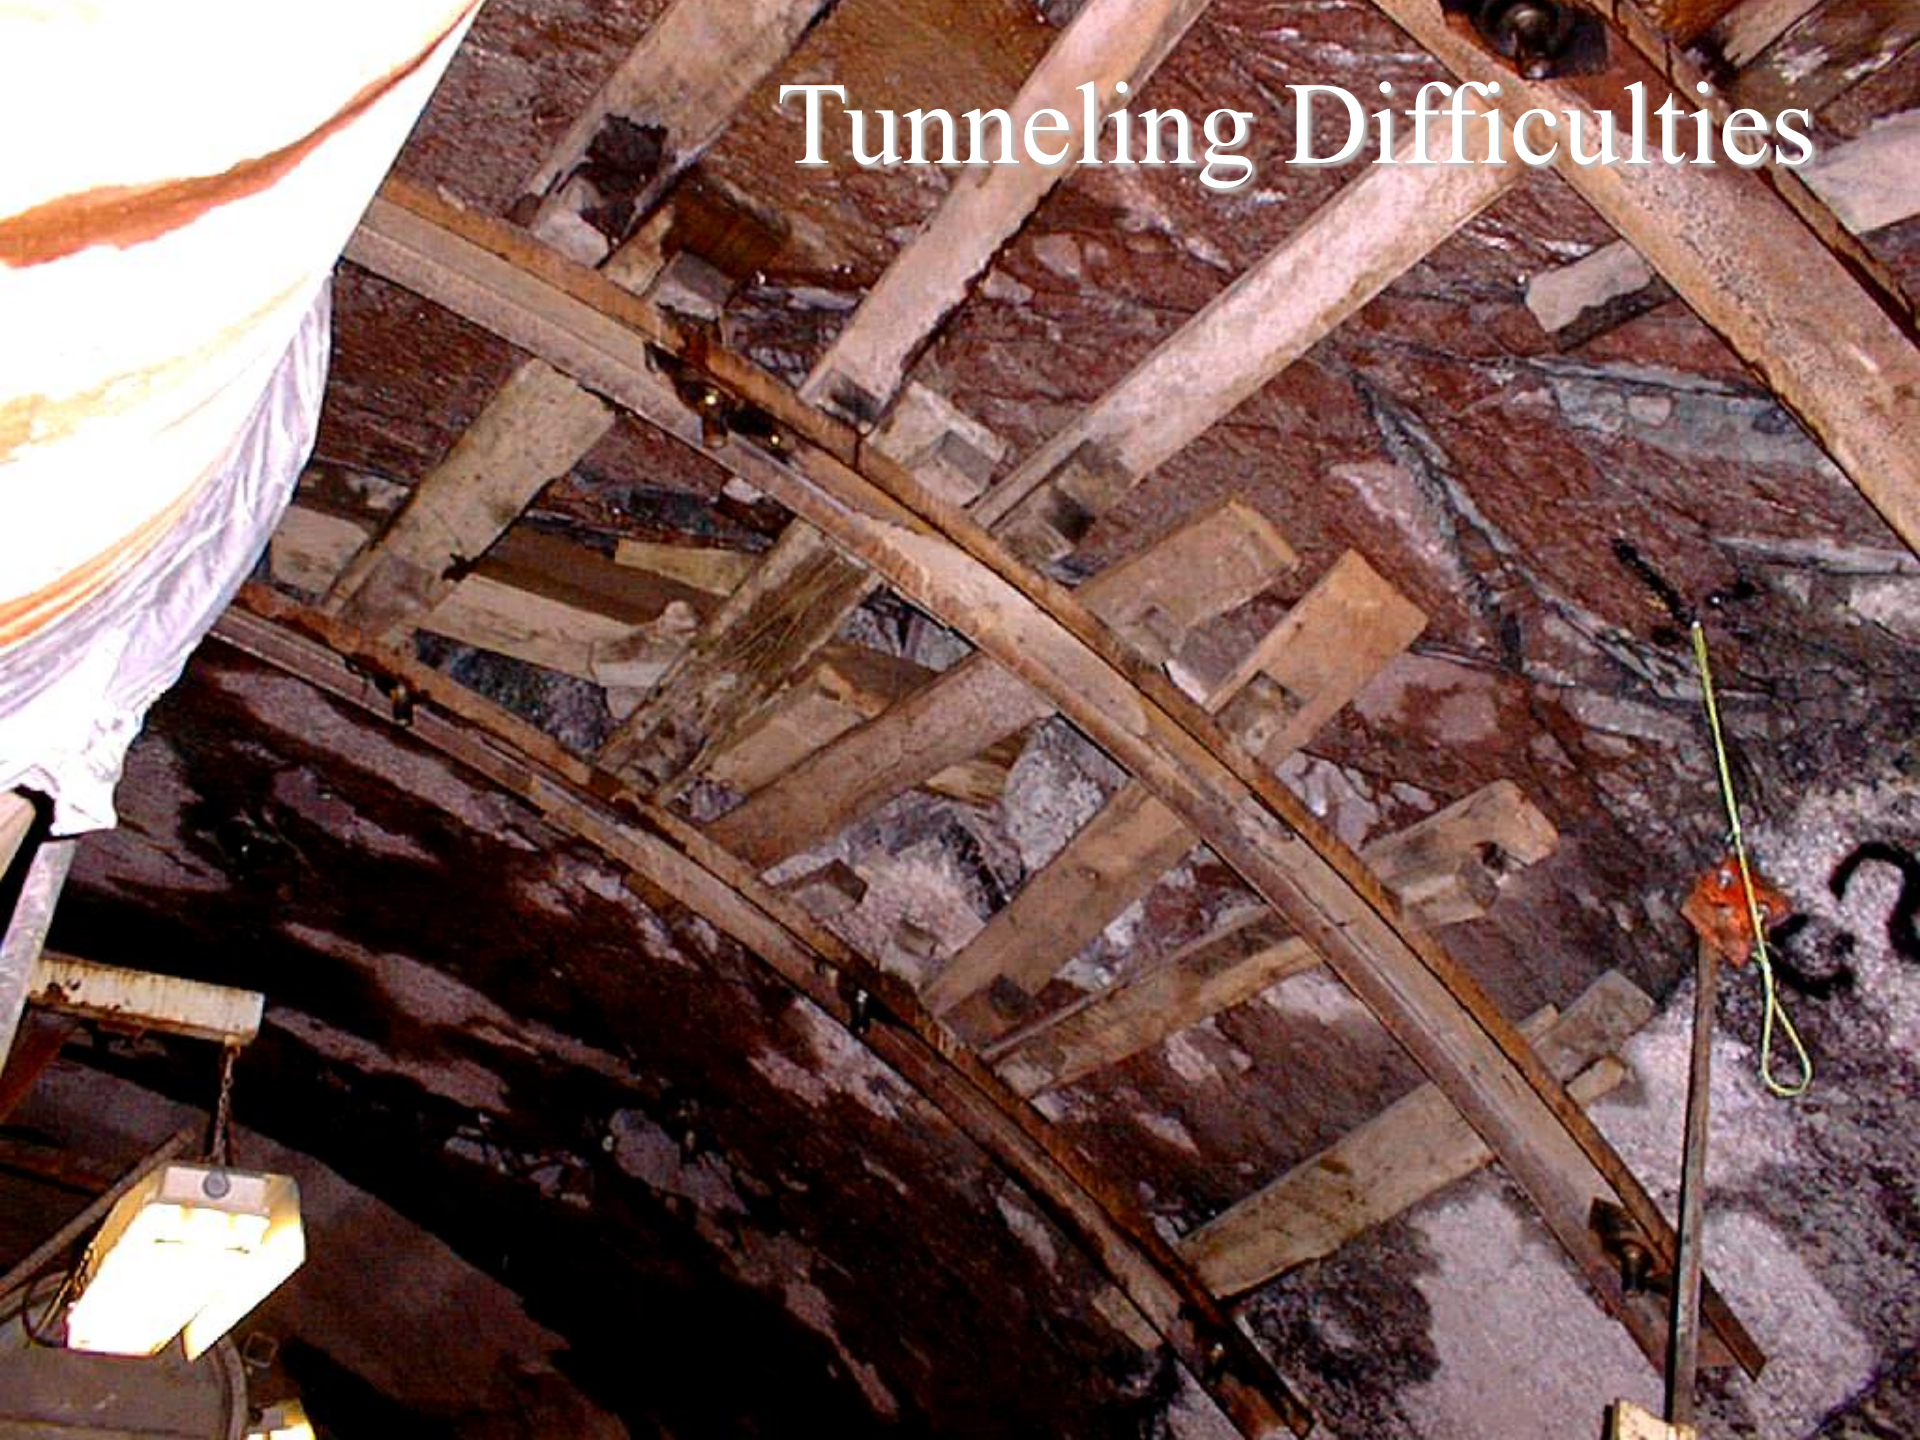
# Tunneling Difficulties

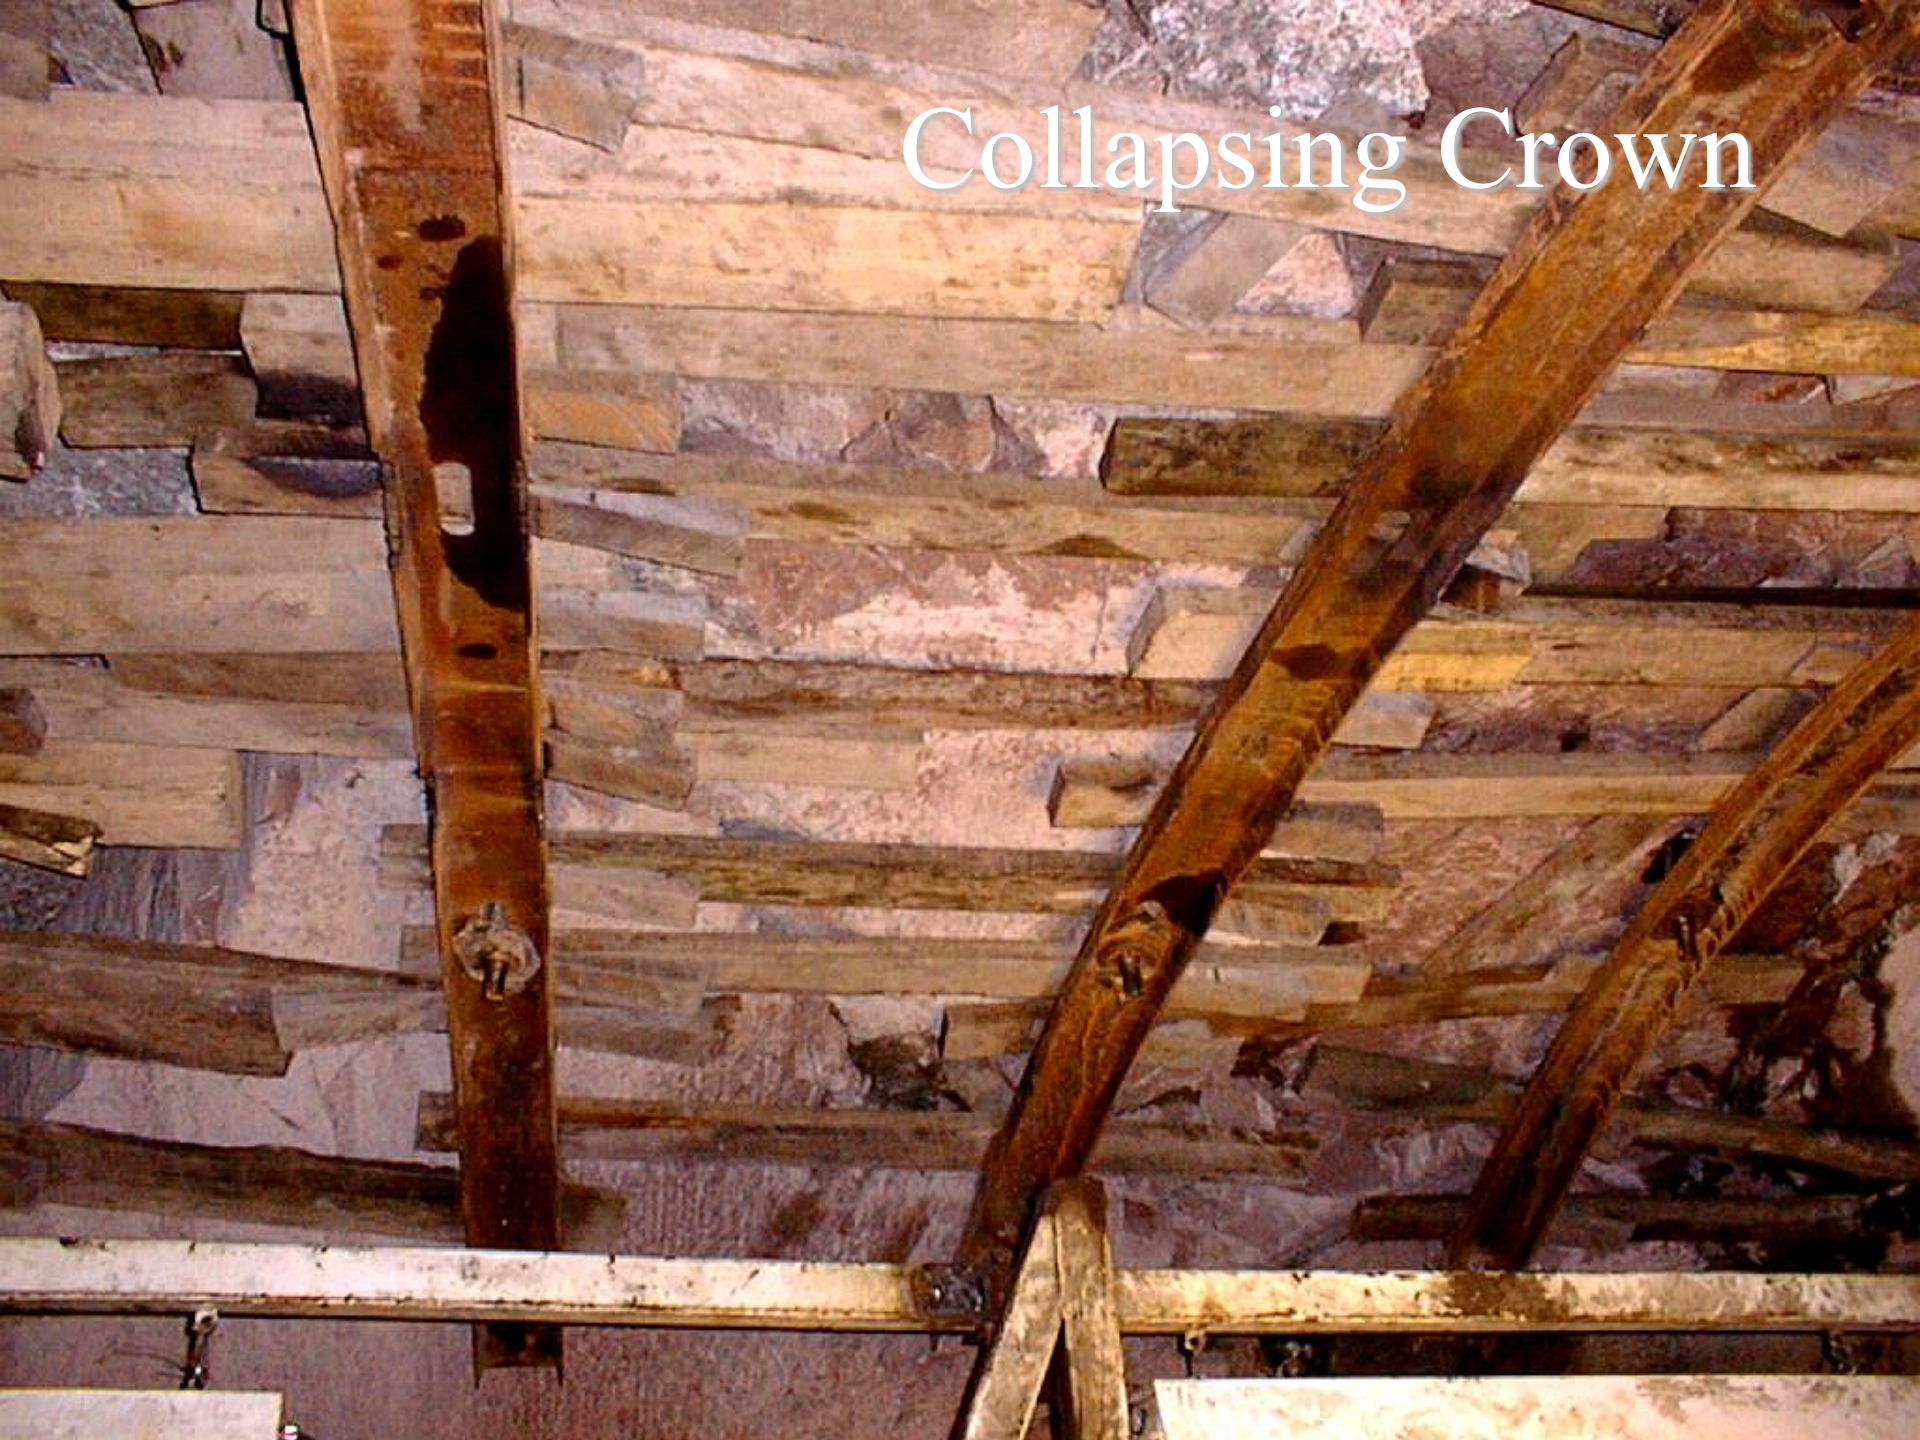
# Collapsing Crown

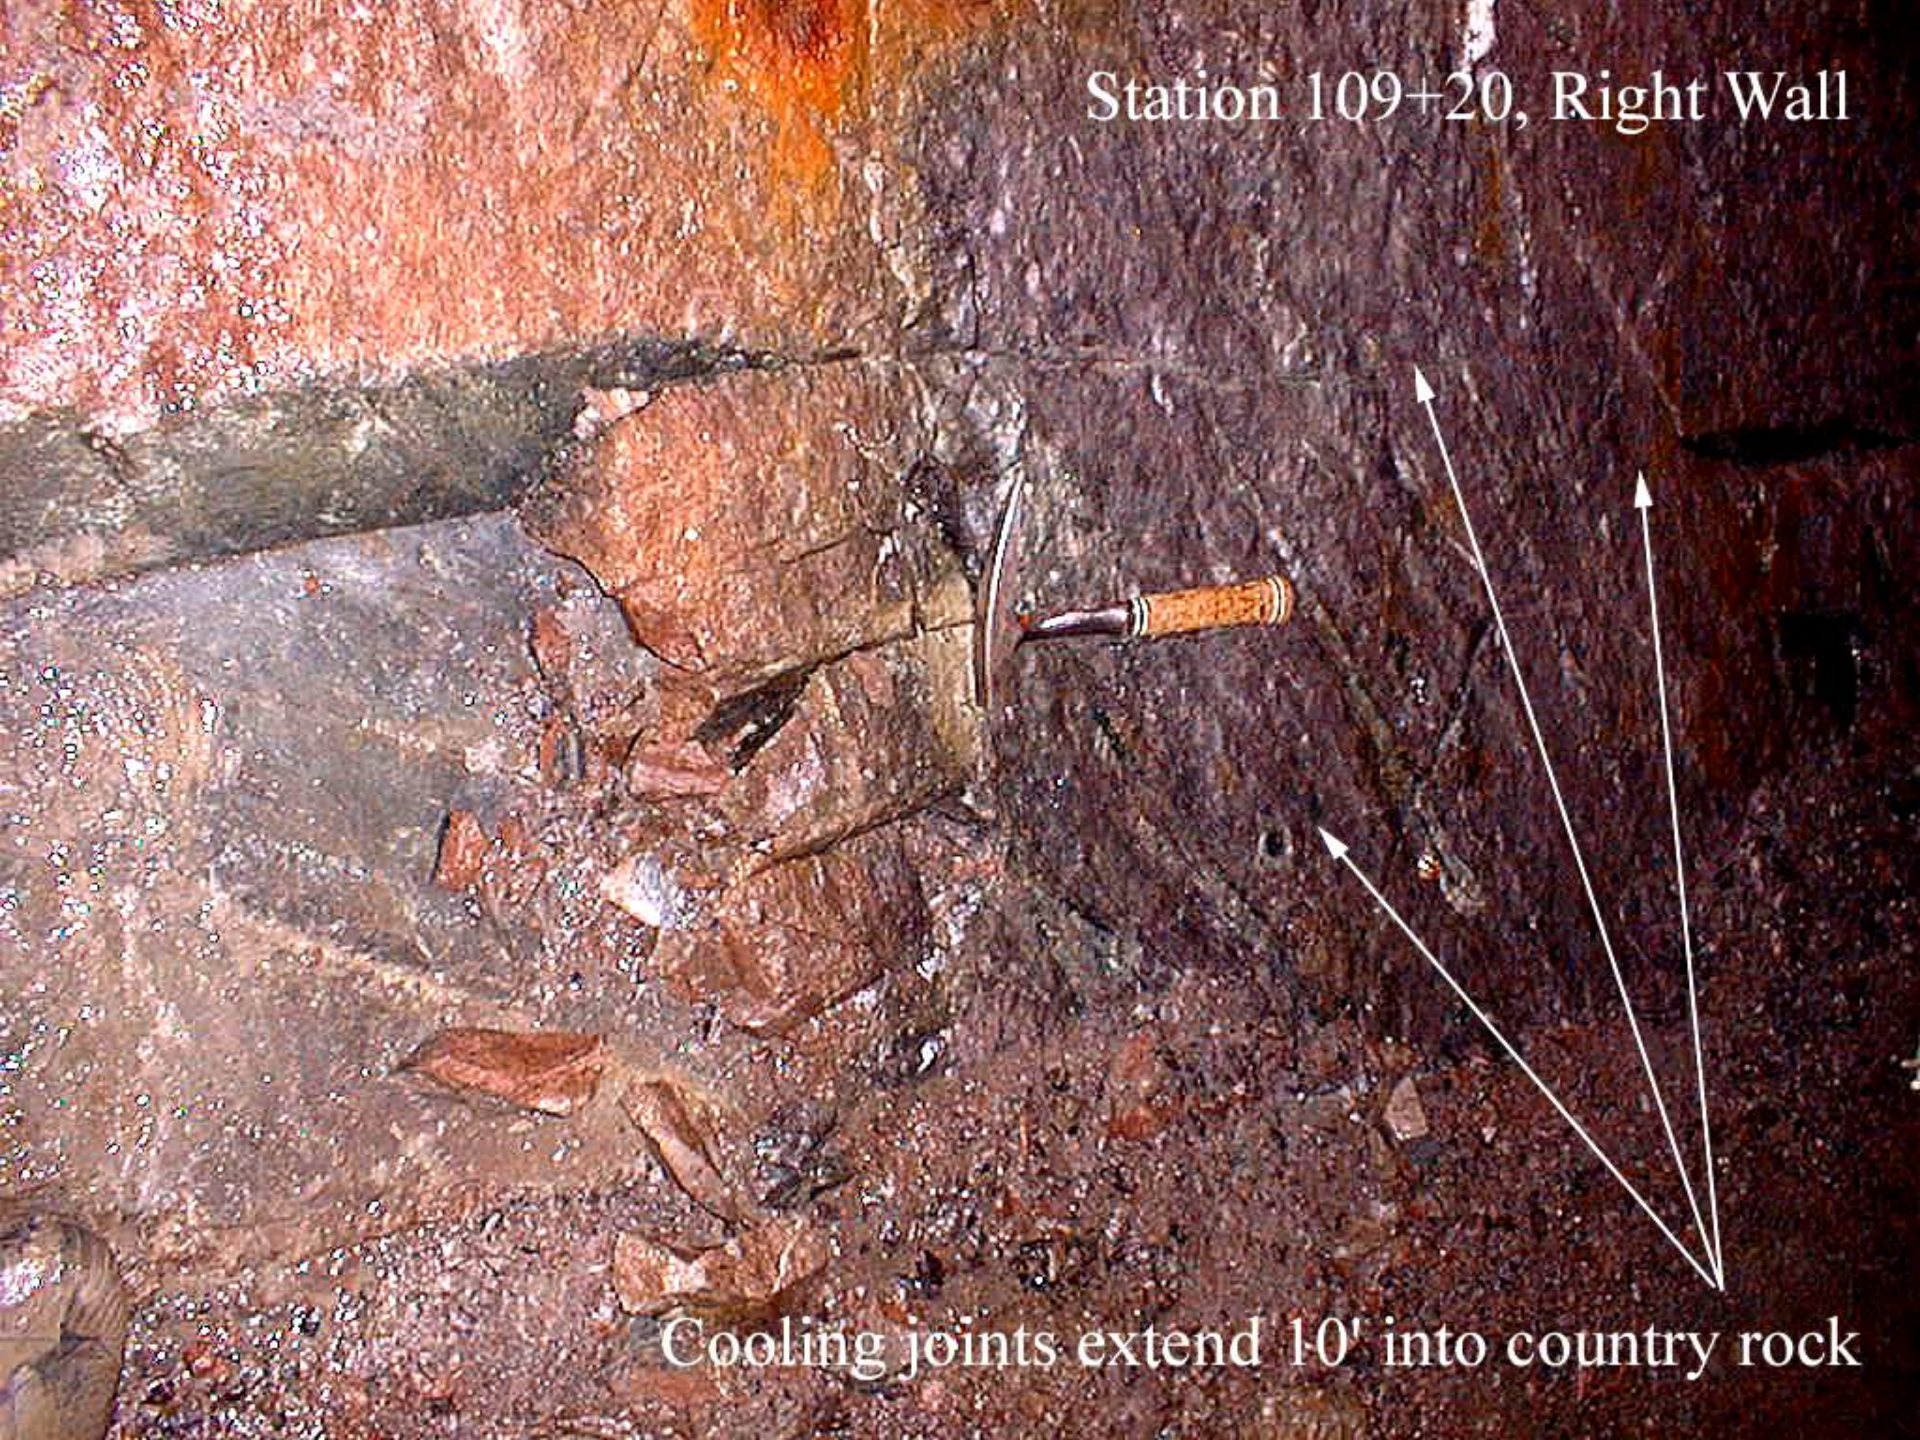
Station 109+20, Right Wall

Cooling joints extend 10' into country rock

| Dike | Stations | Orientation | Exposed | | Brief Comments |
|---|---|---|---|---|---|
| 1 | 109+20 - 109+52 | N65°W, 57°NE | 32' | 12' | cuts N58°E, 83°NW normal fault |

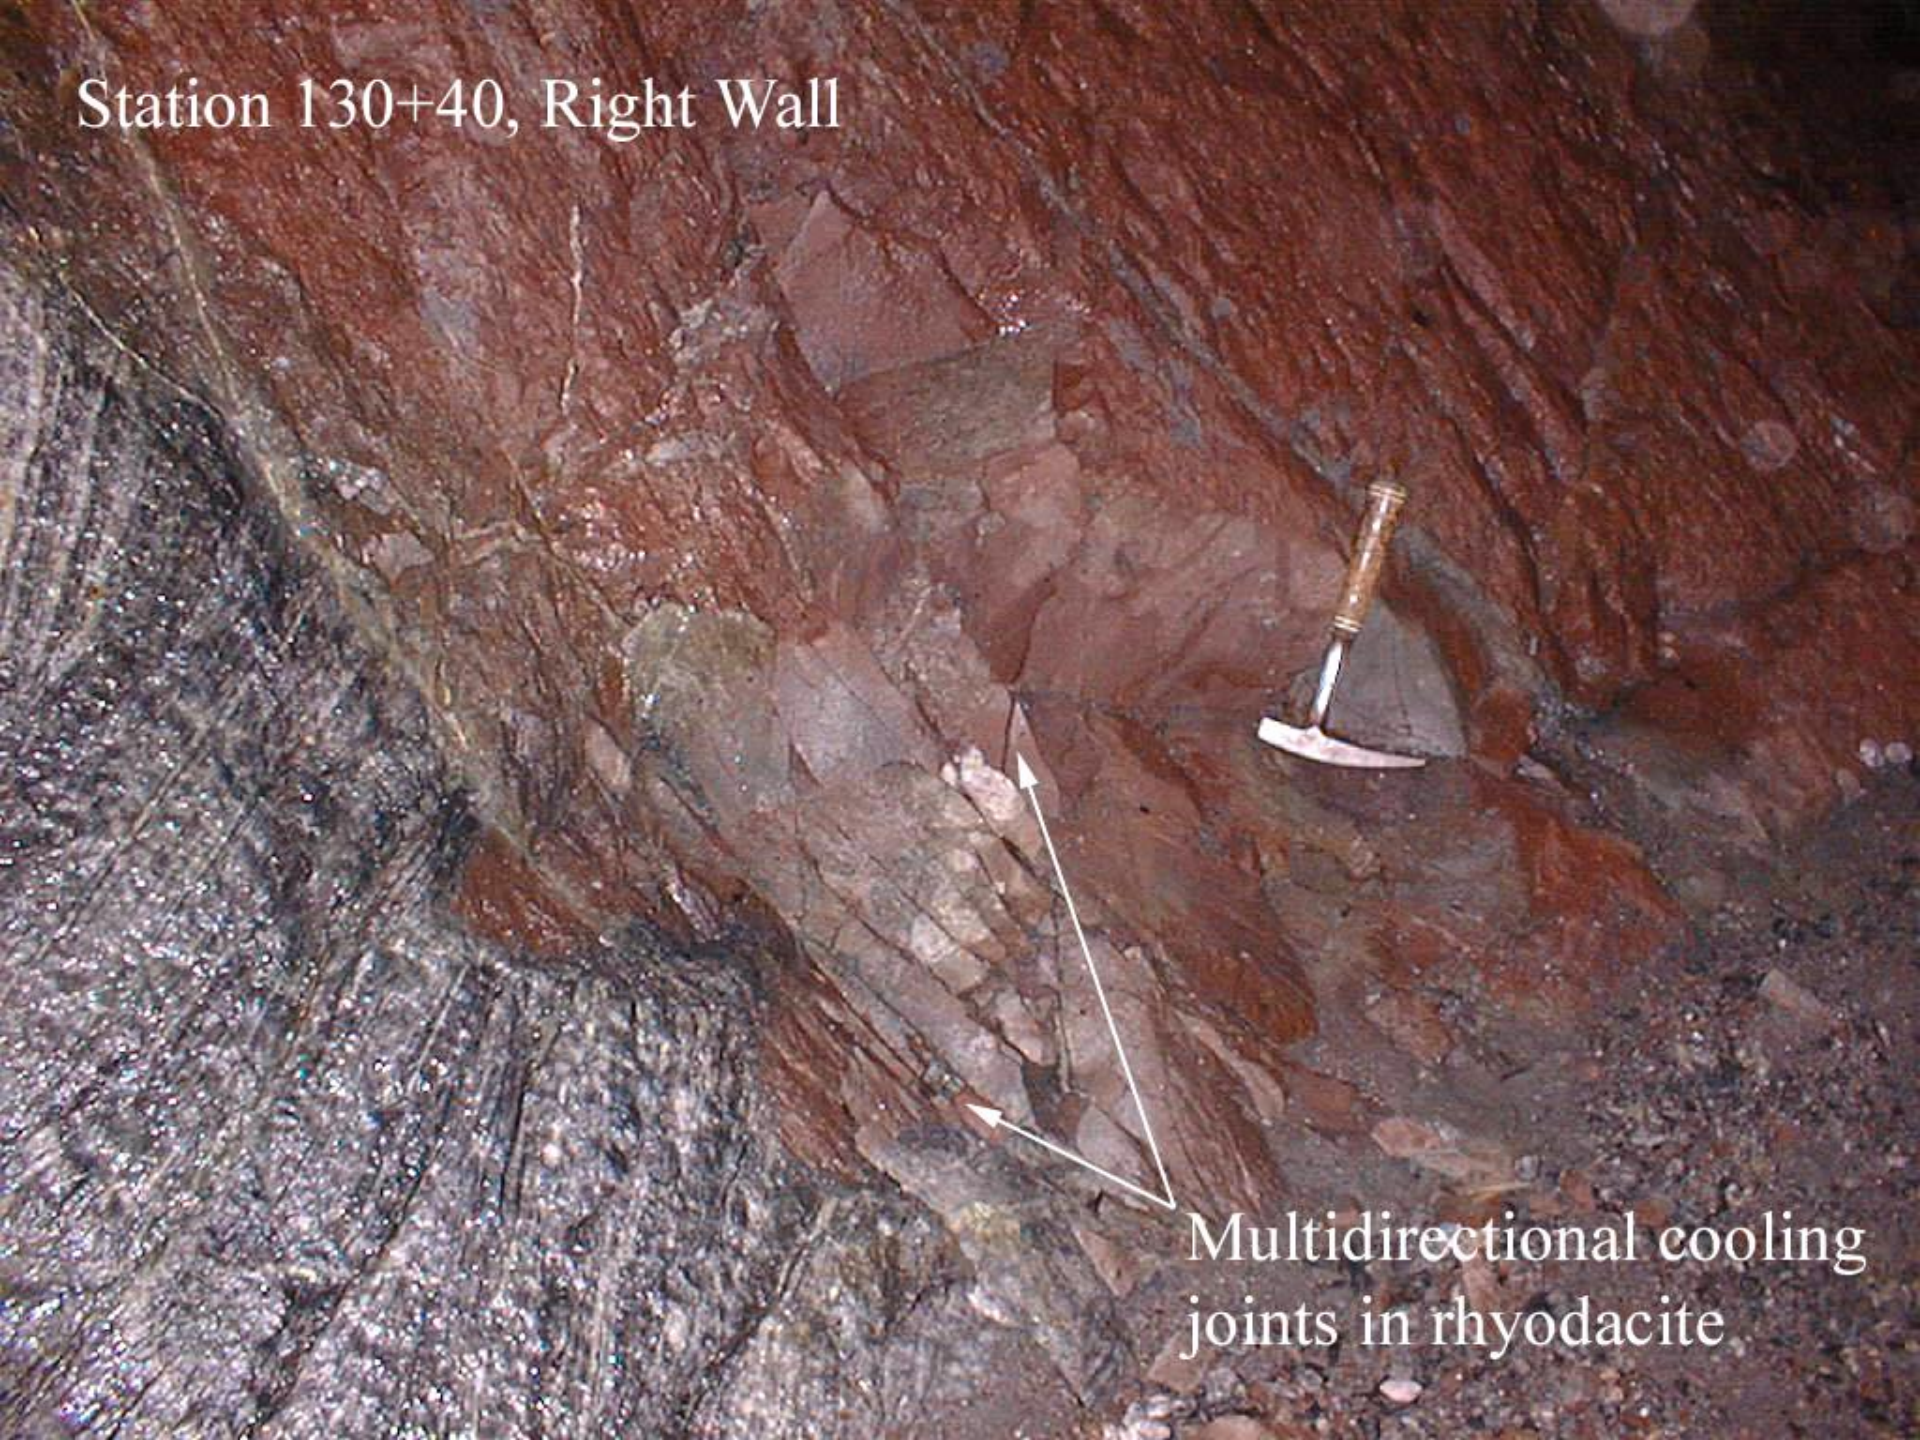
Station 130+40, Right Wall

Multidirectional cooling joints in rhyodacite

The photograph shows a close-up of a rock face with a reddish-brown, layered appearance. A geological hammer is placed on the right side for scale. Two white arrows point to specific features on the rock face, which are identified as multidirectional cooling joints in rhyodacite. The rock surface is rough and shows signs of weathering and fracturing.

| Dike | Stations | Orientation | Exposed | | Brief Comments |
|---|---|---|---|---|---|
| | 129+53 - 130+41 | N48°W, 78°SW | 88' | 11' | cuts N20°E, 10°NW thrusts and older F <sub>3</sub> fold |
