# Hofstra University IDEAS Lecture

## Deep Science of Subterranean New York City

*Charles Merguerian*  
*Hofstra Geology*  
*02 May 2013*

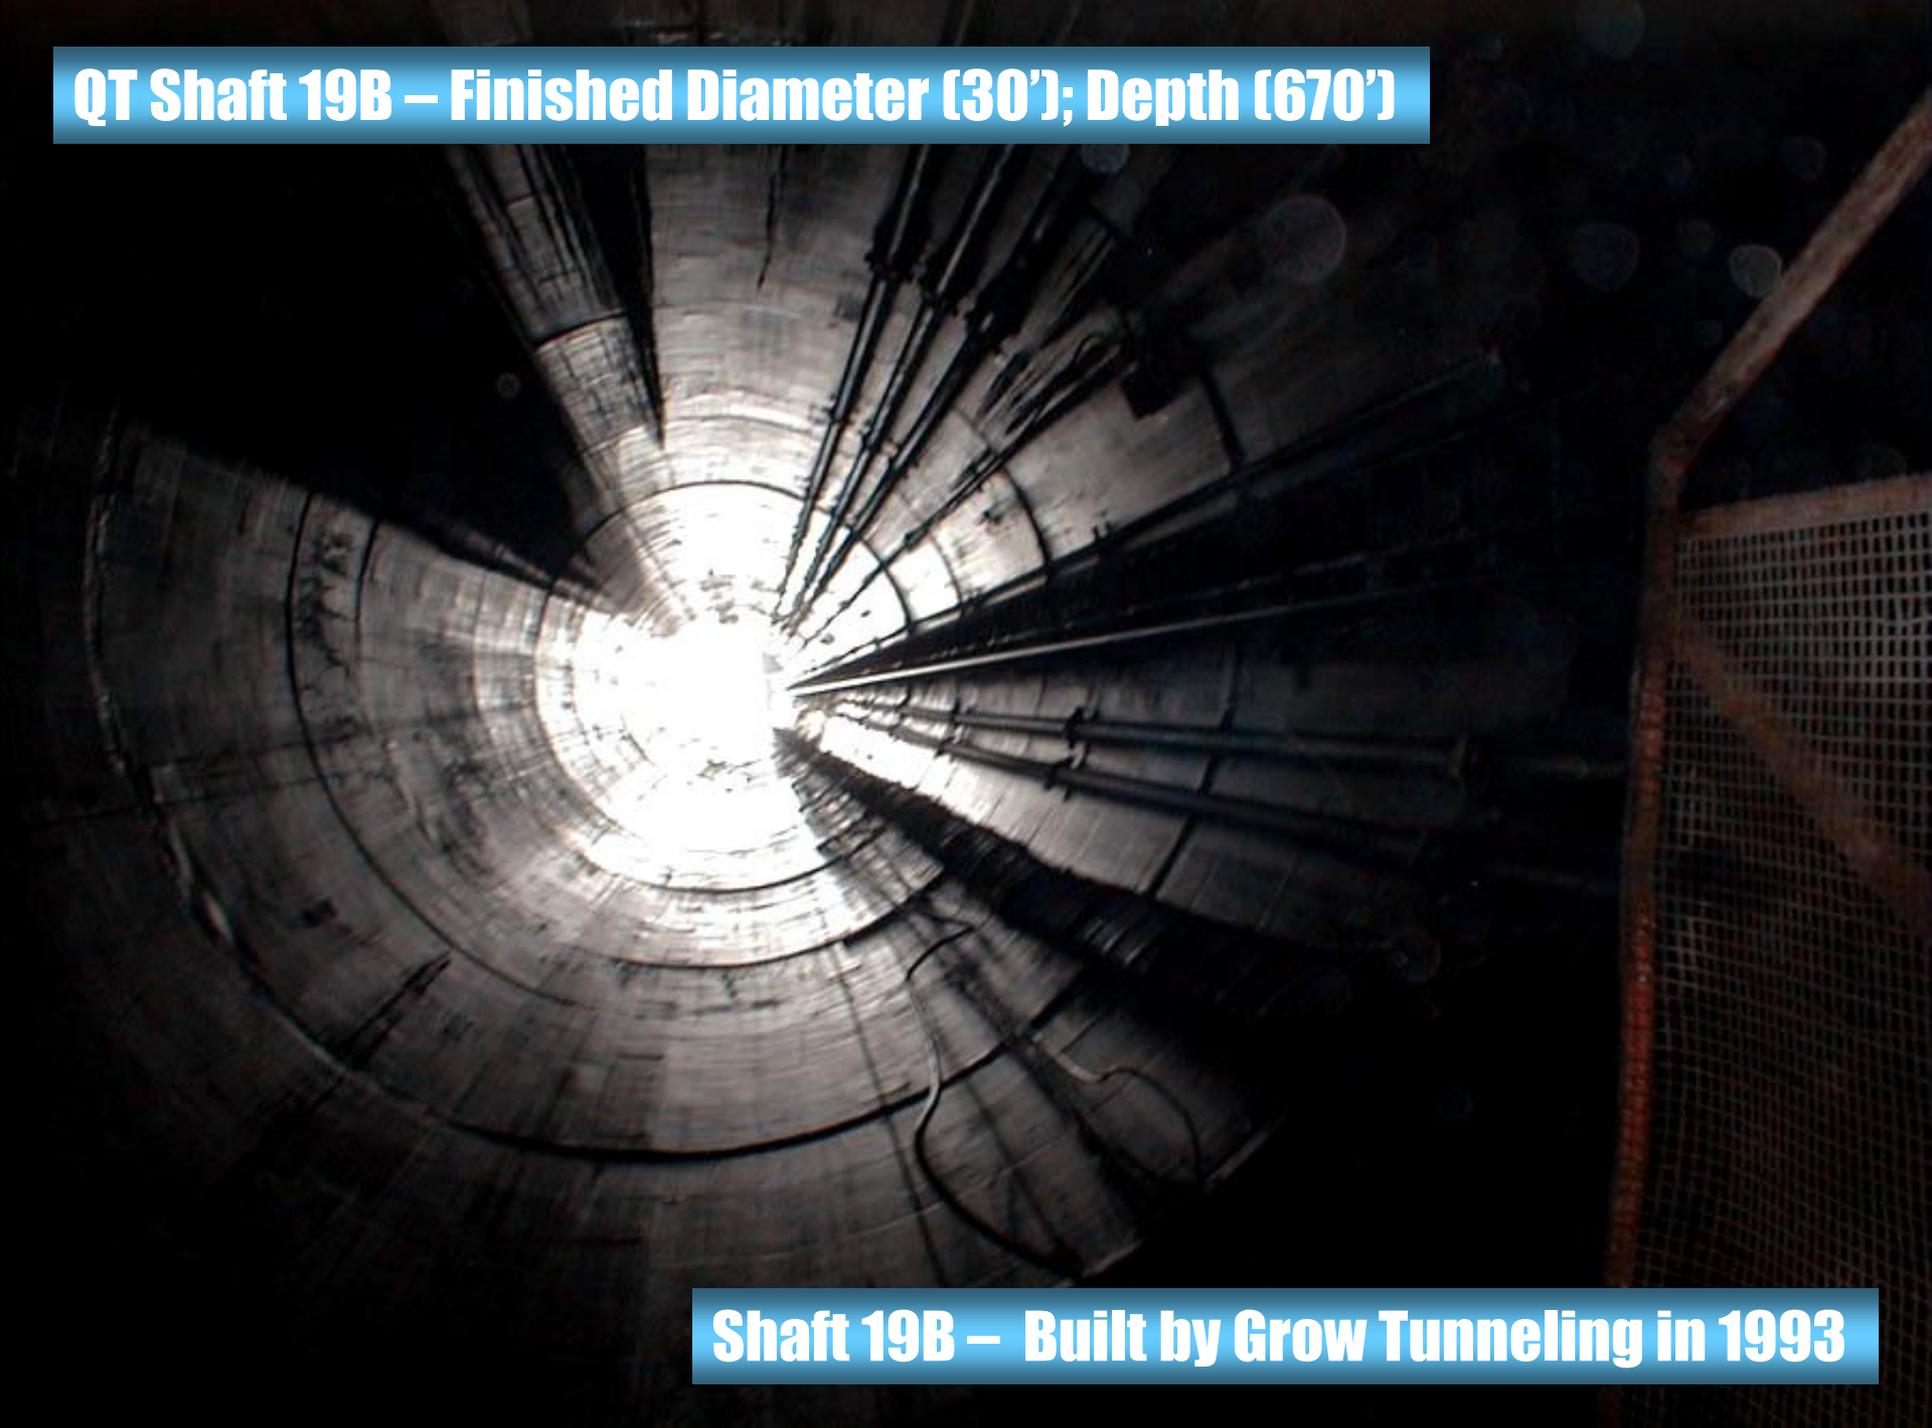
**QT Shaft 19B – Finished Diameter (30’); Depth (670’)**

**Shaft 19B – Built by Grow Tunneling in 1993**

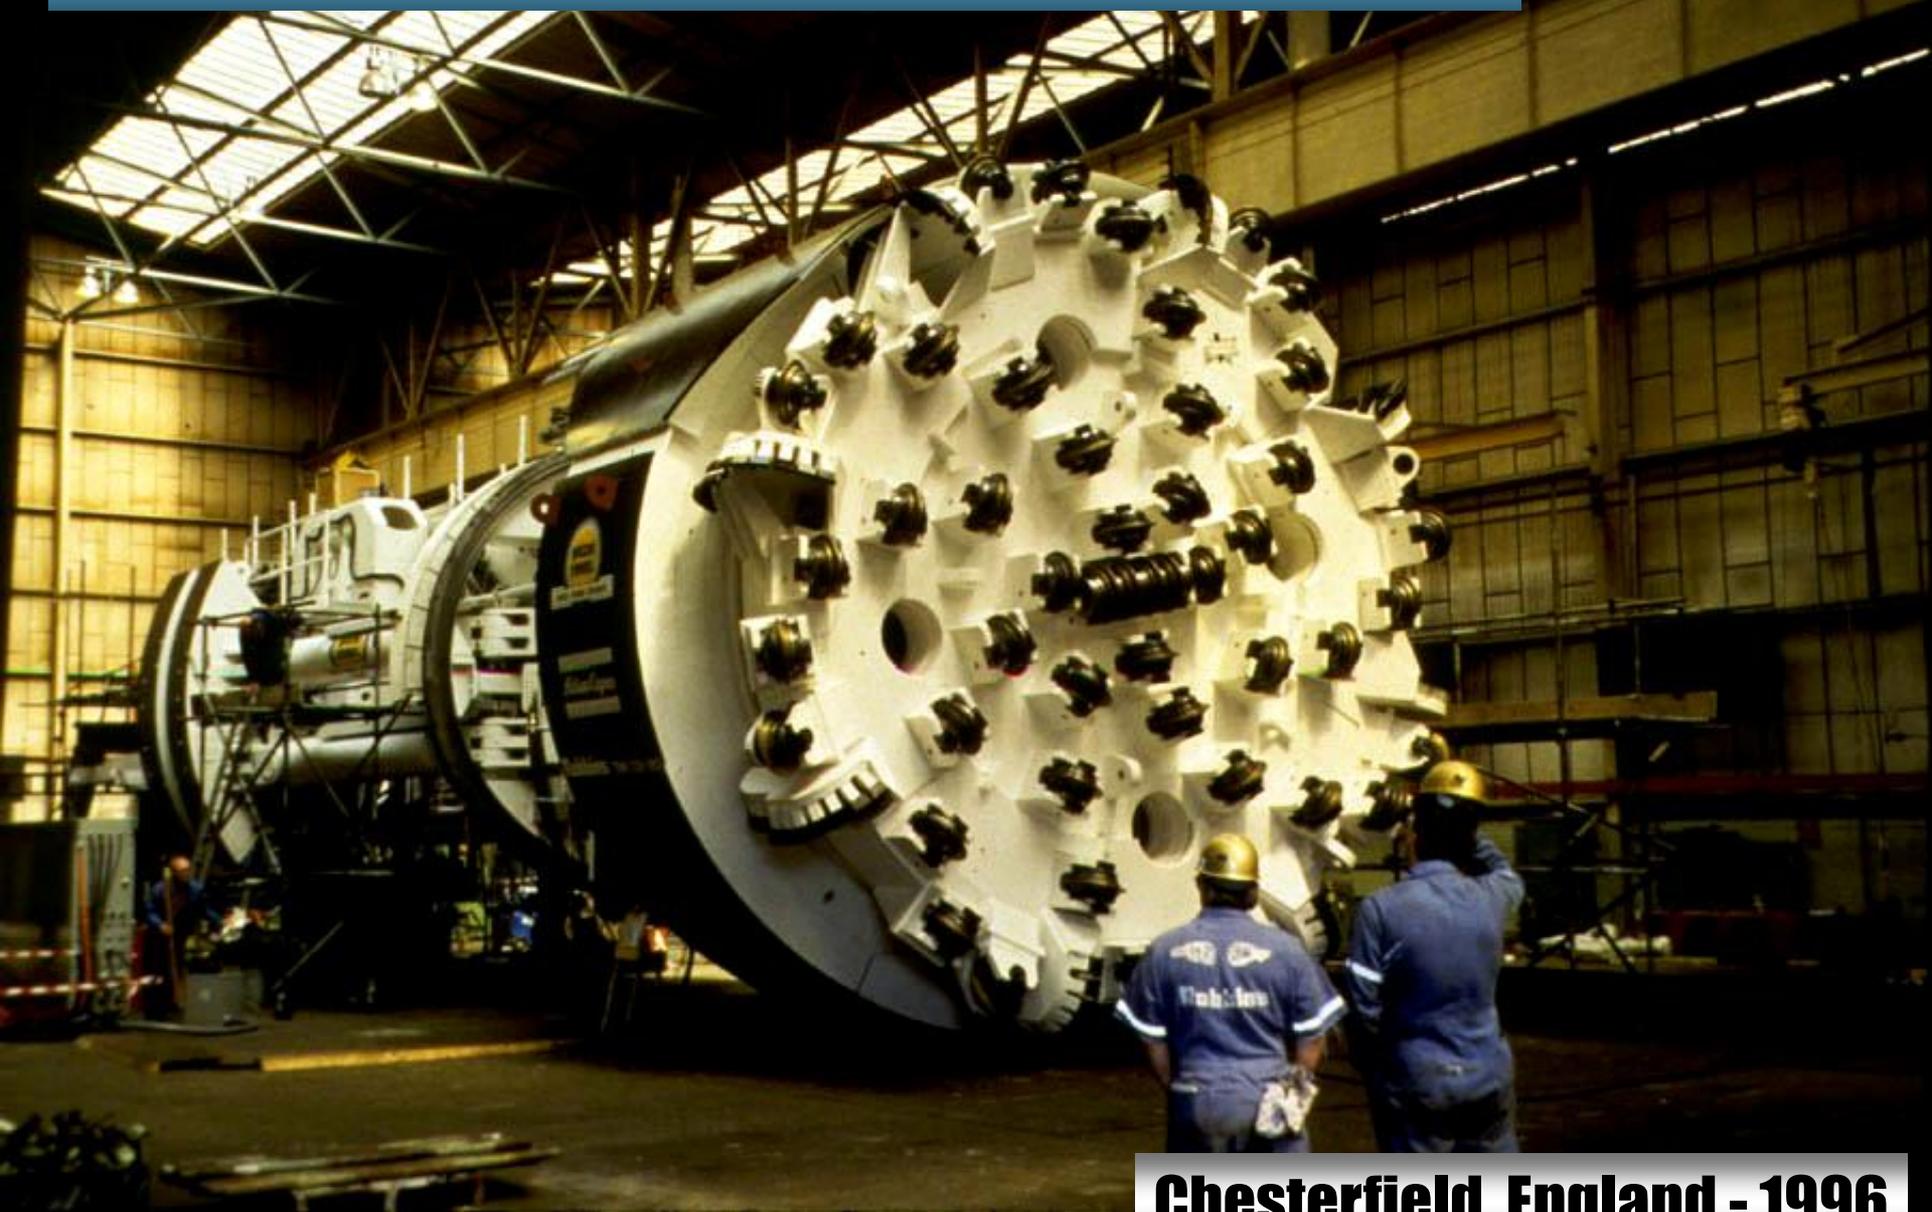
# Robbins 235-282 HP Hard Rock Main Beam TBM

**Chesterfield, England - 1996**

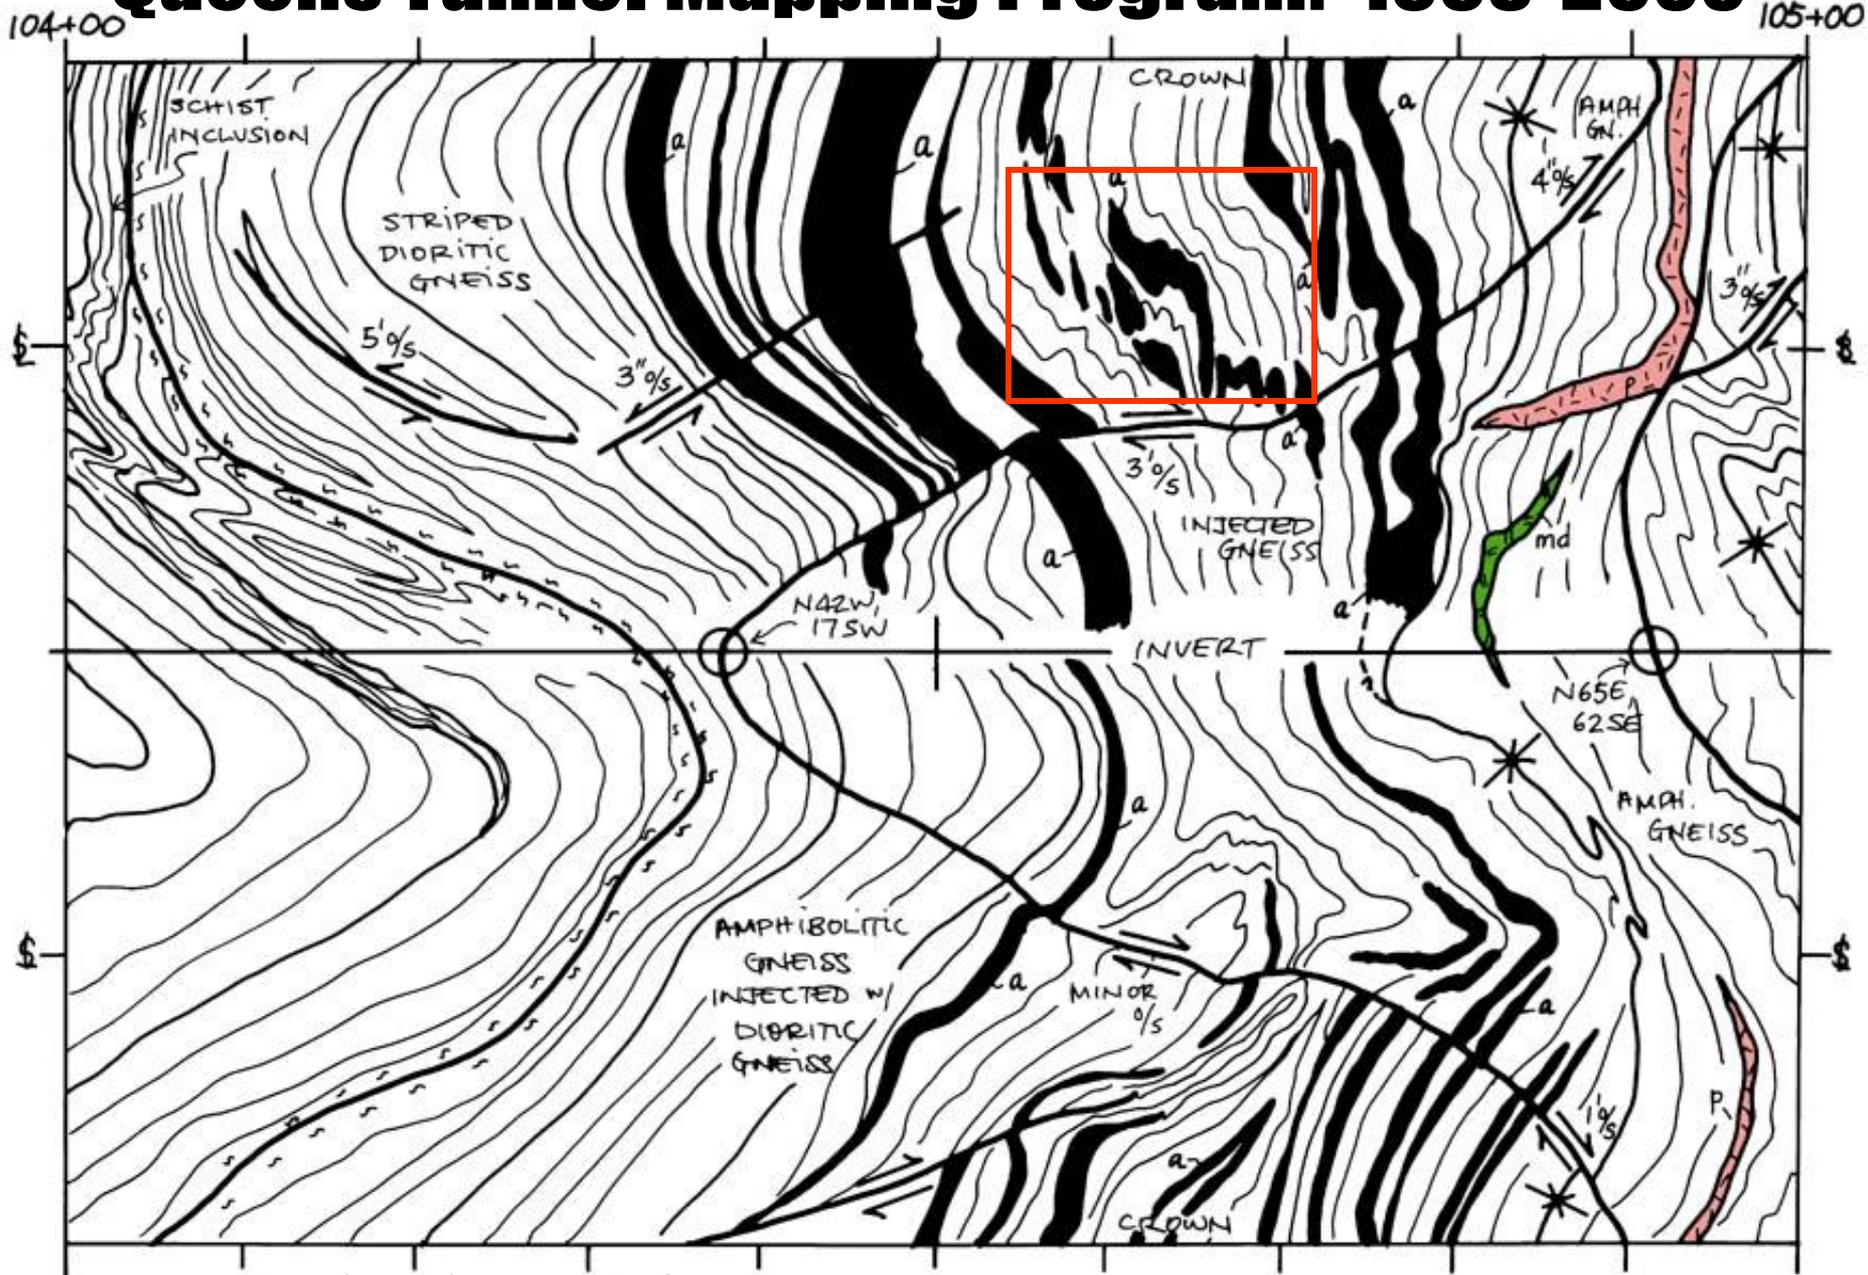
# Queens Tunnel Mapping Program: 1998-2000

- Scale 1 in. = 10 ft

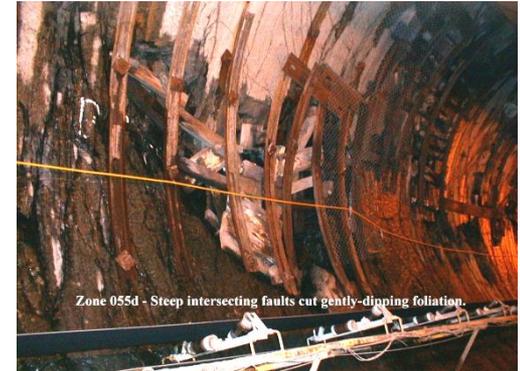
# Orientation of Rock Layering

**NE strike and moderate 57° dip anticipated**

**Highly variable trends found**

- Extended reaches of tunnel exhibited gentle dips**

**Only one boring (QTL-12) exhibited gentle dips at tunnel horizon**

NE Leg		NW Leg	
Gentle Dips		17/93	18%	44/139	32%
Moderate Dips		34/93	37%	28/139	20%
Steep Dips		42/93	45%	67/139	48%

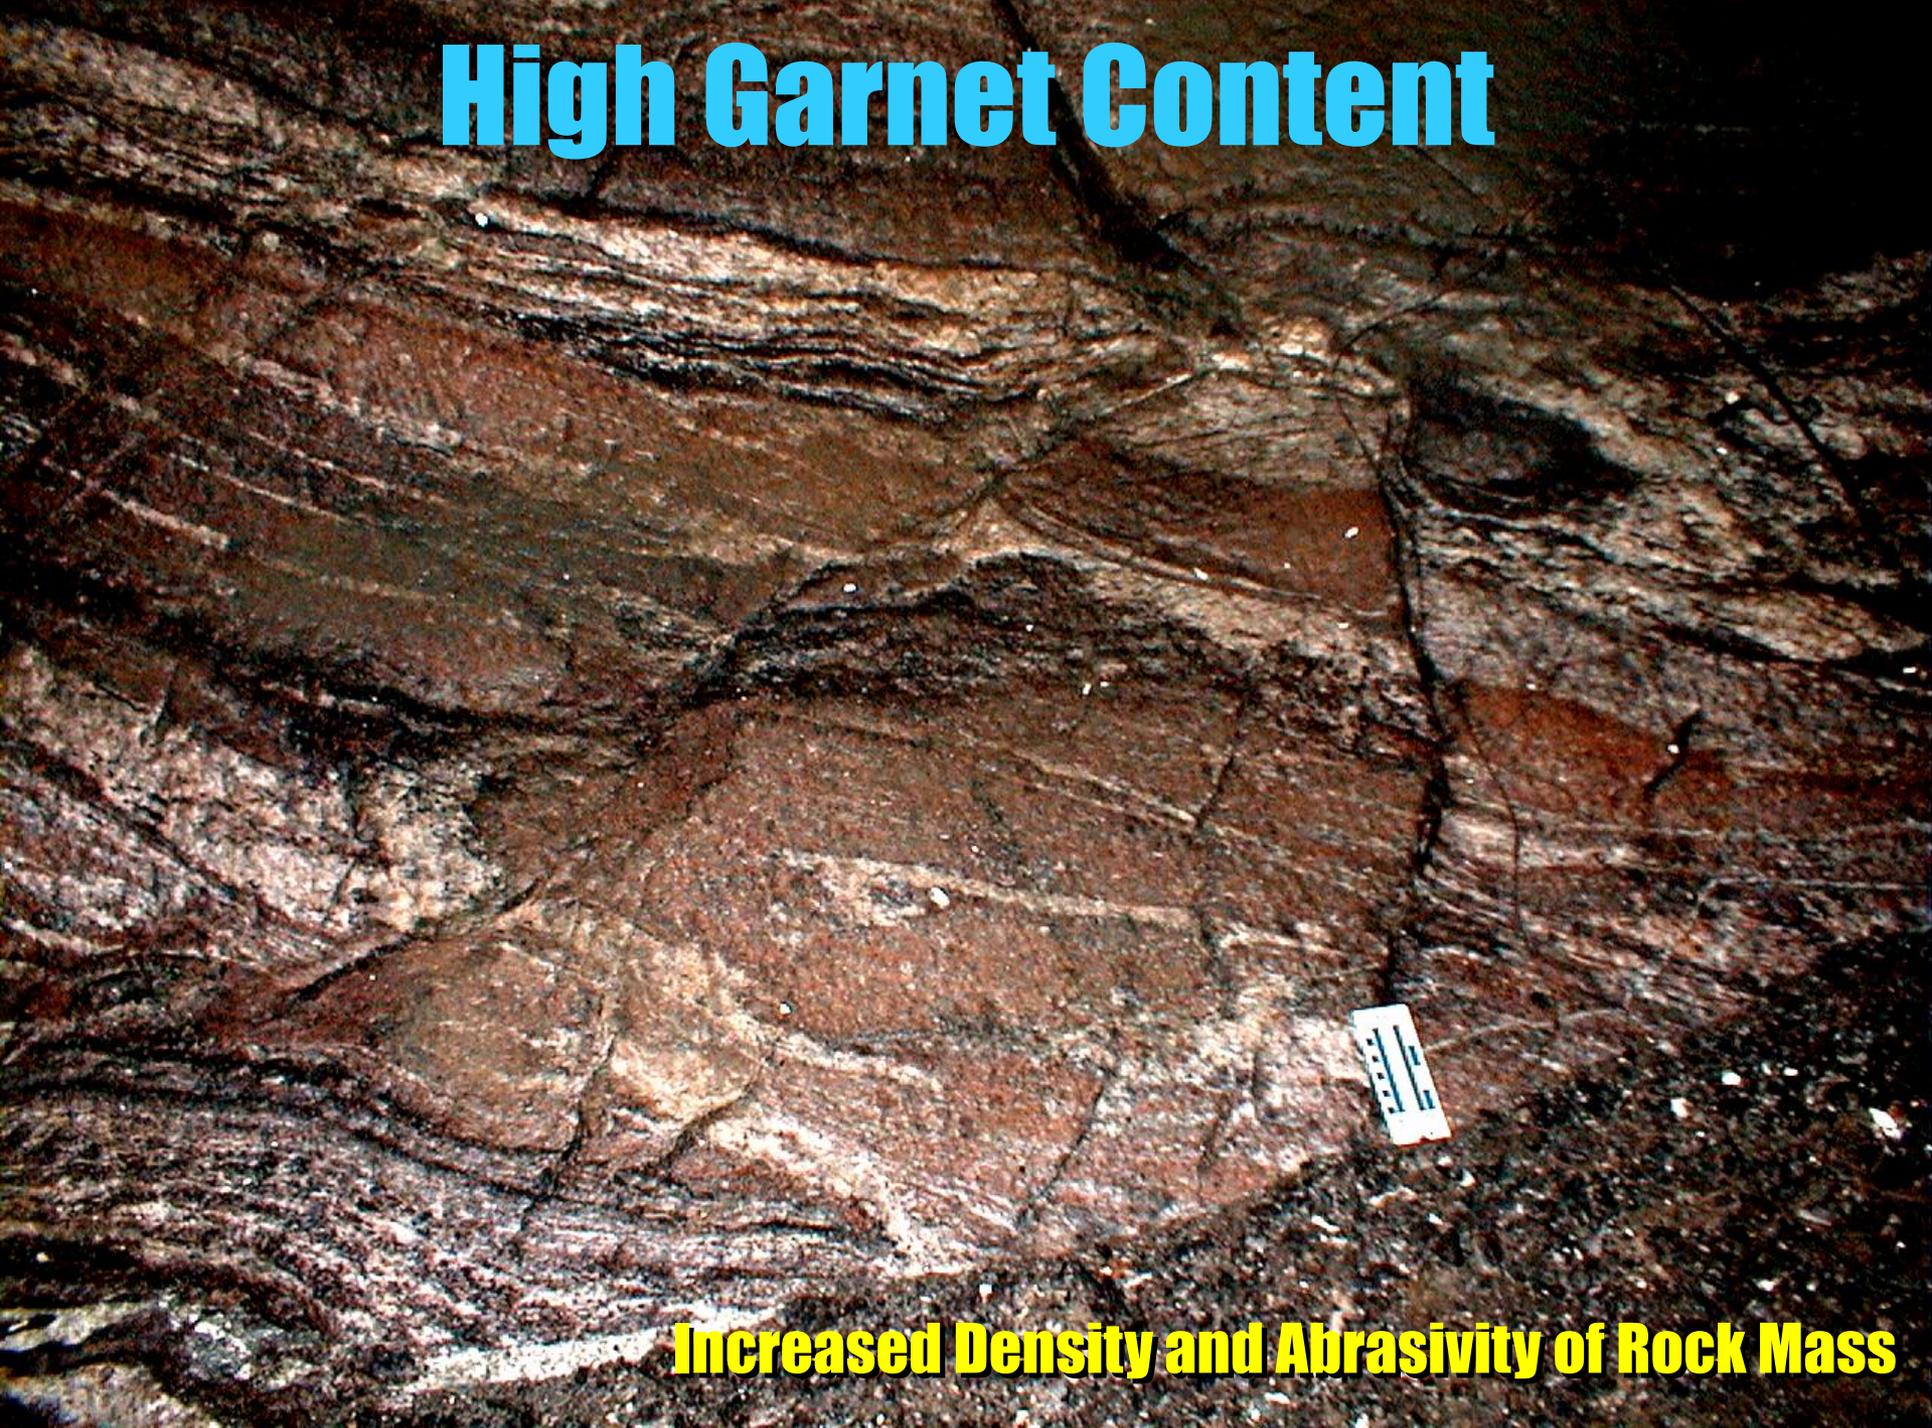
# High Garnet Content

**Increased Density and Abrasivity of Rock Mass**

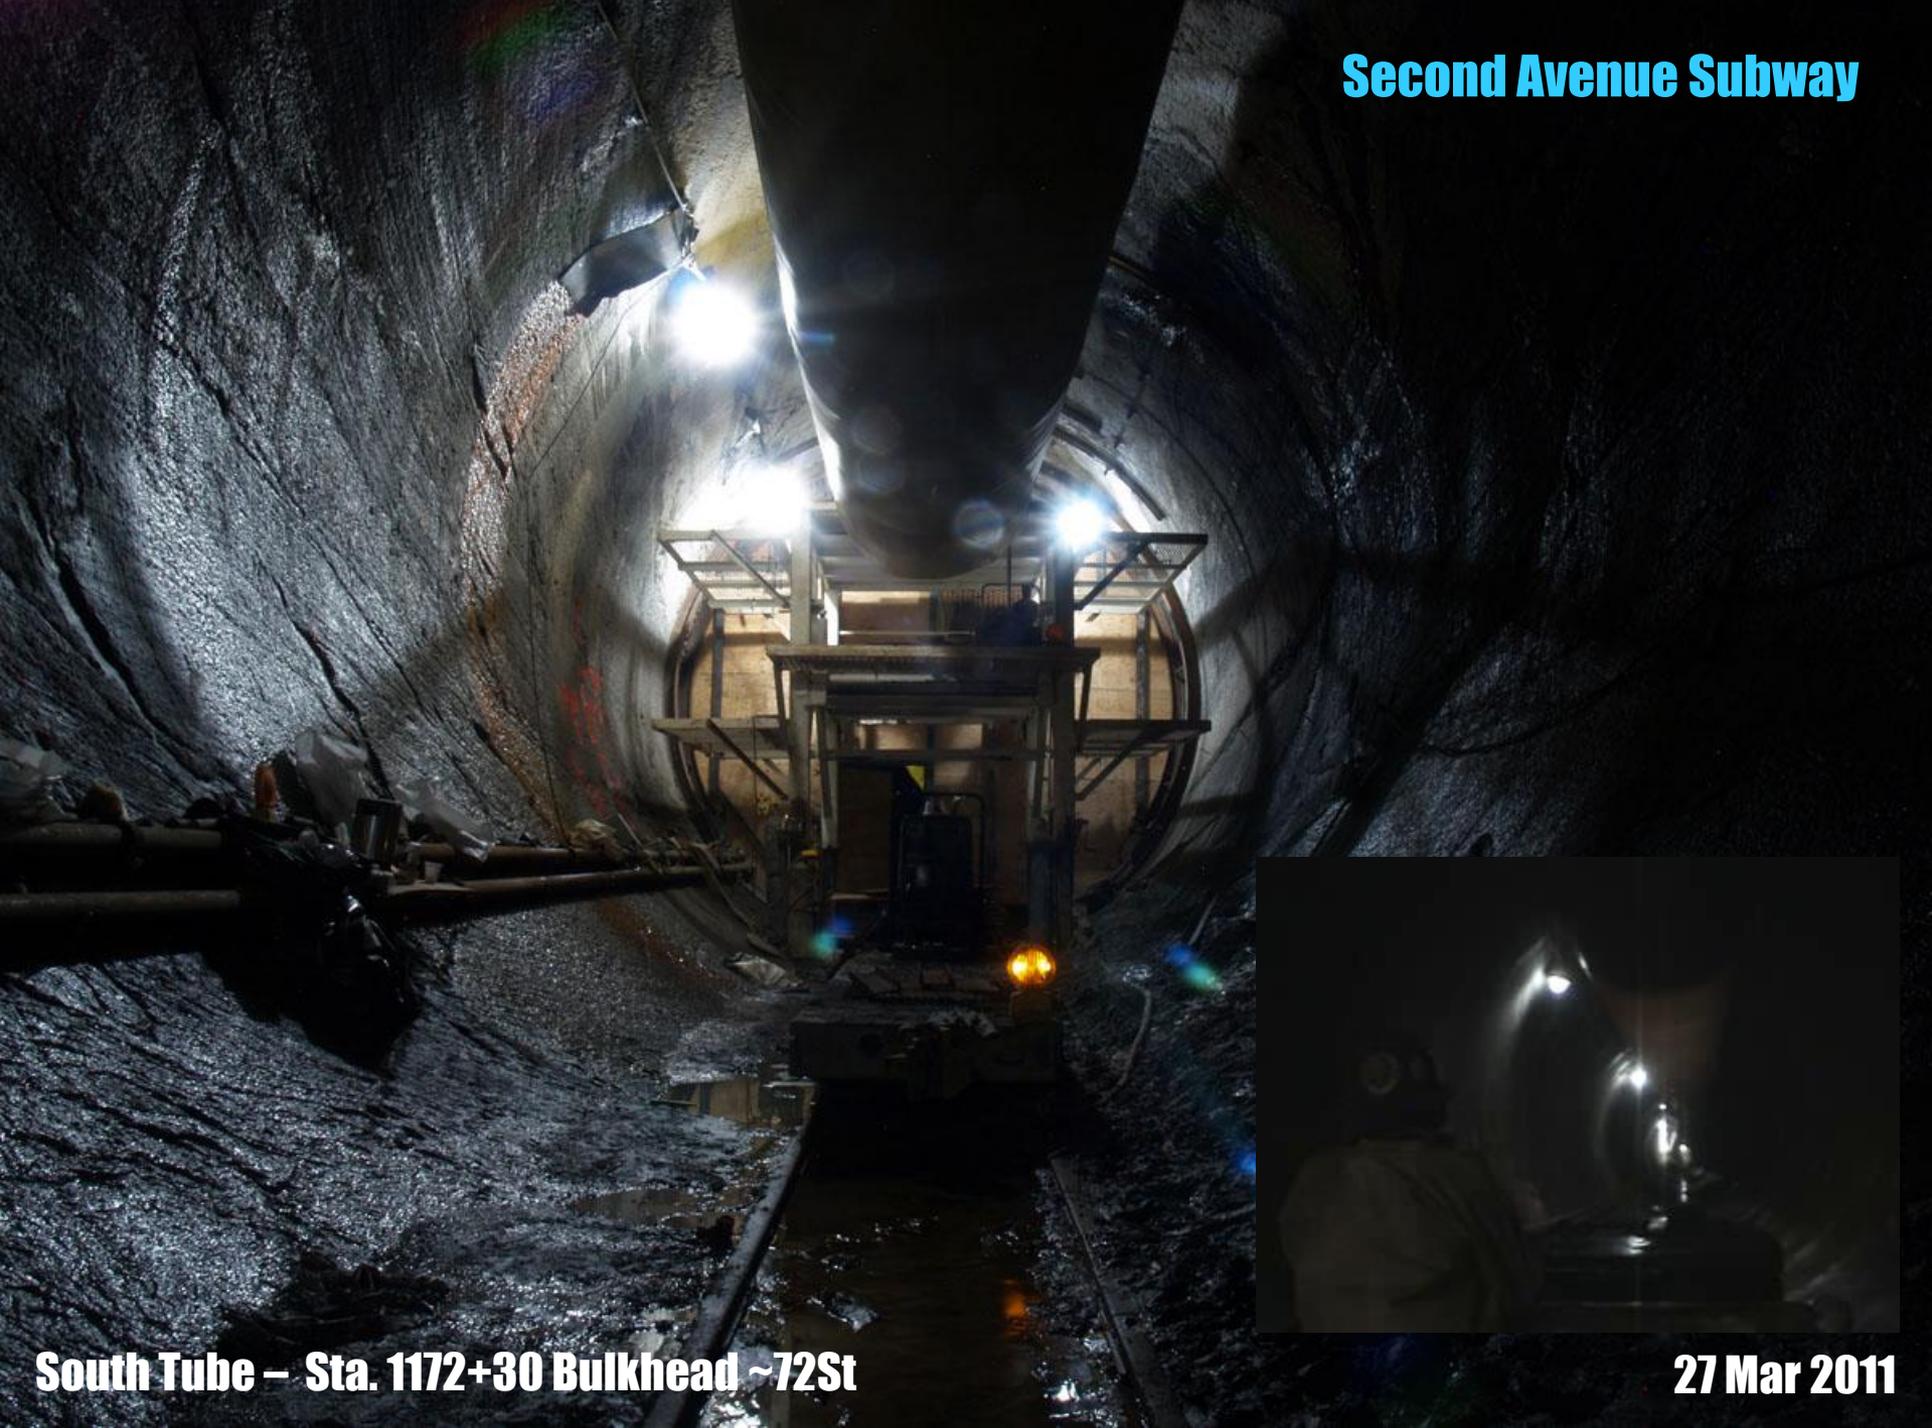
**South Tube – Sta. 1172+30 Bulkhead ~72St**

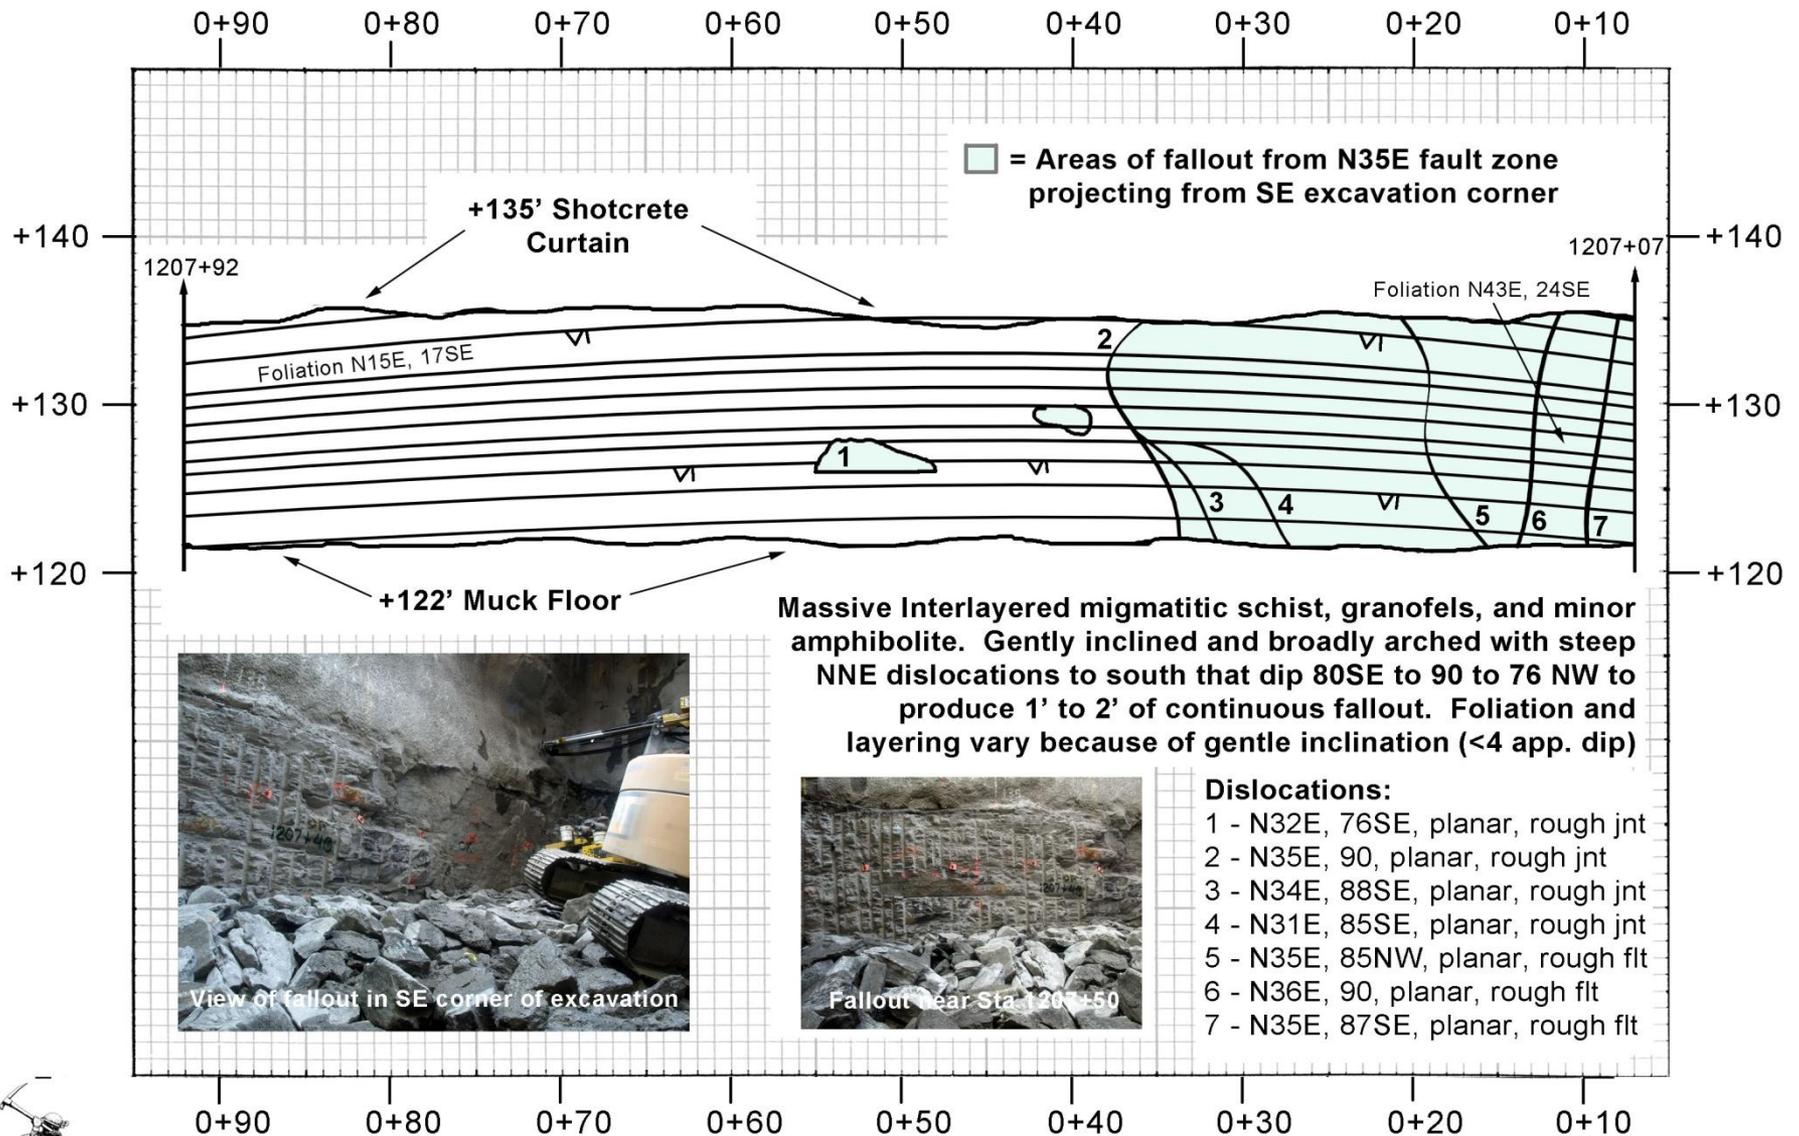
# Second Avenue Subway - Ancillary #2 East Wall (Sta. 1207+07 to 1207+92); Elev. +135' to +122'

Massive Interlayered migmatitic schist, granofels, and minor amphibolite. Gently inclined and broadly arched with steep NNE dislocations to south that dip 80SE to 90 to 76 NW to produce 1' to 2' of continuous fallout. Foliation and layering vary because of gentle inclination (<4 app. dip)

- 1 - N32E, 76SE, planar, rough jnt
- 2 - N35E, 90, planar, rough jnt
- 3 - N34E, 88SE, planar, rough jnt
- 4 - N31E, 85SE, planar, rough jnt
- 5 - N35E, 85NW, planar, rough flt
- 6 - N36E, 90, planar, rough flt
- 7 - N35E, 87SE, planar, rough flt

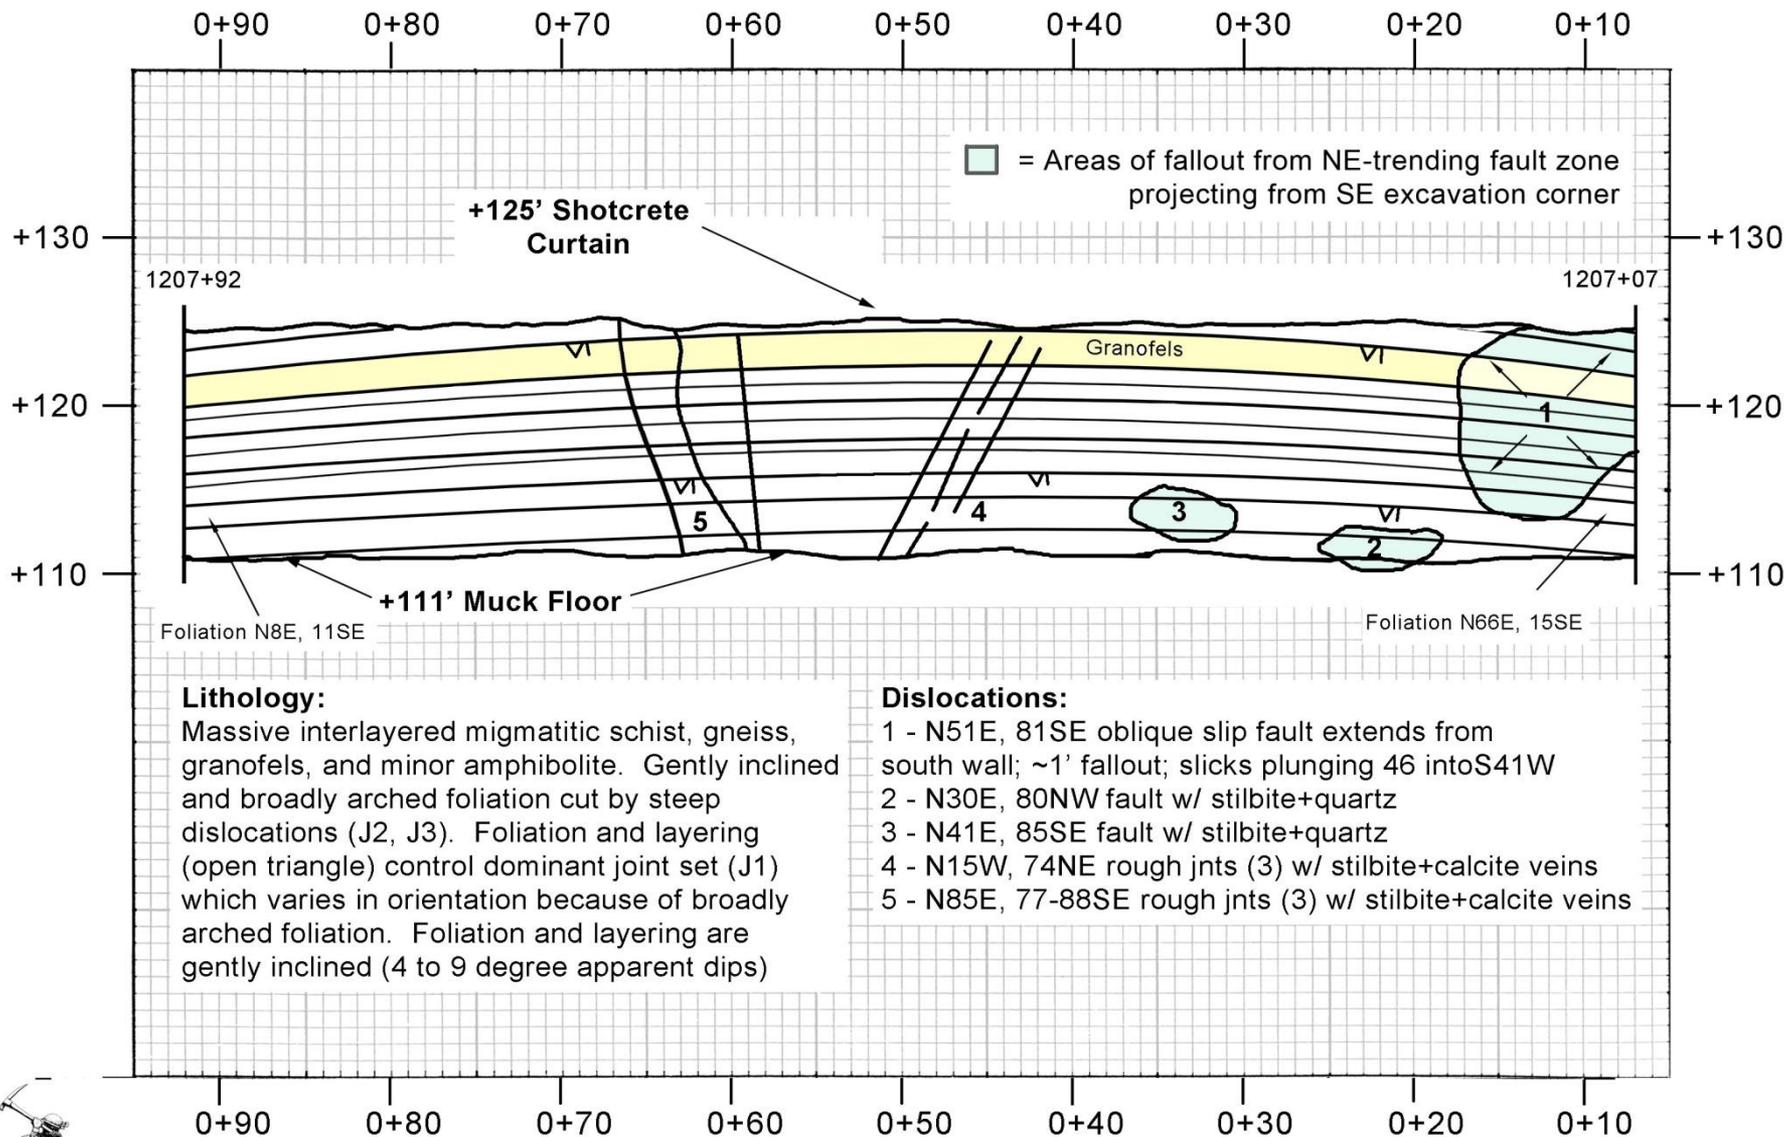
# Second Avenue Subway - Ancillary #2 East Wall Sta. 1207+07 to 1207+92; Elev. +125' to +111'

Massive interlayered migmatitic schist, gneiss, granofels, and minor amphibolite. Gently inclined and broadly arched foliation cut by steep dislocations (J2, J3). Foliation and layering (open triangle) control dominant joint set (J1) which varies in orientation because of broadly arched foliation. Foliation and layering are gently inclined (4 to 9 degree apparent dips)

- 1 - N51E, 81SE oblique slip fault extends from south wall; ~1' fallout; slicks plunging 46 into S41W
- 2 - N30E, 80NW fault w/ stilbite+quartz
- 3 - N41E, 85SE fault w/ stilbite+quartz
- 4 - N15W, 74NE rough jnts (3) w/ stilbite+calcite veins
- 5 - N85E, 77-88SE rough jnts (3) w/ stilbite+calcite veins

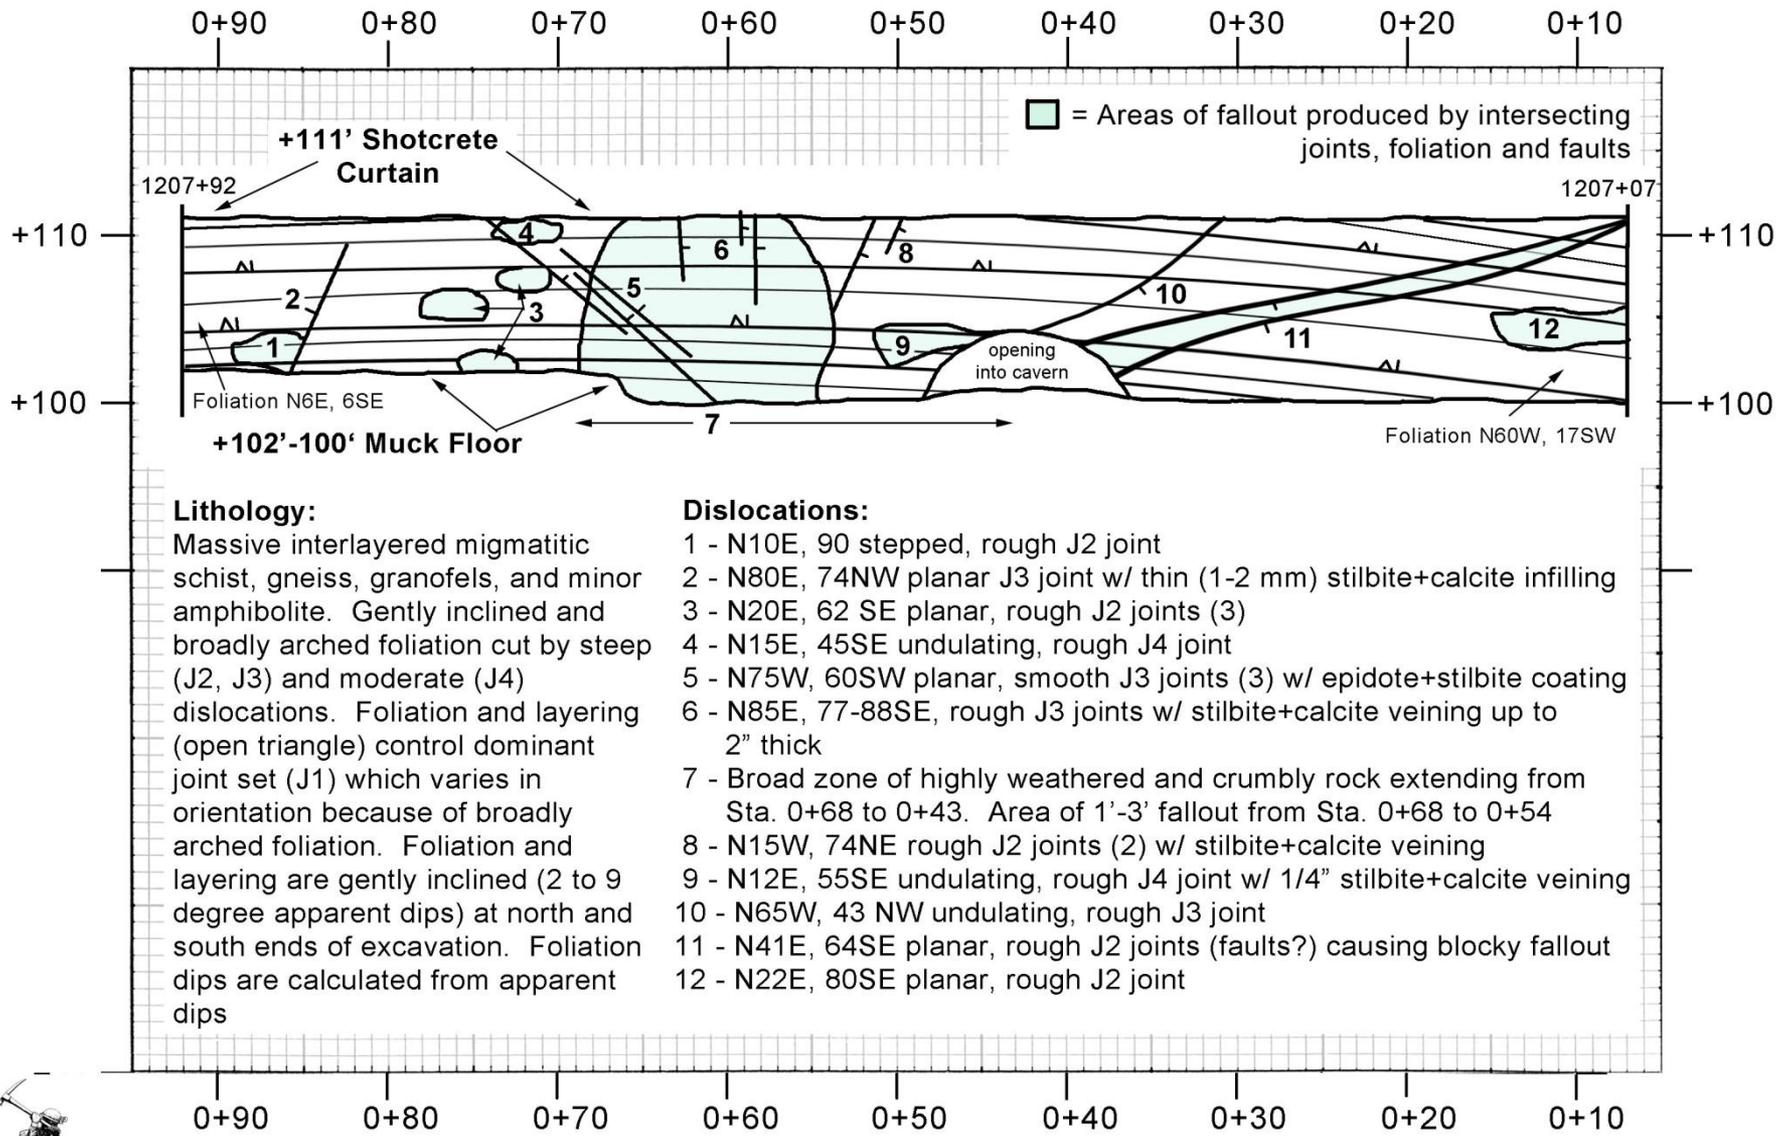
# Second Avenue Subway - Ancillary #2 East Wall Sta. 1207+07 to 1207+92; Elev. +111' to +100'

█ = Areas of fallout produced by intersecting joints, foliation and faults

Massive interlayered migmatitic schist, gneiss, granofels, and minor amphibolite. Gently inclined and broadly arched foliation cut by steep (J2, J3) and moderate (J4) dislocations. Foliation and layering (open triangle) control dominant joint set (J1) which varies in orientation because of broadly arched foliation. Foliation and layering are gently inclined (2 to 9 degree apparent dips) at north and south ends of excavation. Foliation dips are calculated from apparent dips

- 1 - N10E, 90 stepped, rough J2 joint
- 2 - N80E, 74NW planar J3 joint w/ thin (1-2 mm) stilbite+calcite infilling
- 3 - N20E, 62 SE planar, rough J2 joints (3)
- 4 - N15E, 45SE undulating, rough J4 joint
- 5 - N75W, 60SW planar, smooth J3 joints (3) w/ epidote+stilbite coating
- 6 - N85E, 77-88SE, rough J3 joints w/ stilbite+calcite veining up to 2" thick
- 7 - Broad zone of highly weathered and crumbly rock extending from Sta. 0+68 to 0+43. Area of 1'-3' fallout from Sta. 0+68 to 0+54
- 8 - N15W, 74NE rough J2 joints (2) w/ stilbite+calcite veining
- 9 - N12E, 55SE undulating, rough J4 joint w/ 1/4" stilbite+calcite veining
- 10 - N65W, 43 NW undulating, rough J3 joint
- 11 - N41E, 64SE planar, rough J2 joints (faults?) causing blocky fallout
- 12 - N22E, 80SE planar, rough J2 joint
